Smithy at Cwm Elan Mine, Elan Valley, Photographs, Test Pits and Watching Brief

Report by: Trysor

April 2017

Trysor Project No. 2017/550

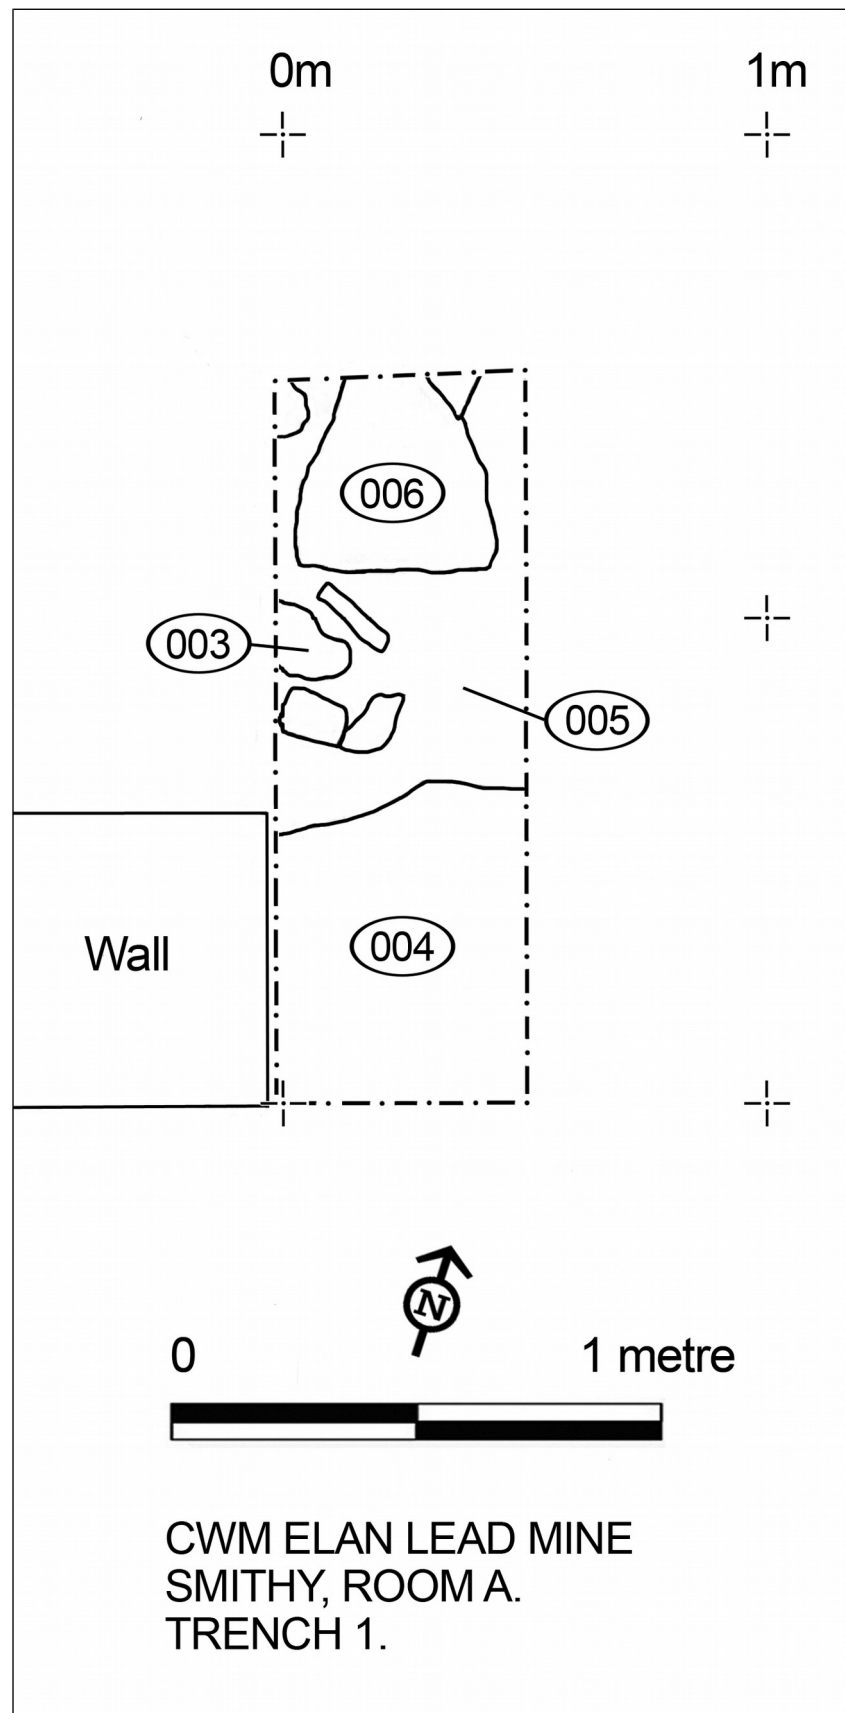
Figure 3: Plan of Trench 1 after removal of (001), (002) and most of (003)

9.2 Trench 1 in the eastern cell of the building (Room A) had recent mortar (001) from the renovation work, overlying a turf layer (002), overlying a mixed mortar soil with small fragments of stone/slate (003) a layer developed as the building began to decay. At its base were fragments of window glass.

9.3 Layer (003) overlaid the threshold slab (004) in the doorway of the eastern cell (Room A), and over a slate slab (006) thought to be a slate floor at the northern end of the trench. Between (004) and (006) was a band of fine slate gravel (005). The origin or purpose of (005) was not clear but was thought to possibly represent some form of drainage. Contexts (004), (005) and (006) were left in situ.

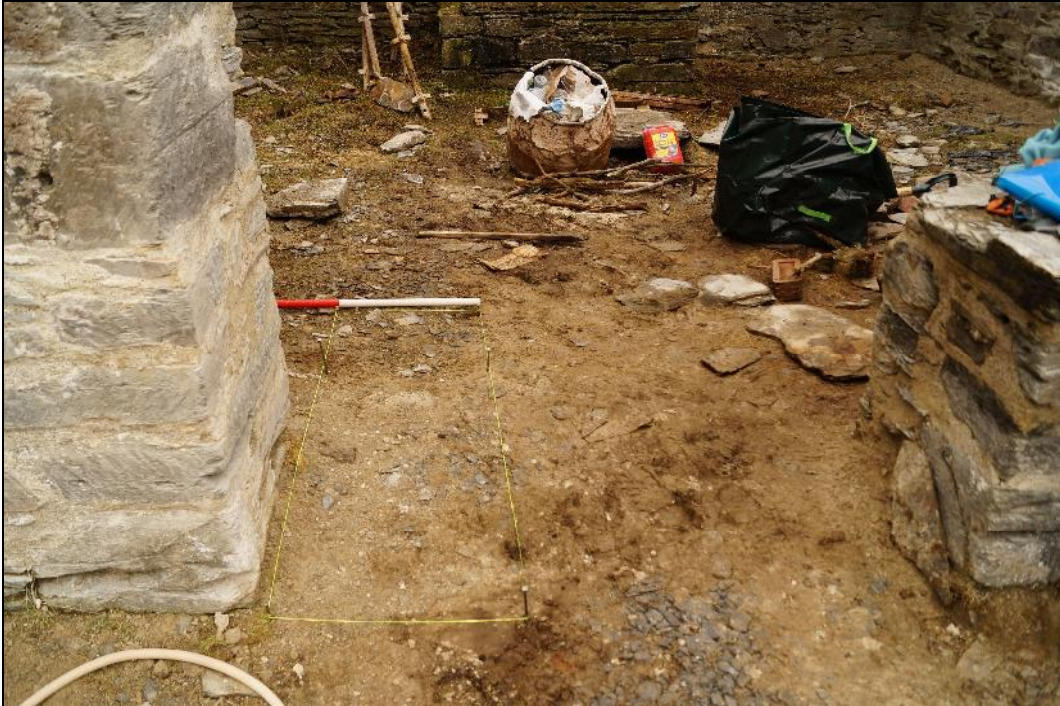
Plate 11: CEM2017_111. The existing ground surface (001), which includes modern building rubble and cement, at the entrance of Room A, showing Test Pit 1 pegged out ready for excavation. Looking north-northwest.

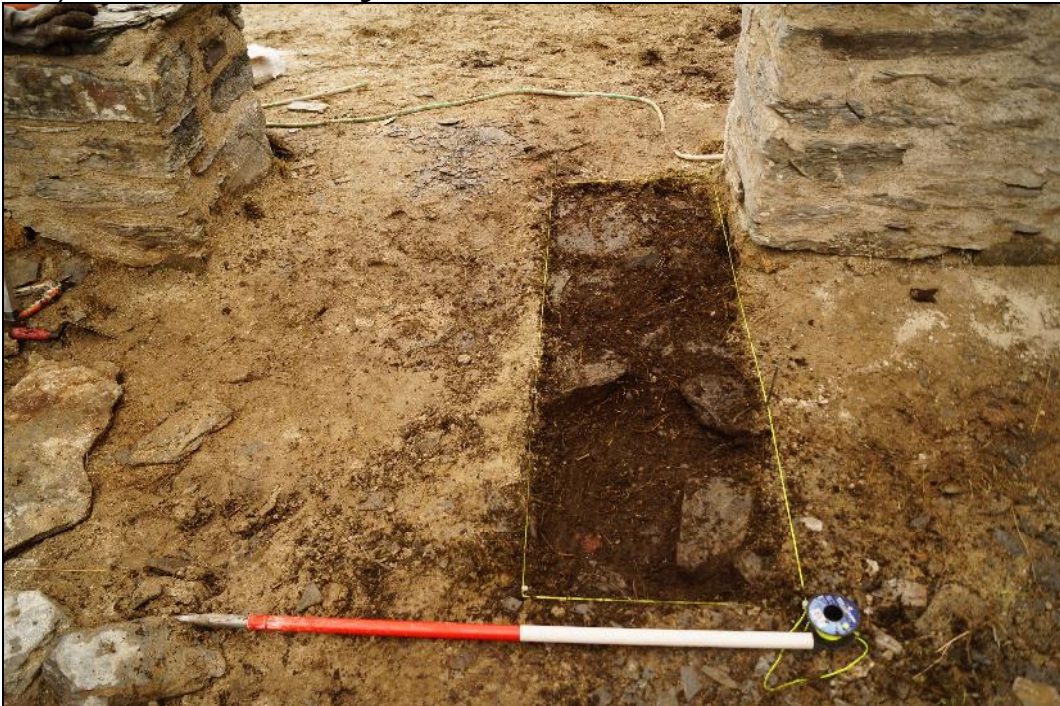
Plate 12: CEM2017_112. The removal of the renovation material (001) in Trench A reveals the turf layer (002) above a jumble of stones derived from the ruination of the building after it fell out of use (003). Looking south-southeast.

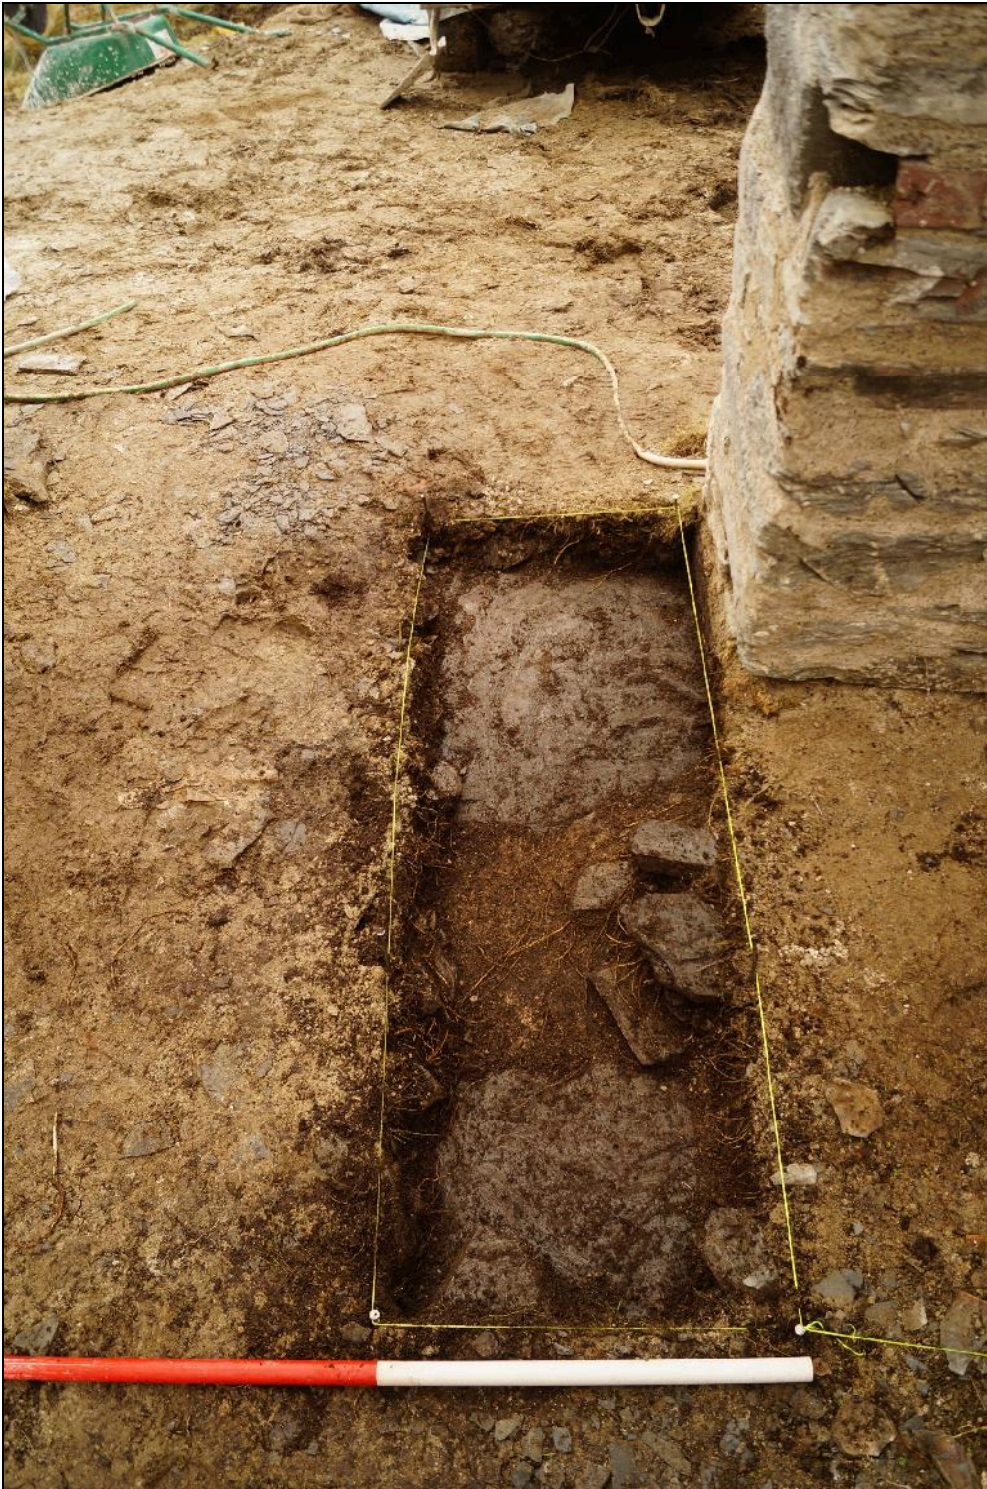
Plate 13: CEM2017_113. A view of Test Pit 1 showing the flagstone of the smithy floor (006) in the foreground with a large threshold slab (004) at the top of the trench, separated by a layer of shale gravel (005) which may represent an infilled gully or drain (this was not excavated). Looking south-southeast.

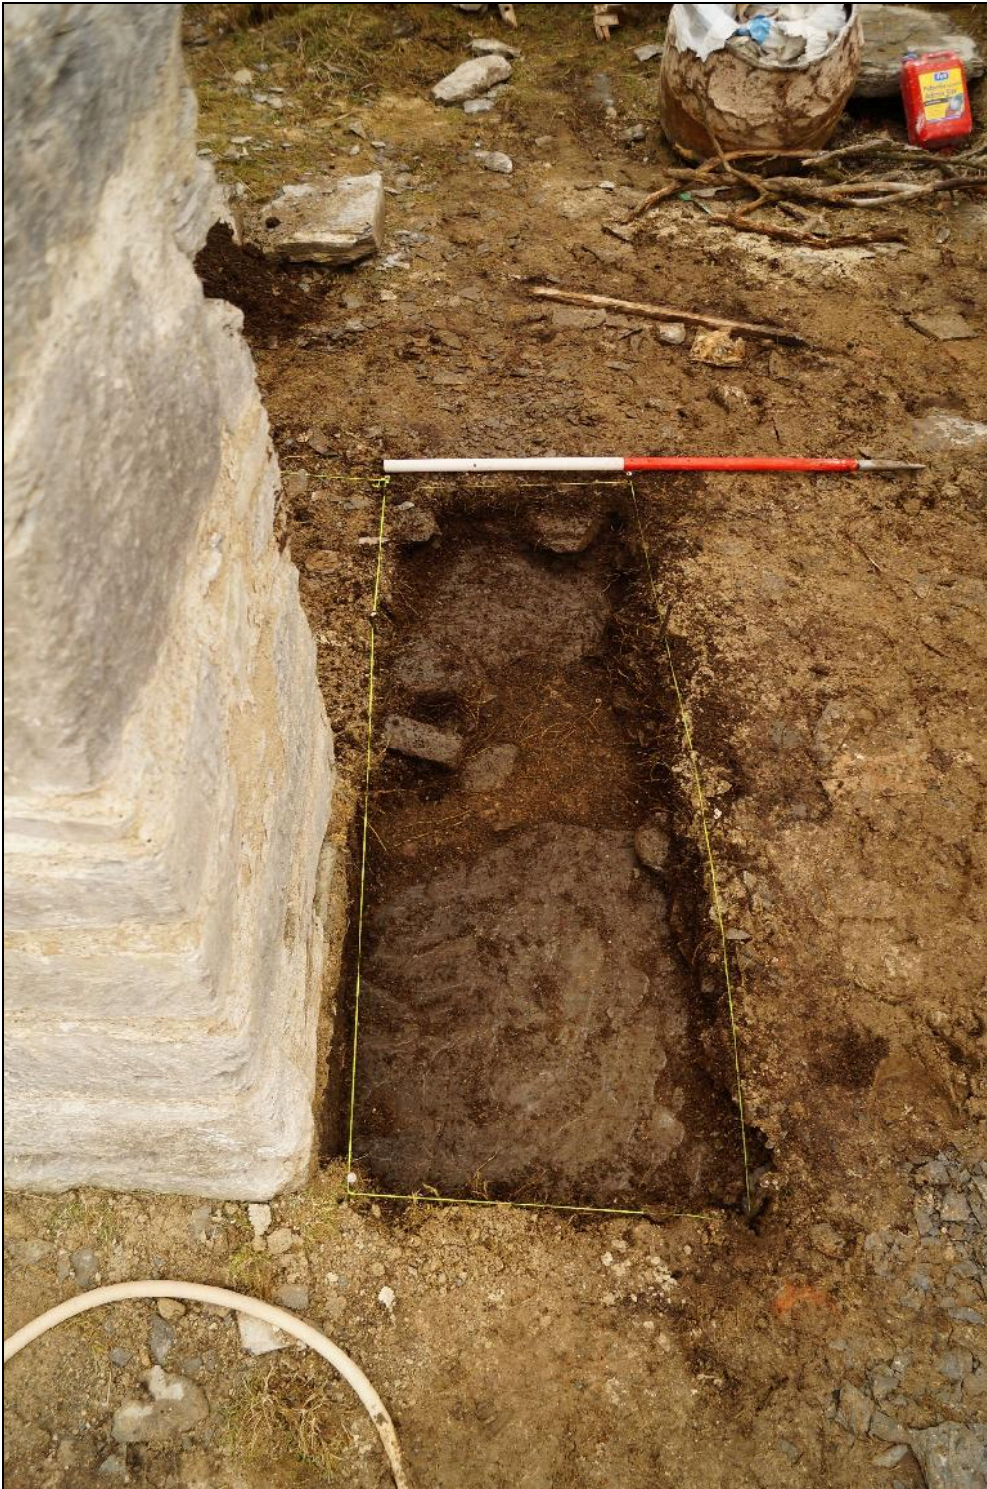
Plate 14: CEM2017_114. A view of Test Pit 1 showing the flagstone of the smithy floor (006) in the foreground with a large threshold slab (004) at the top of the trench, separated by a layer of shale gravel (005) which may represent an infilled gully or drain (this was not excavated). Looking north-northwest.

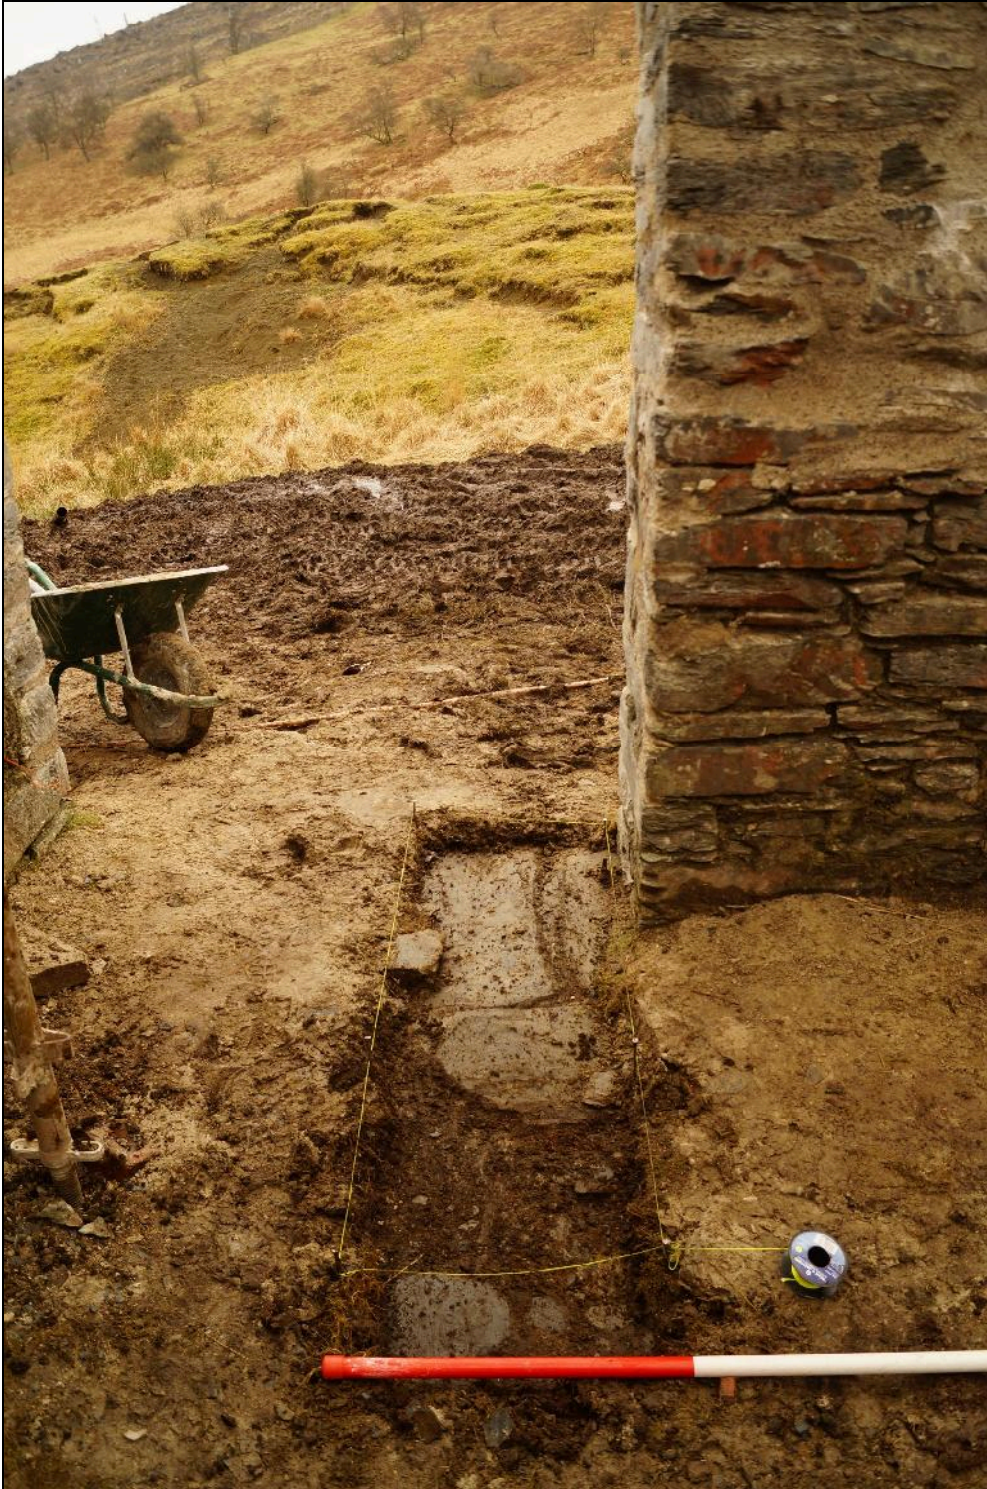
Plate 15: CEM2017_115. A view of Test Pit 2 at the entrance into Room B after removing layer (007). The view shows threshold stones (008) at the doorway and evidence of a stone and clay floor (009) in the foreground. Looking south-southeast.

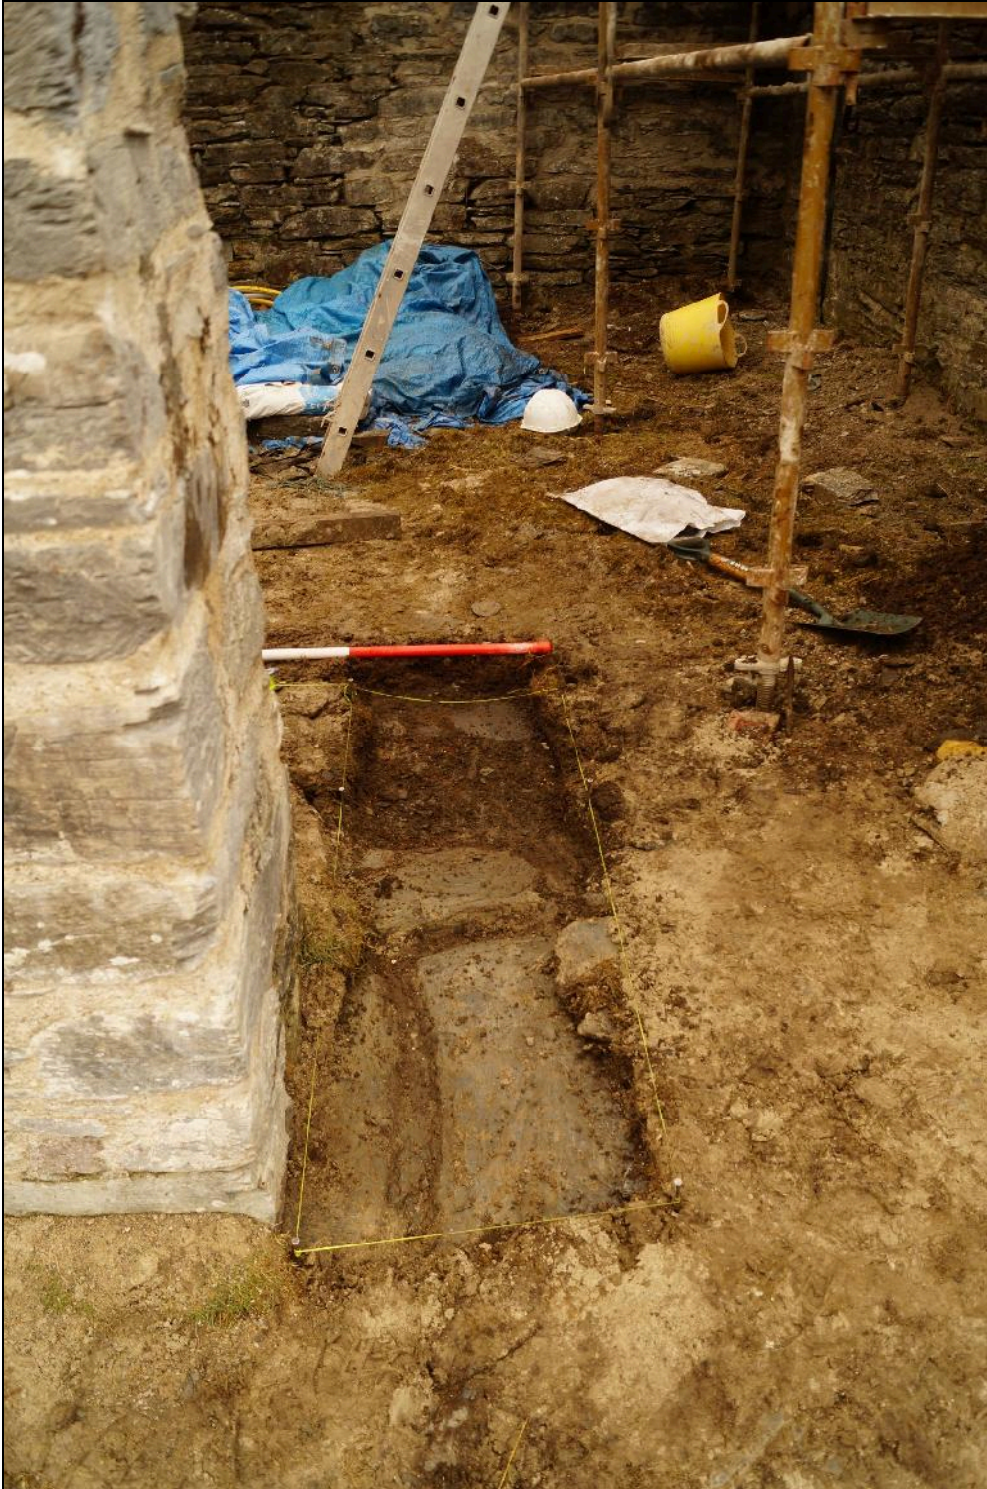
Plate 16: CEM2017_116. A view of Test Pit 2 at the entrance into Room B after removing layer (007). The view shows threshold stones (008) at the doorway and evidence of a stone and clay floor (009) in the foreground. Looking north-northwest.

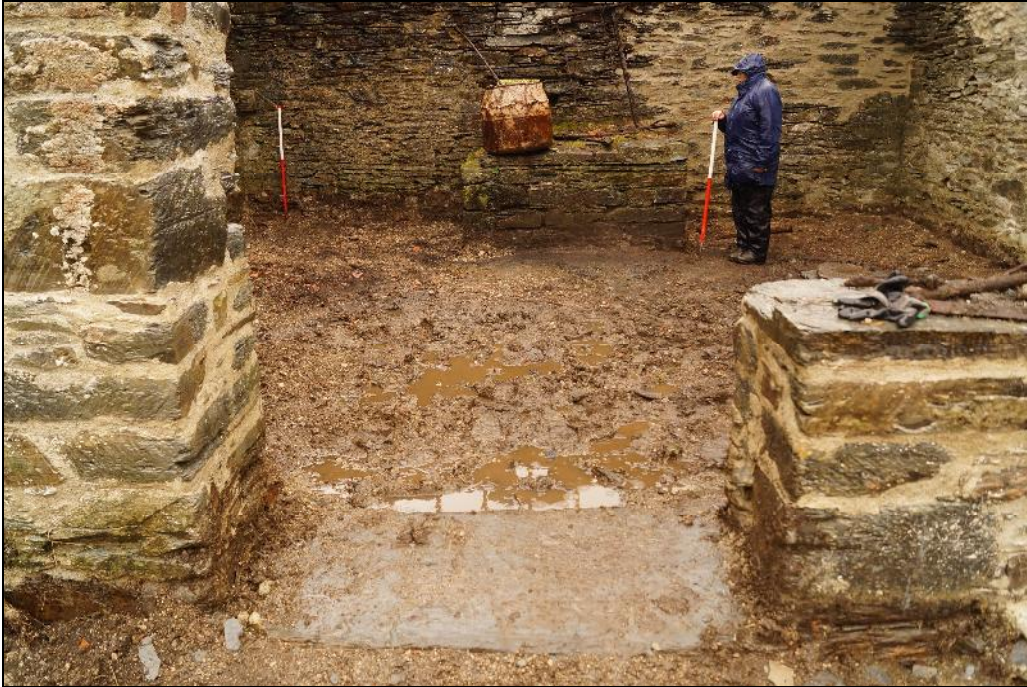
Plate 29: CEM2017_129. A view of the entrance into Room A, the forge, showing the threshold stone (004), after the removal of the layers (001) and (002) inside the room. This level was maintained and terram and gravel was to be laid across the interior without further material being removed. Looking north-northwest.

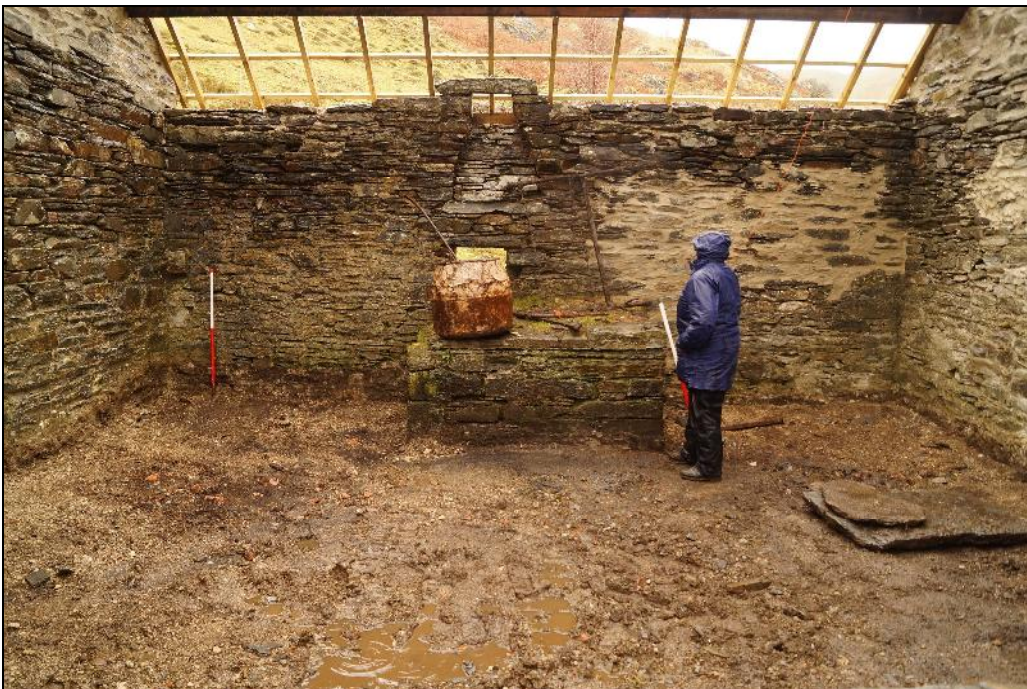
Plate 30: CEM2017_130. A view of the forge inside Room A after partial removal of layers (001) and (002). Note the darker layer (010) exposed in front of the forge, which may be waste derived from the work at the smithy. Looking north-northwest.

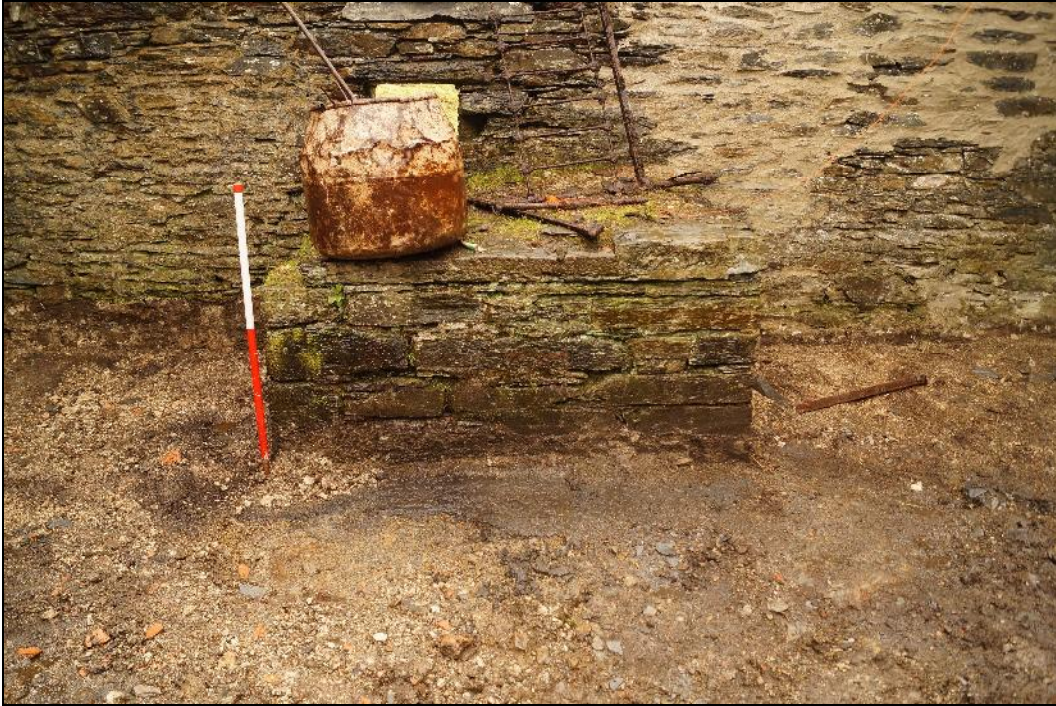
Plate 31: CEM2017_131. A closer view of the forge and the darker layer (010) around its base. Looking north-northwest.

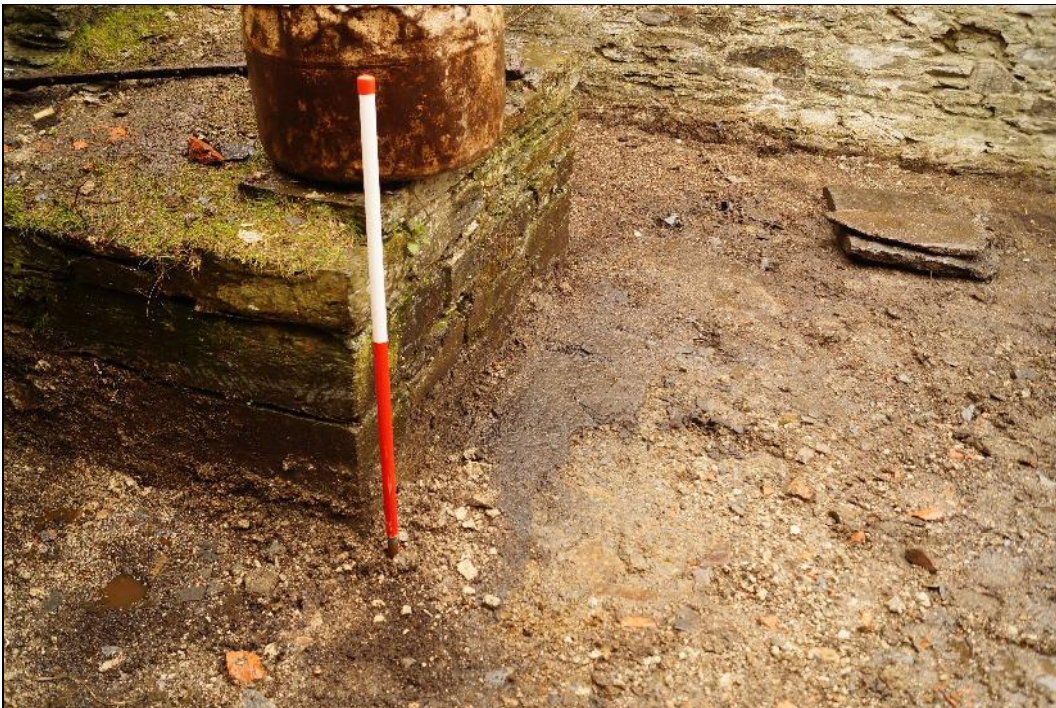
Plate 32: CEM2017_132. A closer view of the forge and the darker layer (010) around its base. Looking northeast.

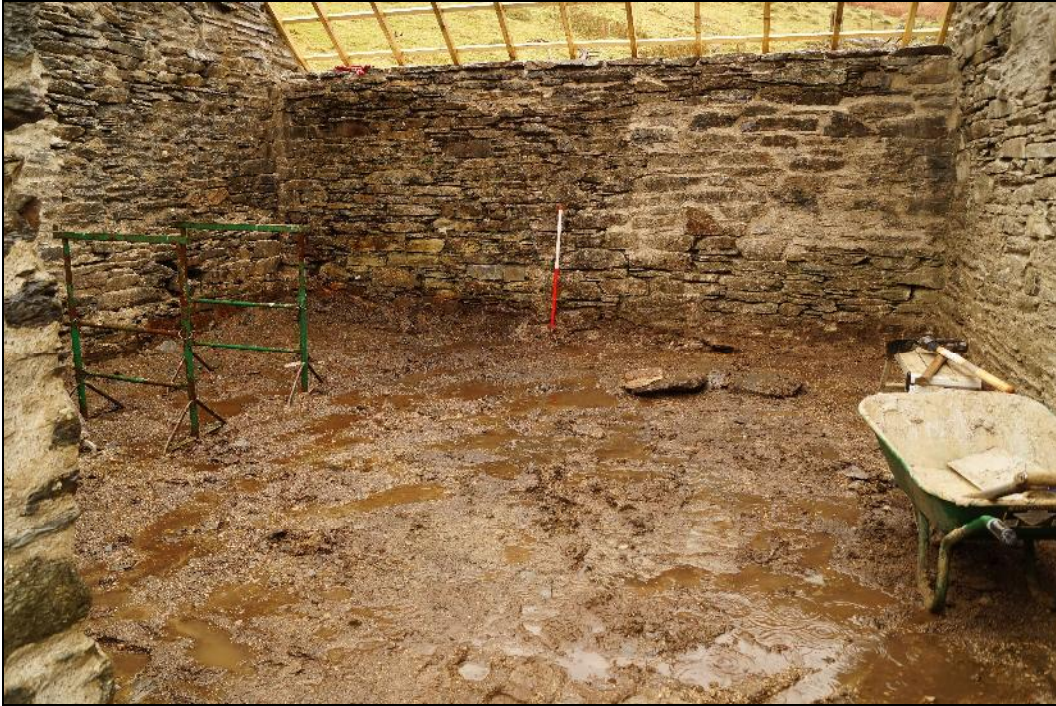
Plate 33: CEM2017_133. A view of the floor of Room B, after the removal of the mixed layer (007). This level was maintained and terram and gravel was to be laid across the interior. Looking northwest.

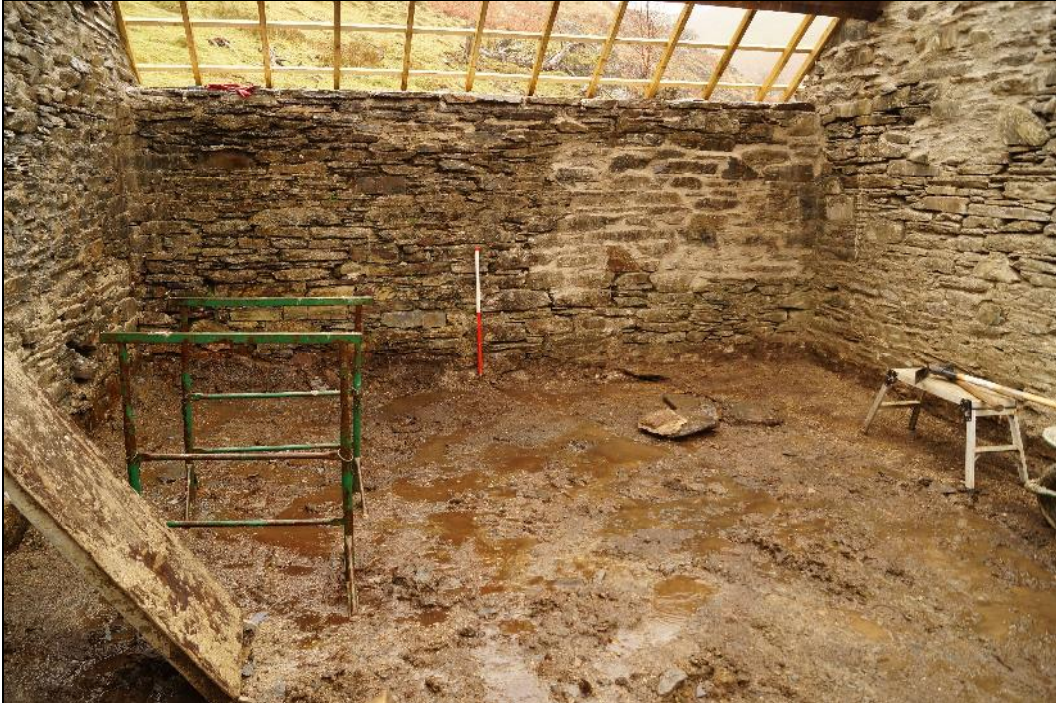
9.5 During the watching brief the levels within the two cells were reduced slightly by machine to just above archaeologically significant contexts. The possible flag floor (006) seen in the evaluation trench in Room A did not appear to be present across the whole of that cell. Around the base of the forge hearth was (010), a black, fine-grained, hard layer, thought to be the remains of scale from the forge. Terram and gravel was laid directly over the reduced level with no raking beforehand. A similar process was undertaken in Room B, which was wetter due to groundwater flowing through the building from the northern wall which is revetted into the slope.

Plate 34: CEM2017_134. A view of the floor of Room B, after the removal of the mixed layer (007). The surface was quickly covered with waterlogged mud, with ground water flowing from the north wall towards the south wall. This level was maintained and terram and gravel was to be laid across the interior. Looking north.
