# Dam Builders Hut at Cwmclyd Farmstead Level 2 Building Recording

Report by: Trysor

For: The Elan Valley Trust

Trysor Project No. 2018/622

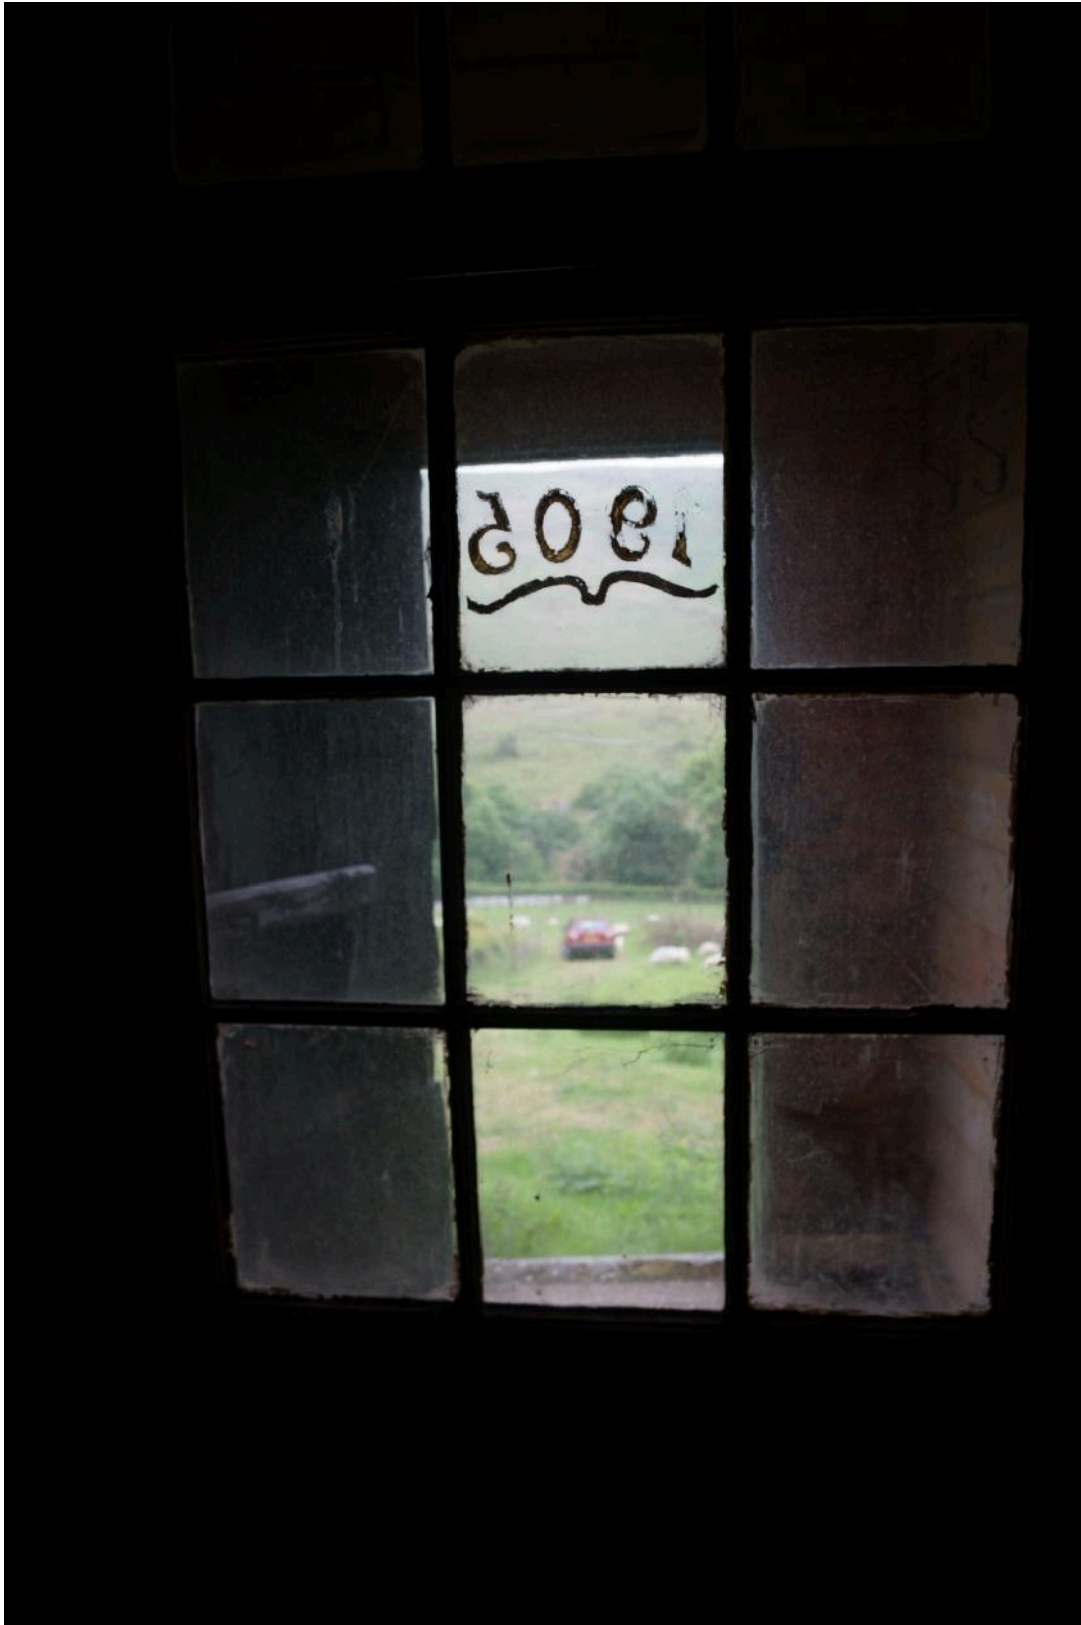
7.2.1 There is no record of when the "Dam Builders' Hut" was taken to Cwmclyd or from where it was brought. It has the date 1905 painted on a glass pane of the front door (see Plates 18 and 19) but it is not certain that the hut was erected at Cwmclyd at that time.

*Plate 19: CYB2018\_019. A view inside the porch at the front door of the Dam Builders' Hut. Note the 1905 date on the glass pane in the door. Looking north-northwest.*

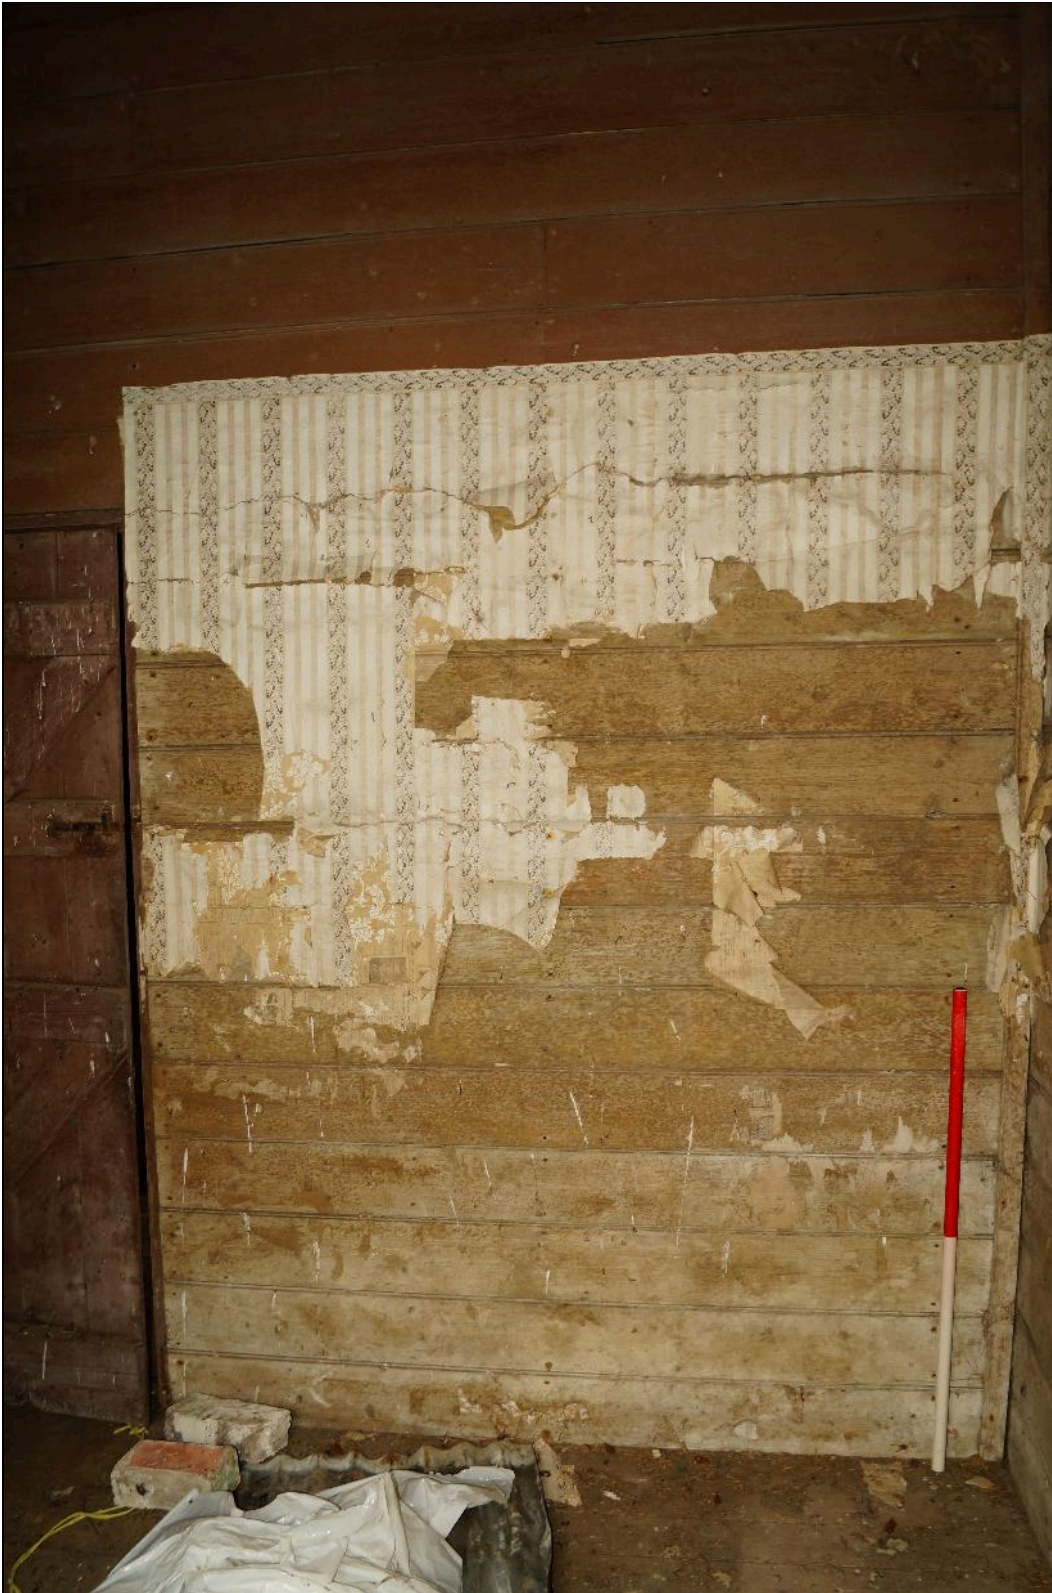
7.2.2 During the building survey it was noted that newspapers used as lining on some of the walls inside the hut date to the period 1910 to 1912. These may point to an early 20<sup>th</sup> century date for the erection and internal decoration of the hut at its present site.

*Plate 78: CYB2018\_078. A view of the southern side of Room 06, showing surviving wallpaper and newspaper lining. Looking south-southwest.*

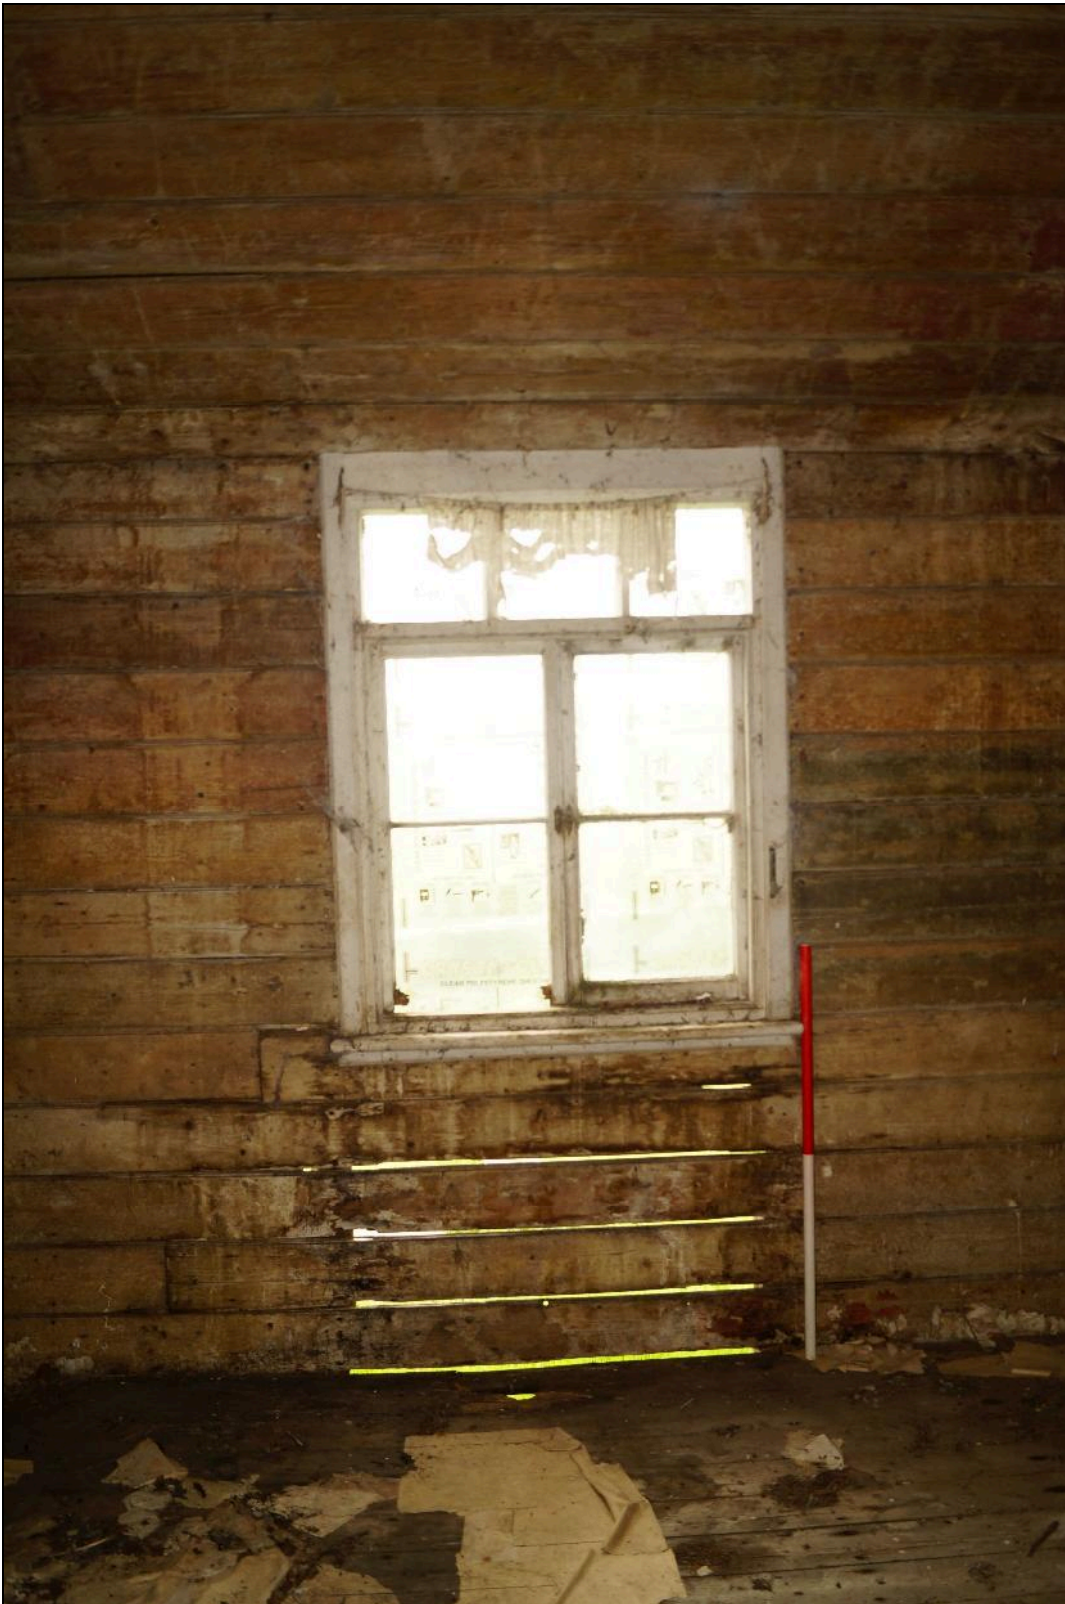
CYB2018_096	A view of the window in the southern wall of Room 08, showing the crude repair to the hole beneath the window.	South-southwest
CYB2018_097	A view of the southern side of Room 08.	Southwest
CYB2018_098	A view of the southern side of Room 08.	South-southeast
CYB2018_099	A view of the fireplace in Room 09. The fire surround and grate have been removed.	North-northwest
CYB2018_100	A view of the western side of Room 09.	West-northwest
CYB2018_101	A view of the doorway in Room 09 which leads out to Room 07, the main corridor.	North-northeast
CYB2018_102	A view of the northern side of Room 09. Note the wooden floorboards.	Northeast
CYB2018_103	A view of the eastern side of Room 09.	East-southeast
CYB2018_104	A view of the eastern side of Room 09.	Southeast
CYB2018_105	A view of the southern side of Room 09.	South-southwest
CYB2018_106	A view of the southern side of Room 09, showing the central window.	South-southwest

*Plate 96: CYB2018\_096. A view of the window in the southern wall of Room 08,  
showing the crude repair to the hole beneath the window. Looking south-southwest.*

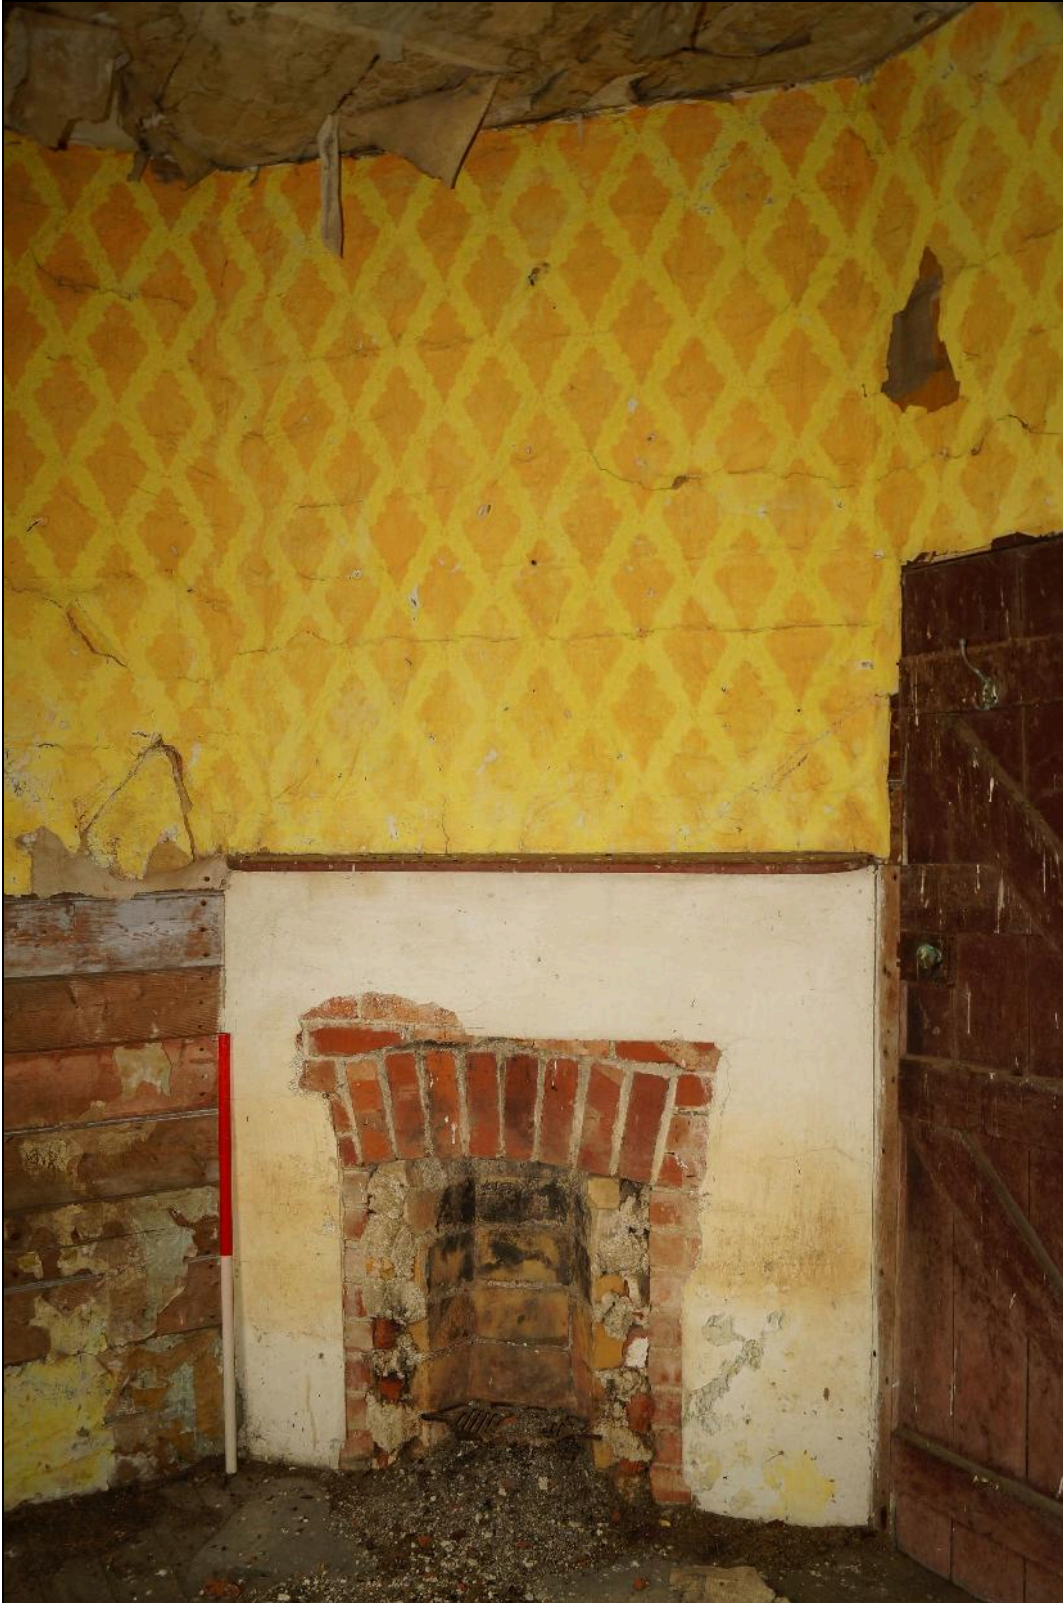
*Plate 99: CYB2018\_099. A view of the fireplace in Room 09. The fire surround and grate have been removed. Looking north-northwest.*
