**Cwmclyd Farmstead,
Claerwen Valley,
Rhayader, Powys
Level 2 Building Recording
P/2017/0573 (Powys)**

For: The Elan Valley Trust

August 2018

Trysor Project No. 2018/619

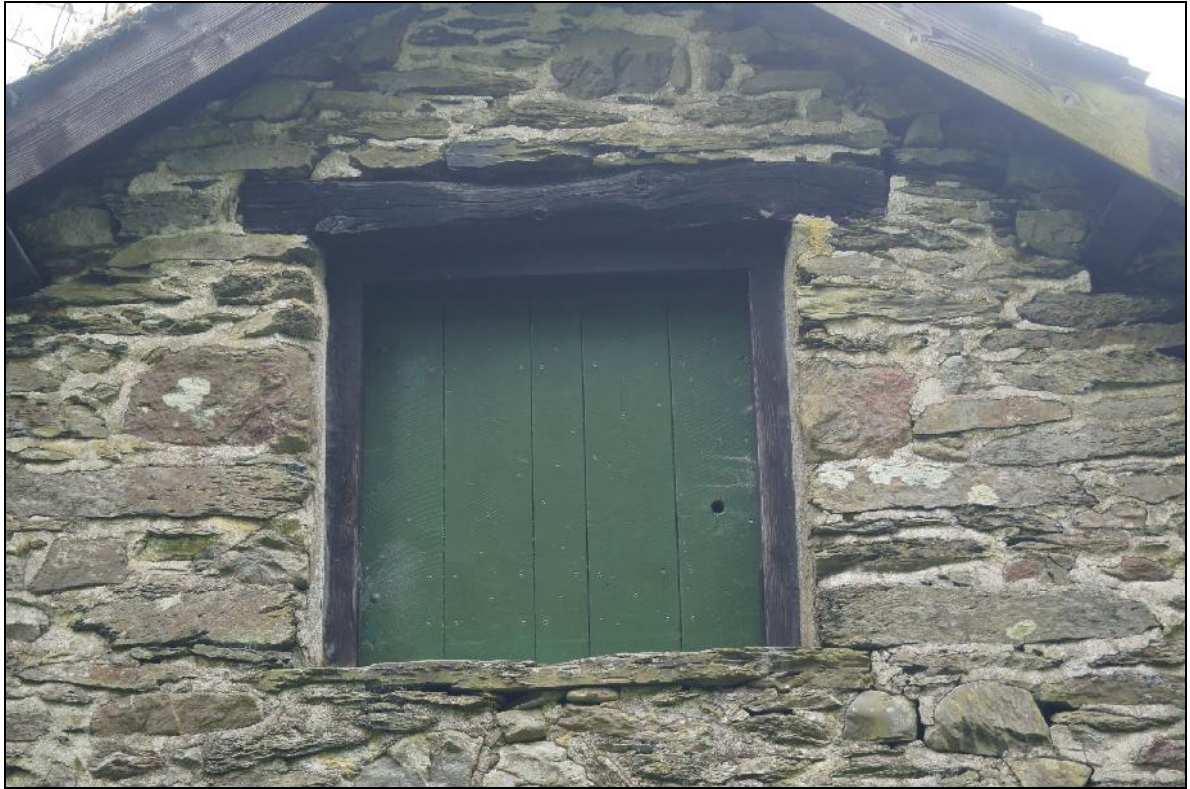
Plate 21: CYD2018_021, external view of the stable and cartshed building looking south-southeast, showing the hayloft door.

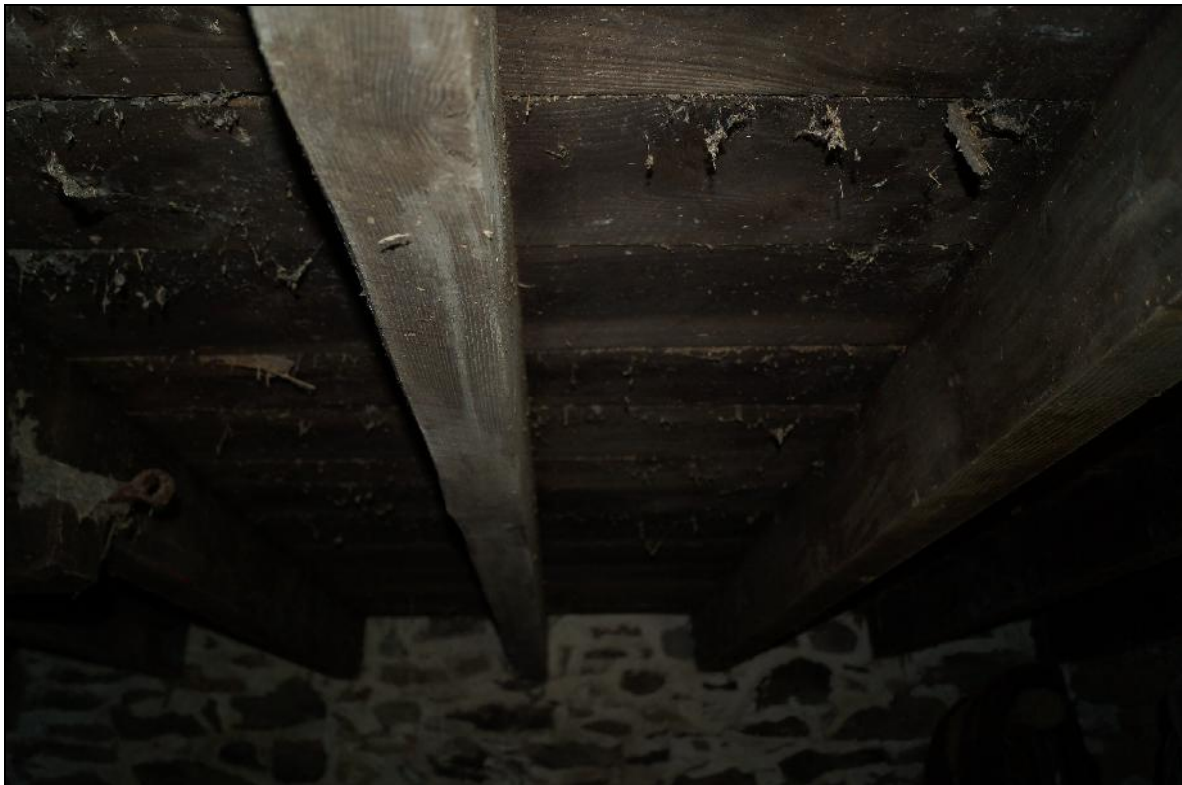
Plate 34: CYD2018_034, the ceiling of the stable is composed of modern, machine-sawn beams with a modern plank floor above. The original beams and flooring must have been replaced in modern times.

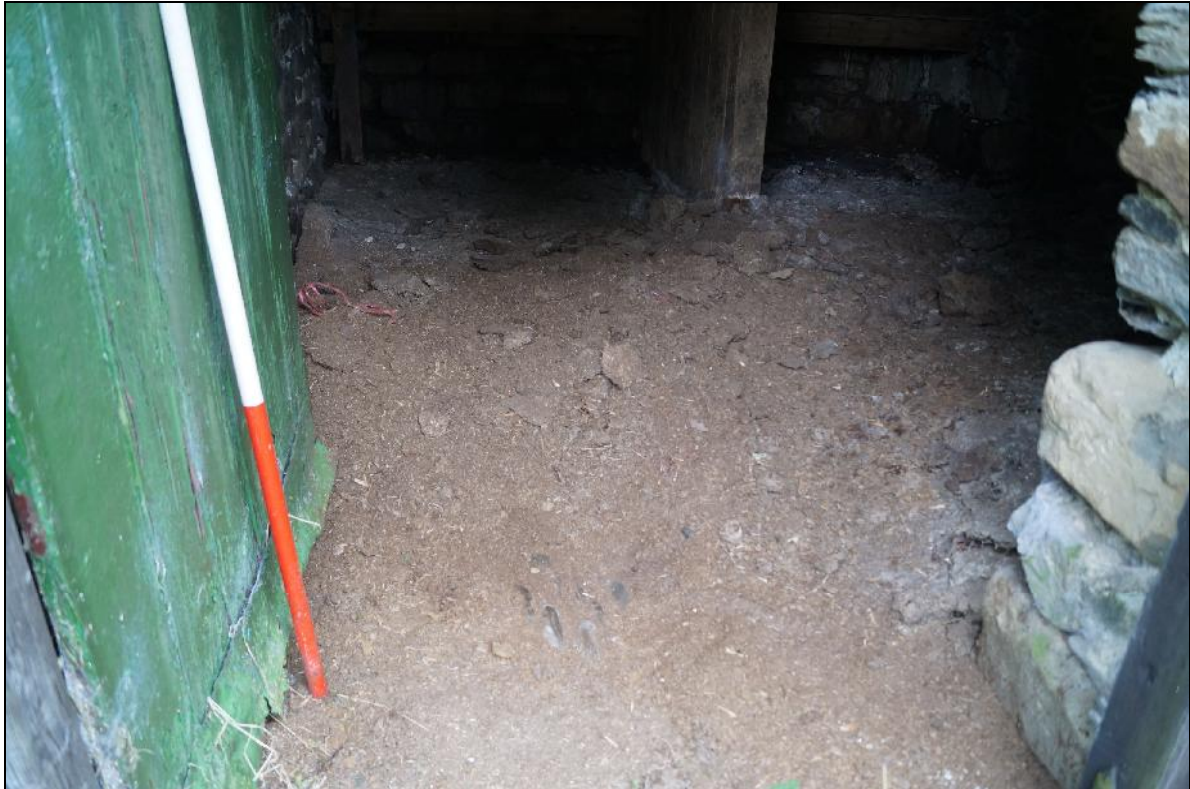
Plate 35: CYD2018_035, a view through the doorway into the stable, with evidence of a cobbled floor exposed through the accumulated debris, looking east-northeast.

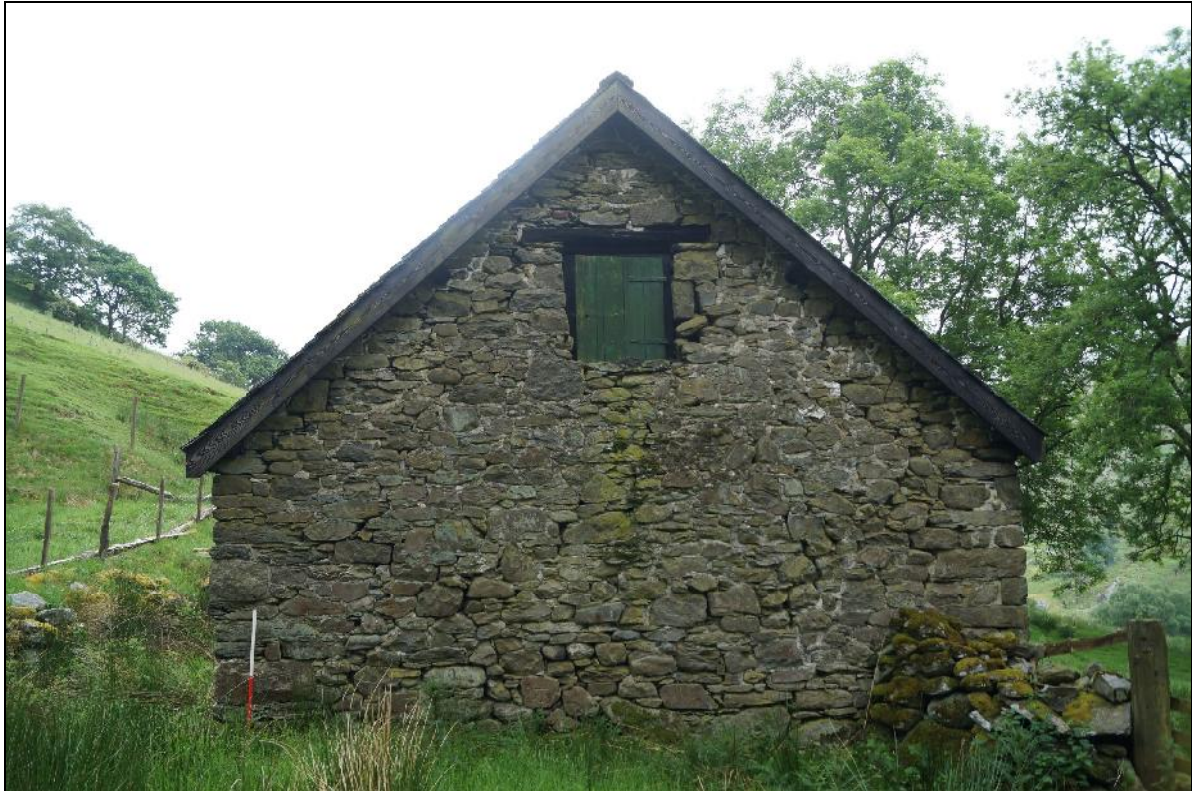
Plate 37: CYD2018_037, an external view of the north wall of the house and cowshed building, looking east-southeast. An Ordnance Survey benchmark is visible towards the base of the centre of the wall.

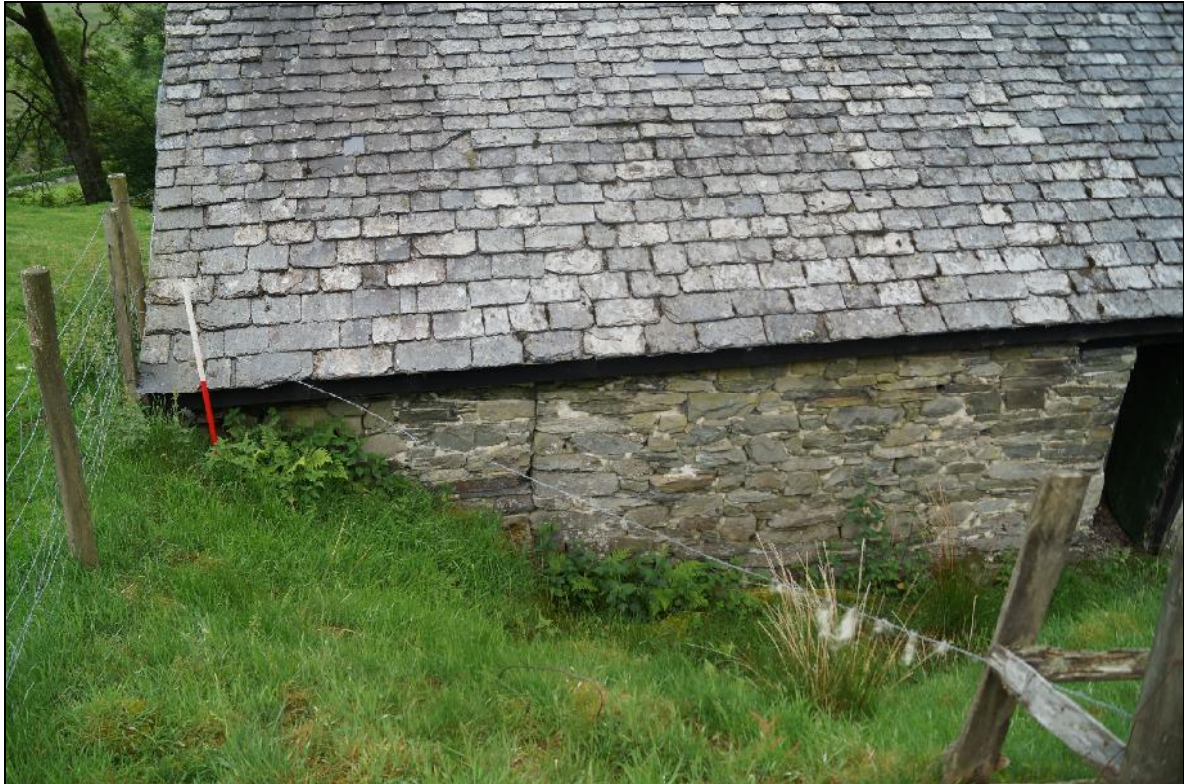
Plate 43: CYD2018_043, external view of the southern end of the house and cowshed building, looking west-southwest, showing rip joint said to represent an original doorway (see Plates 90 & 91 for internal views).

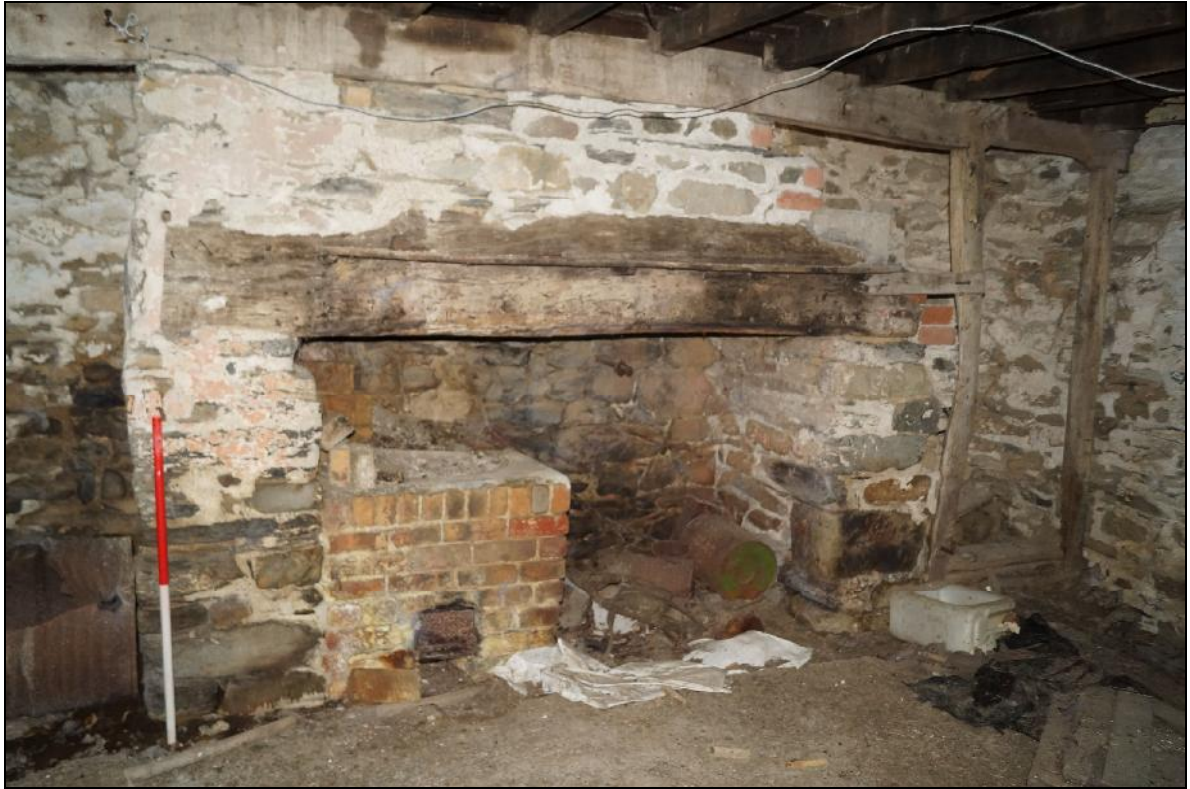
Plate 93: CYD2018_093, an interior view of the fireplace in the kitchen, looking south. The brick insert was the housing for a water boiler.

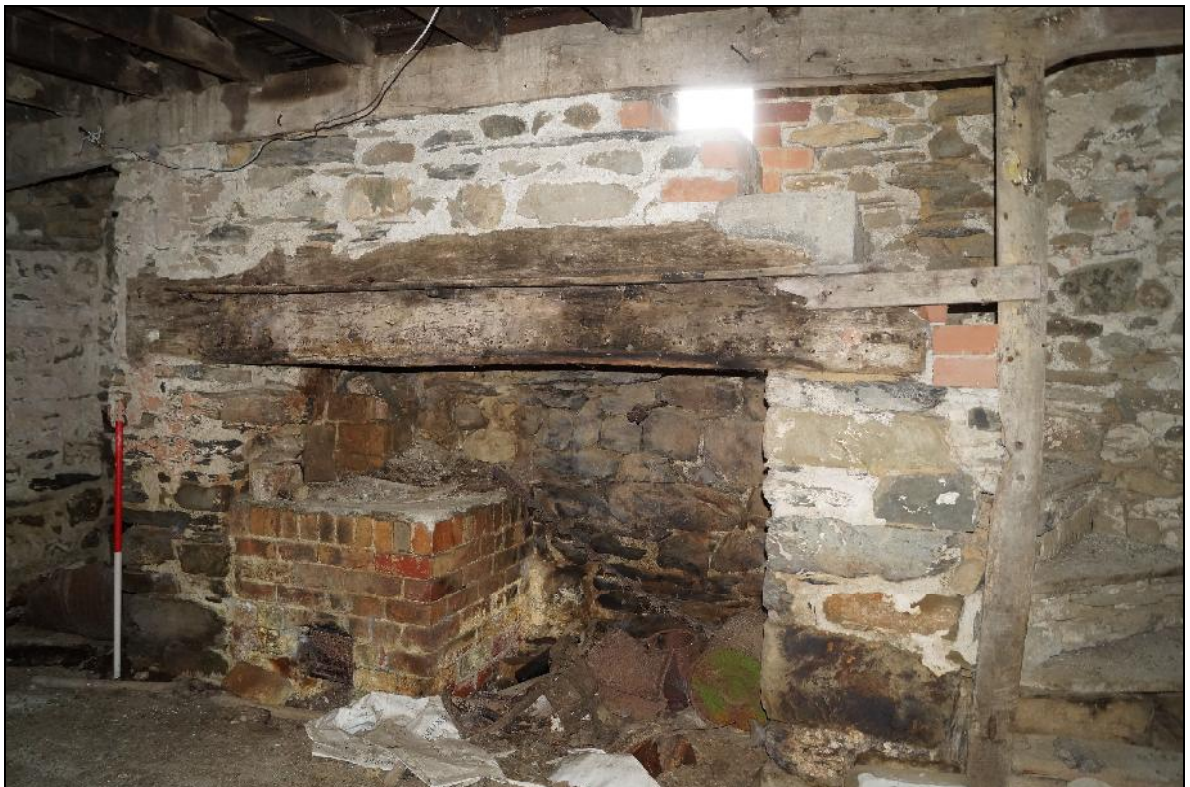
Plate 94: CYD2018_094, an interior view of the fireplace in the kitchen, looking southeast. The brick insert was the housing for a water boiler.

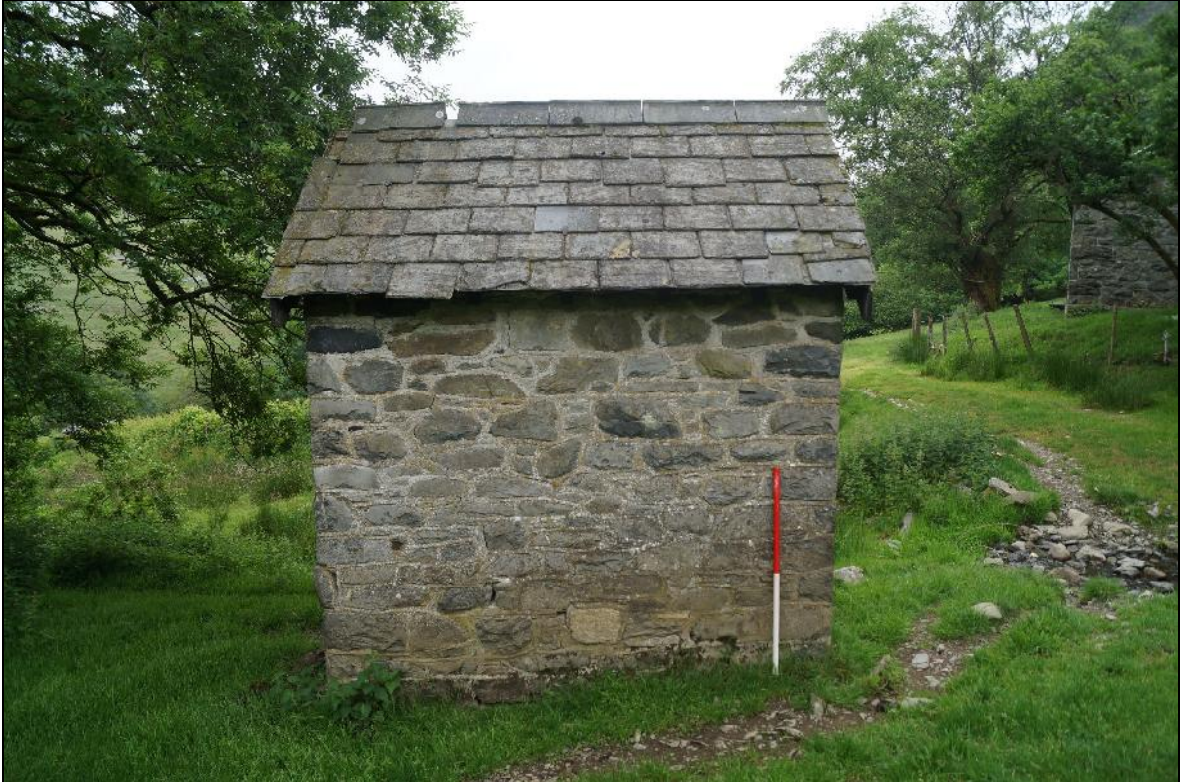
Plate 109: CYD2018_109, a view of the privy at Cwmclyd, looking west-northwest.

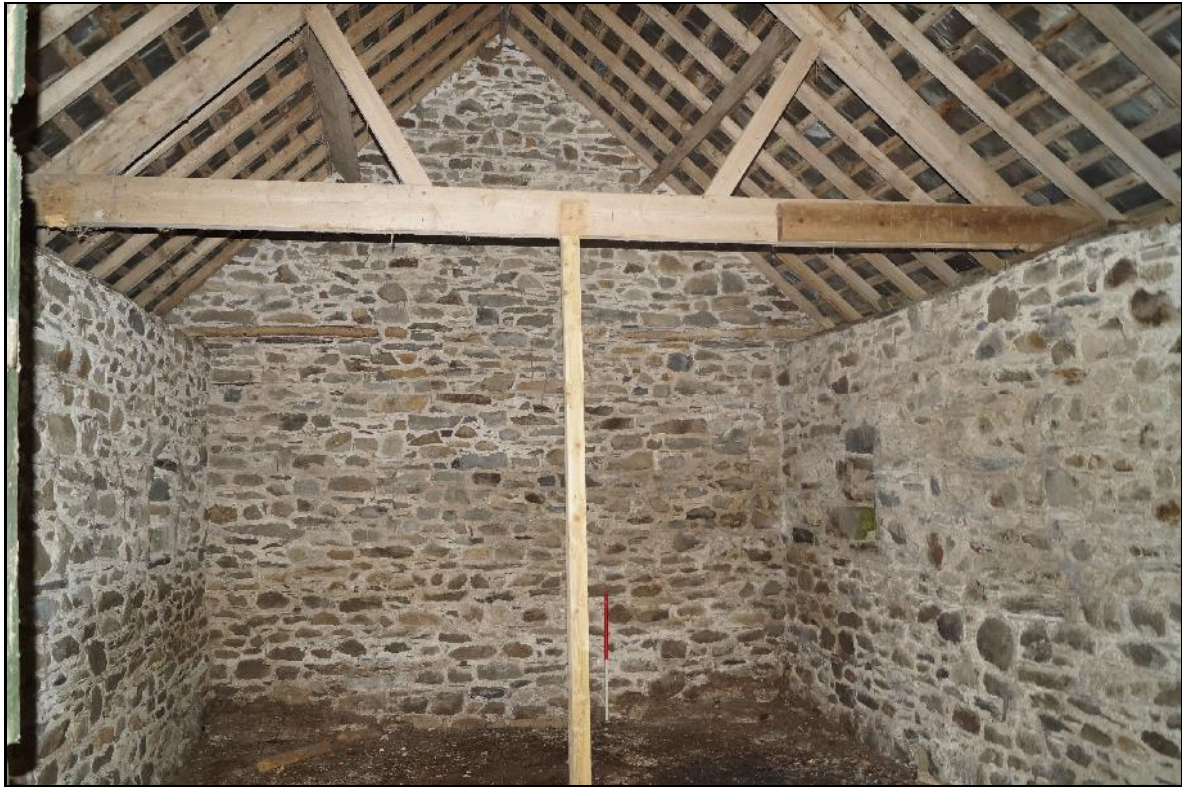
Plate 123: CYD2018_123, an interior view of the barn, looking south towards the gable wall. Note the modern roof and supporting timbers.

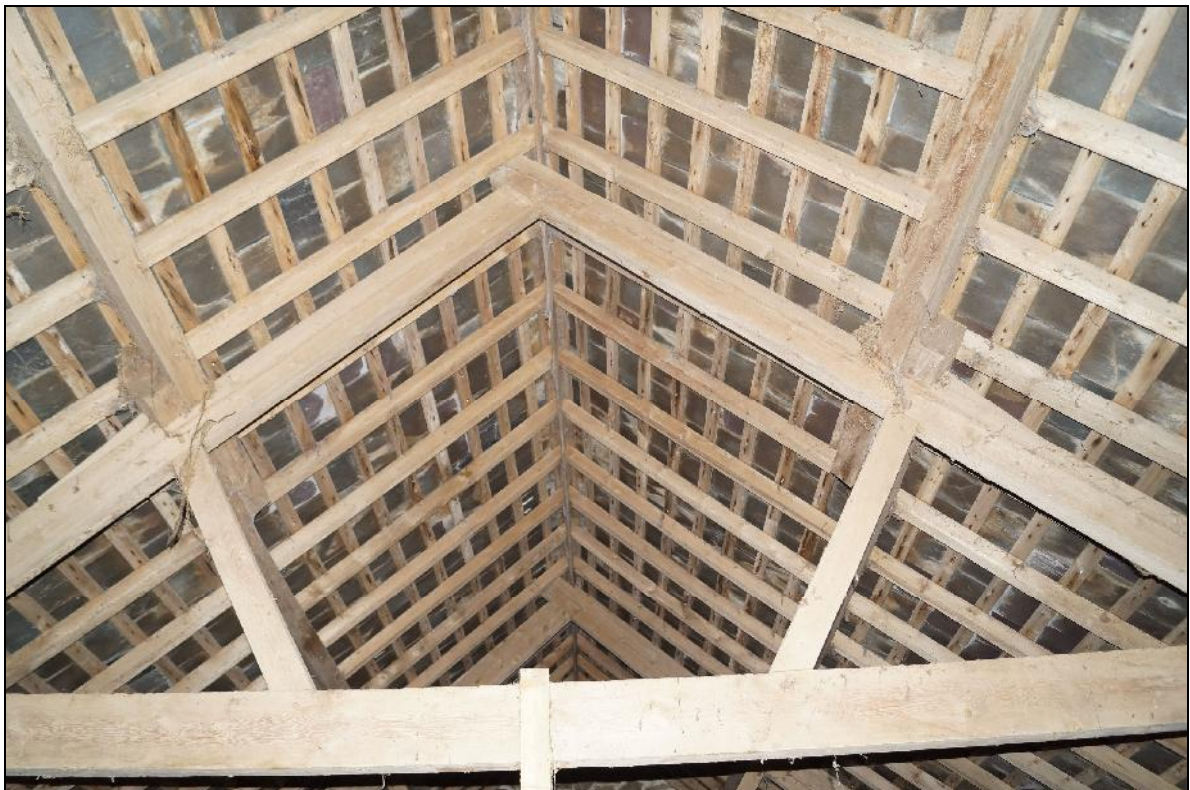
7.6.7 The roof of the building has clearly undergone significant repair to the extent that most of the timberwork is now of modern date. The slates in the roof have been attached with wooden pegs, but on to modern timber.

Plate 136: CYD2018_135, an interior view of the barn roof, which is a modern construction. Roofing nails have been used to fix the slates, whereas as wooden pegs were used to re-roof the house and cowshed. Looking north.
