Test Pit at Pumping Wheel Pit, Cwm Elan Mine, Cwm Elan, Rhayader Scheduled Monument RD153

Report by: Trysor

For: Selwyn Elan Valley Trust

Trysor Project No. 2018/618

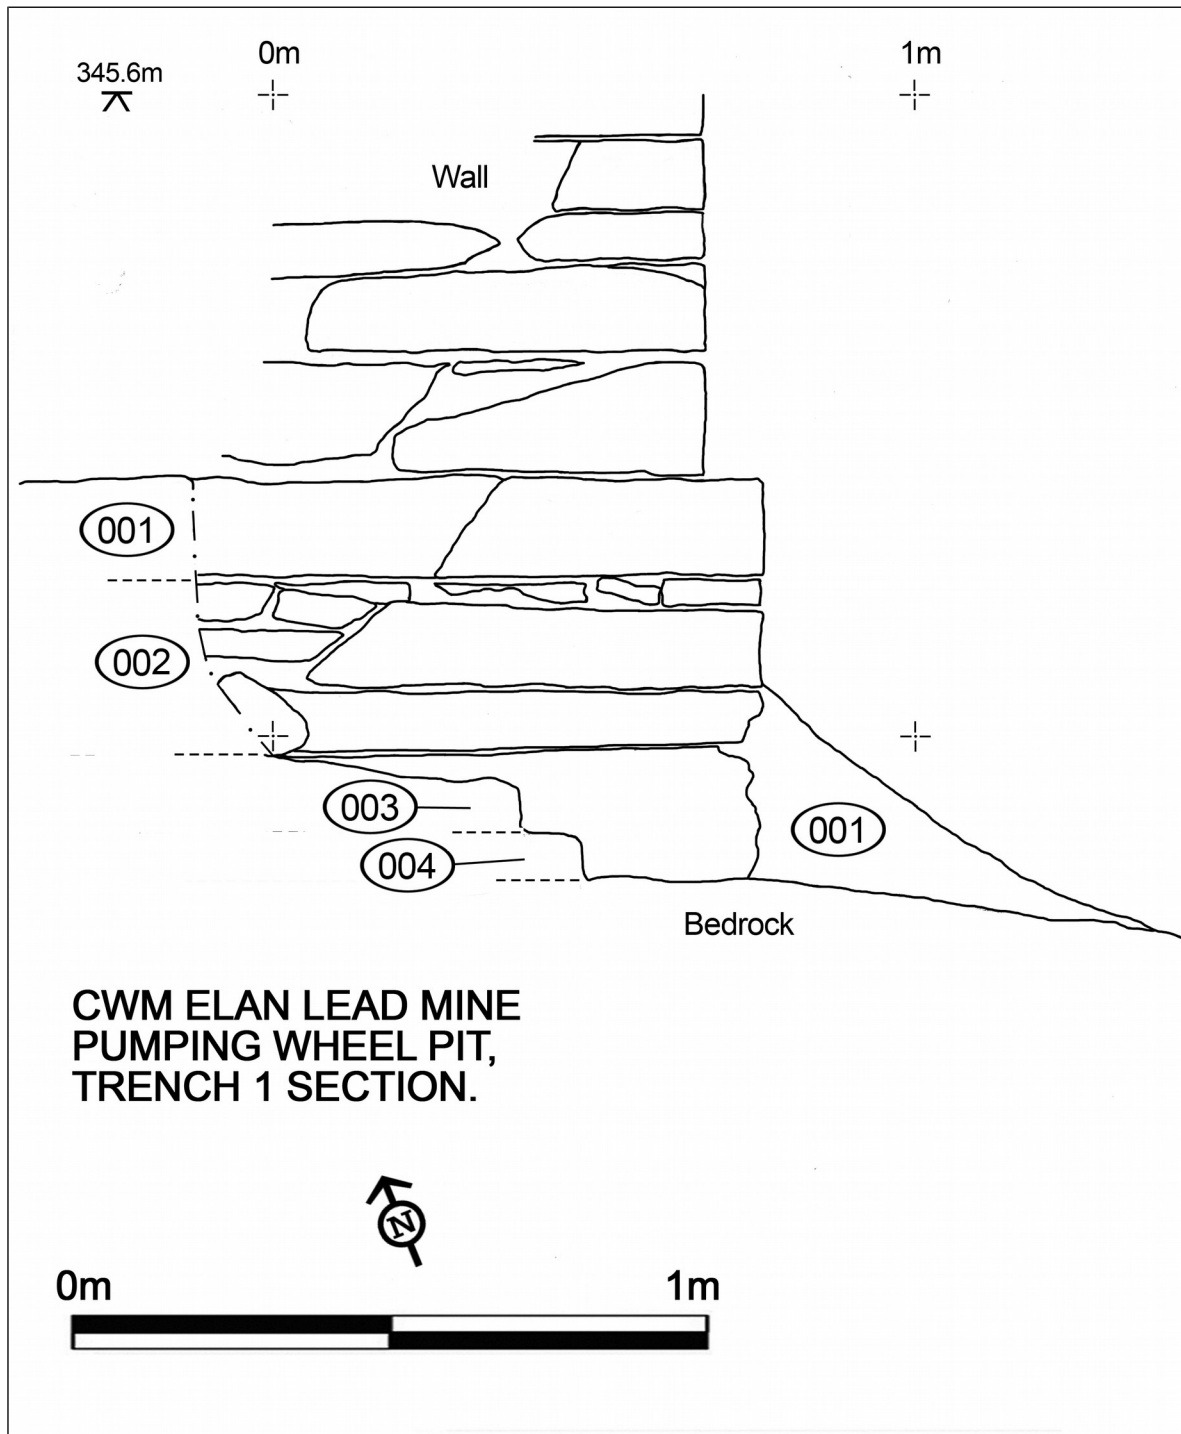
Figure 3: Section showing the wheel pit wall, its plinth courses and the excavated section, drawn at 1:10

8.1 The turf layer (001) was generally 0.11 metres deep but became thicker towards the wall of the wheel pit. Below it was a layer (002) of loose sandy material with many large stones, up to 0.3 metres long. This was interpreted as relating to disuse of the wheel pit with stones falling off the top of the wall. Below this was a clay layer (003) which was interpreted as clay plugging around the base of the wheel pit when it was in use. At the base of (003) water began bubbling into the trench. Layer (004) below (003) was a mixed clay and slate layer which was interpreted as relating to the construction phase of the wheel pit.

10.1 No archaeologically significant contexts were removed. The evidence indicates that the wheel pit structure was built directly on a rock cut shelf. The southeastern corner was in good condition with no slippage.

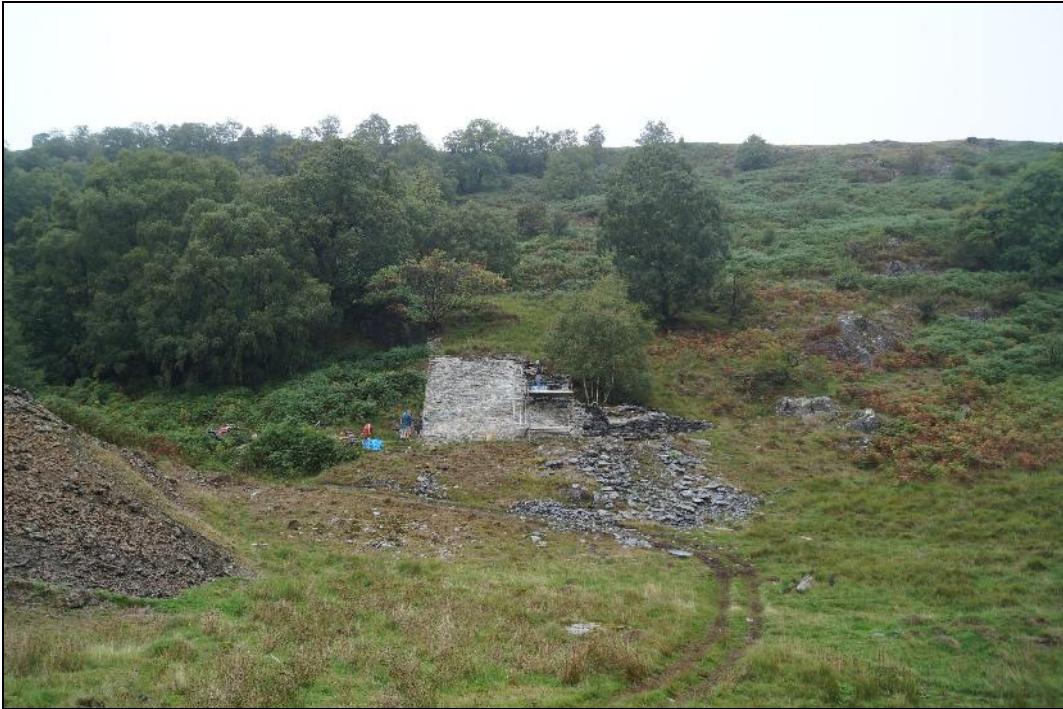
Plate 1: CEM2018_101. A general view of the ruined wheel pit at the Cwm Elan mine. Looking west-northwest.

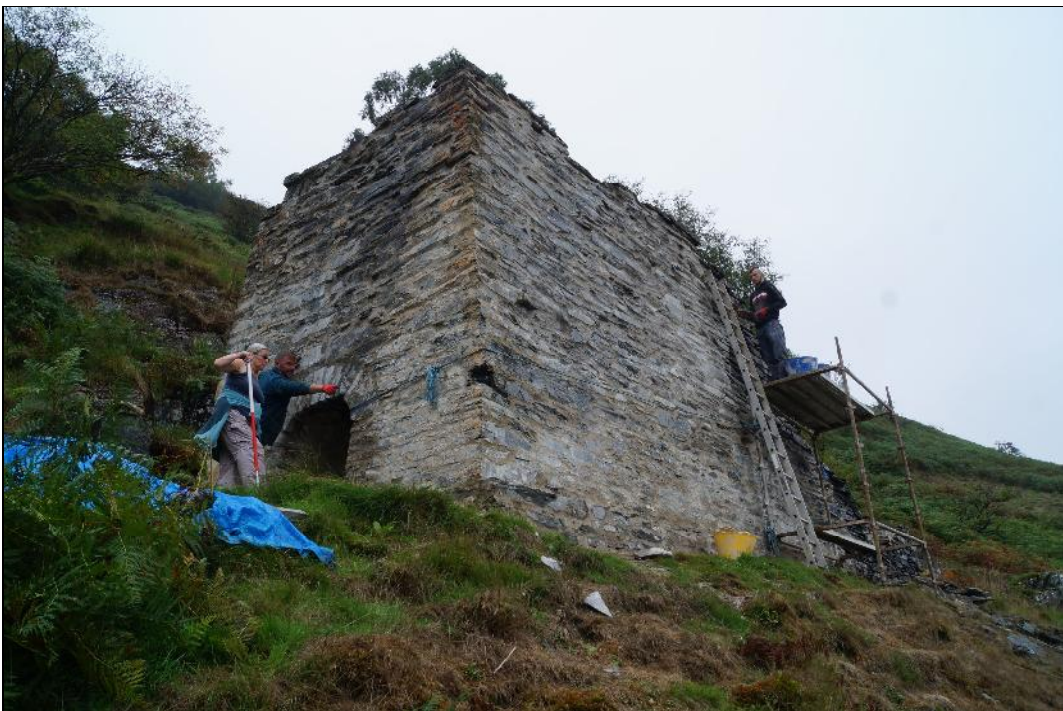
Plate 2: CEM2018_102. A view of the ruined wheel pit undergoing conservation. Looking northwest.

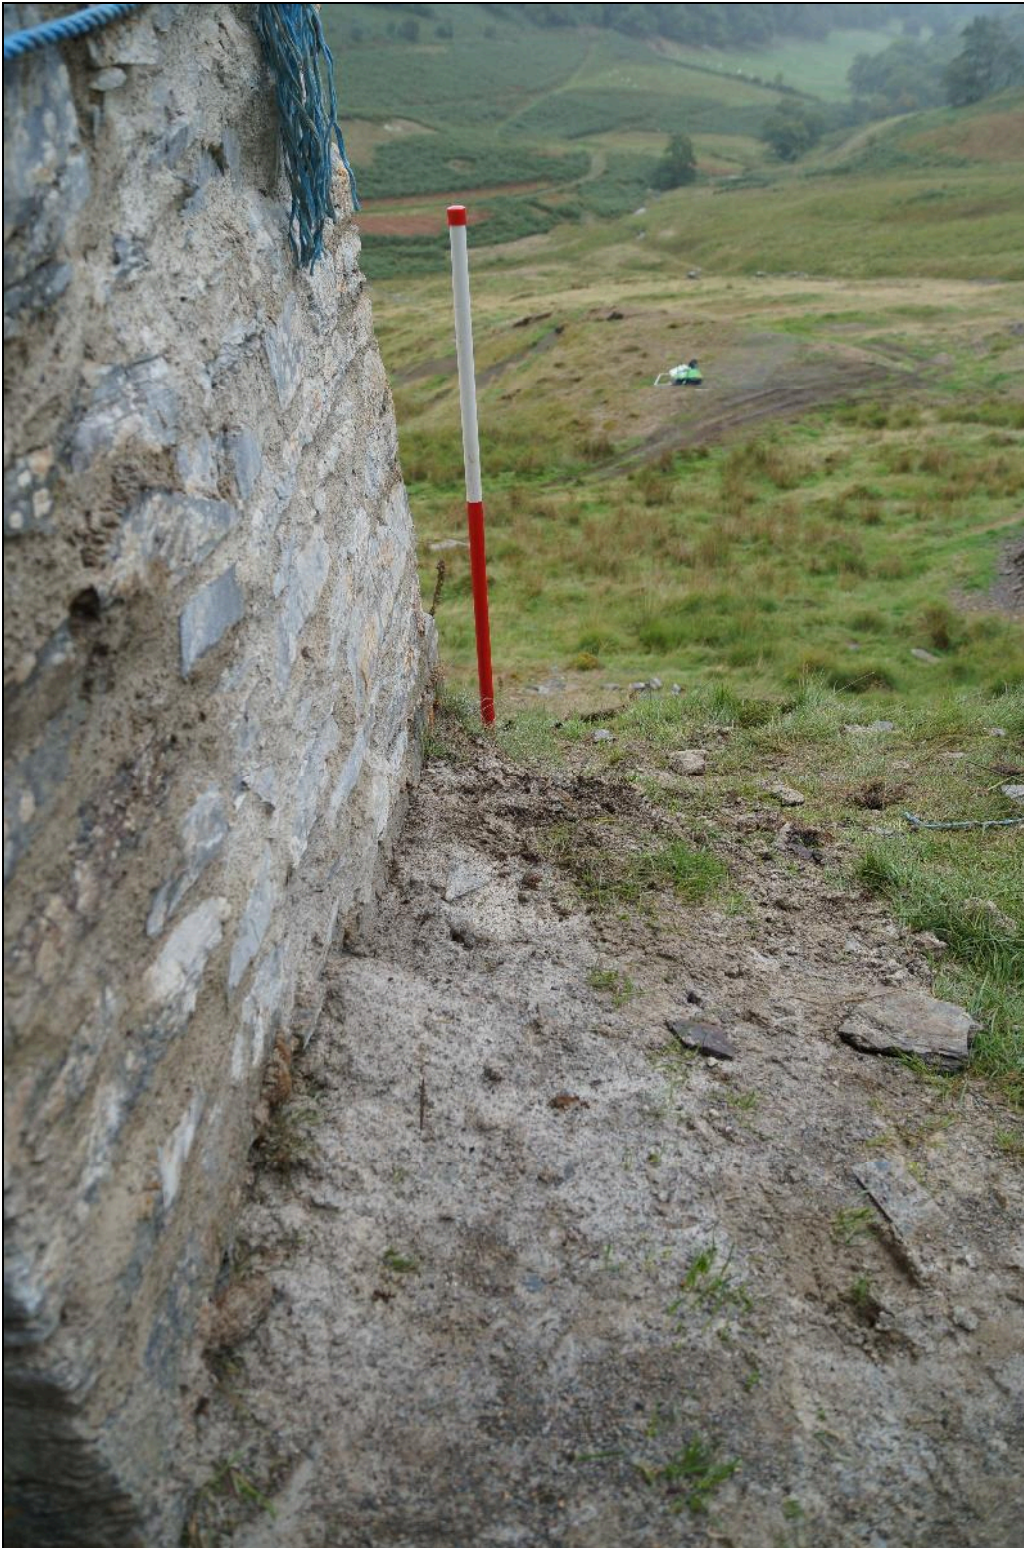
Plate 3: CEM2018_103. A closer view of the location of test pit before excavation. It was situated at the southern end of the wheel pit. Looking east-southeast.

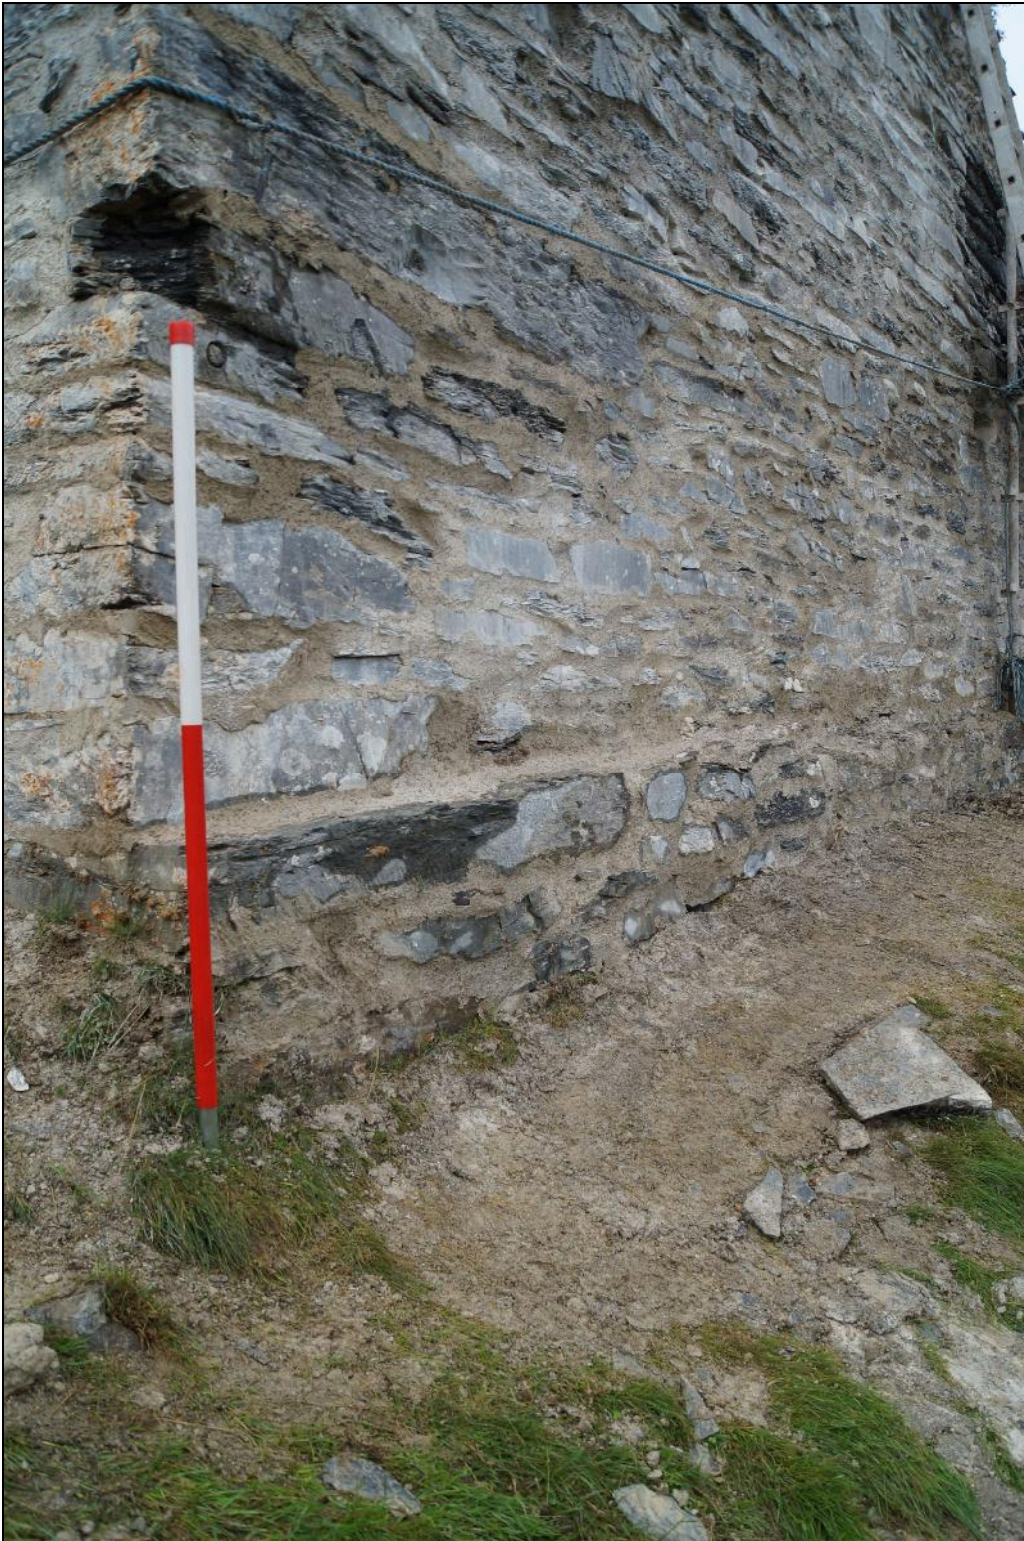
Plate 6: CEM2018_106. A view of the eastern side of the wheel pit, showing the plinth courses at the base of the structure. Looking northwest.

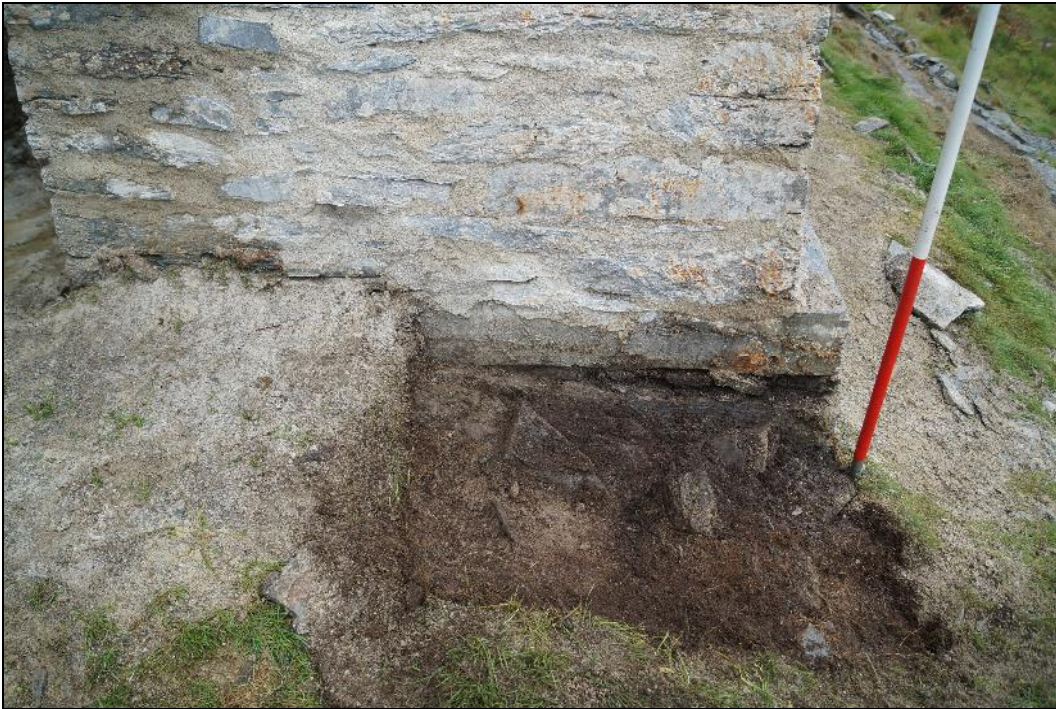
Plate 7: CEM2018_107. A view of test pit after the removal of the turf layer (001). The rubble (002) associated with the gradual dereliction of the wheel pit is revealed. Looking north-northeast.

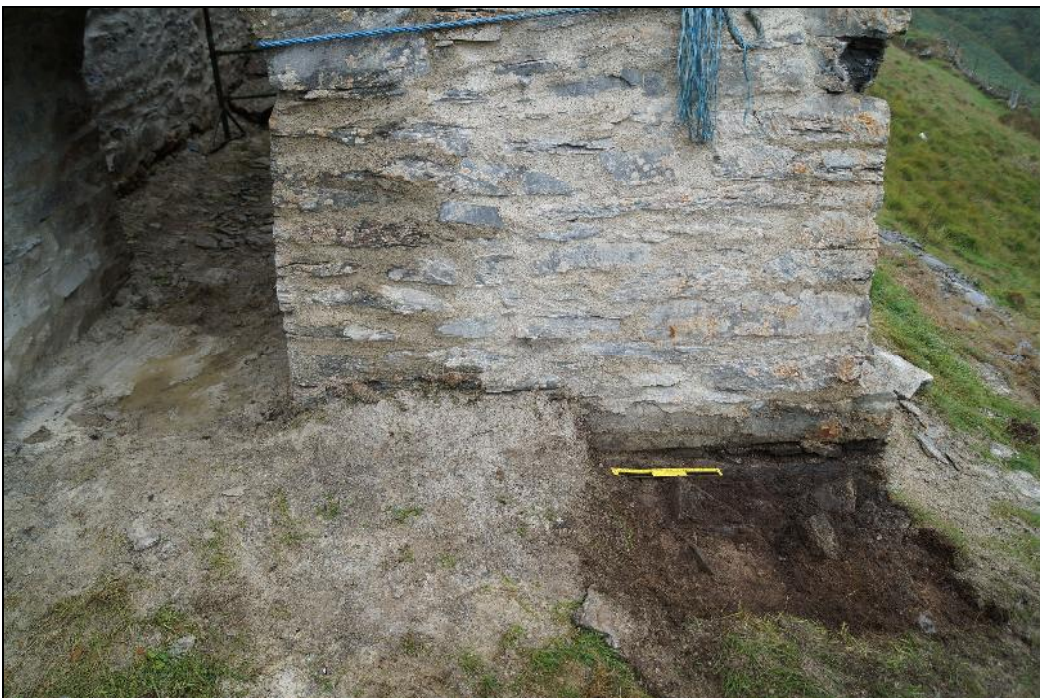
Plate 8: CEM2018_110. Another view of test pit after the removal of the turf (001) and showing (002). The arched outlet at the base of the wheel pit is visible to the left. Looking north-northeast.

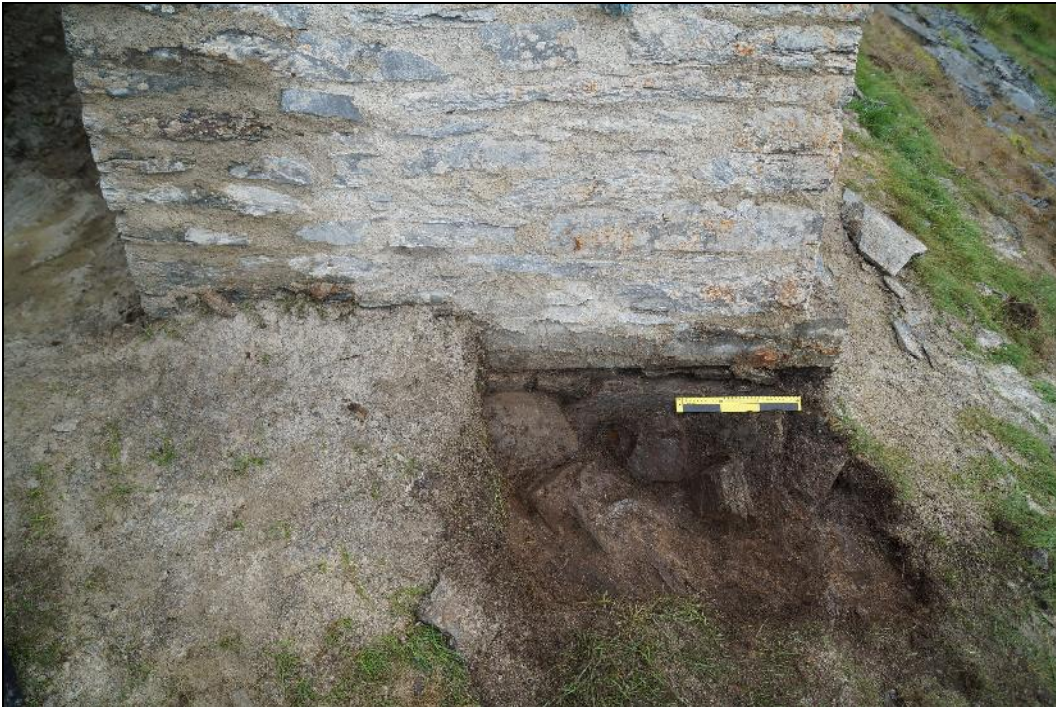
Plate 9: CEM2018_111. A view of test pit showing more collapse rubble (002) exposed. Looking north-northeast.

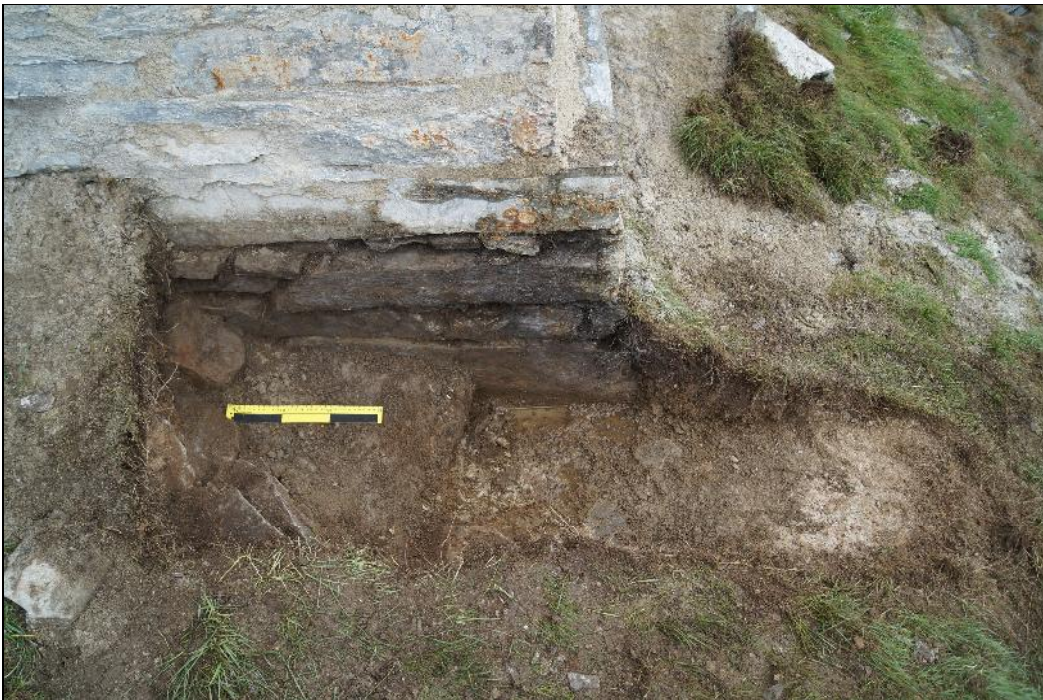
Plate 10: CEM2018_113. A view of test pit as the collapse rubble layer (002) is being removed. It was underlain by a clay layer (003) interpreted as material deposited when the water wheel was in use. Looking north-northeast.

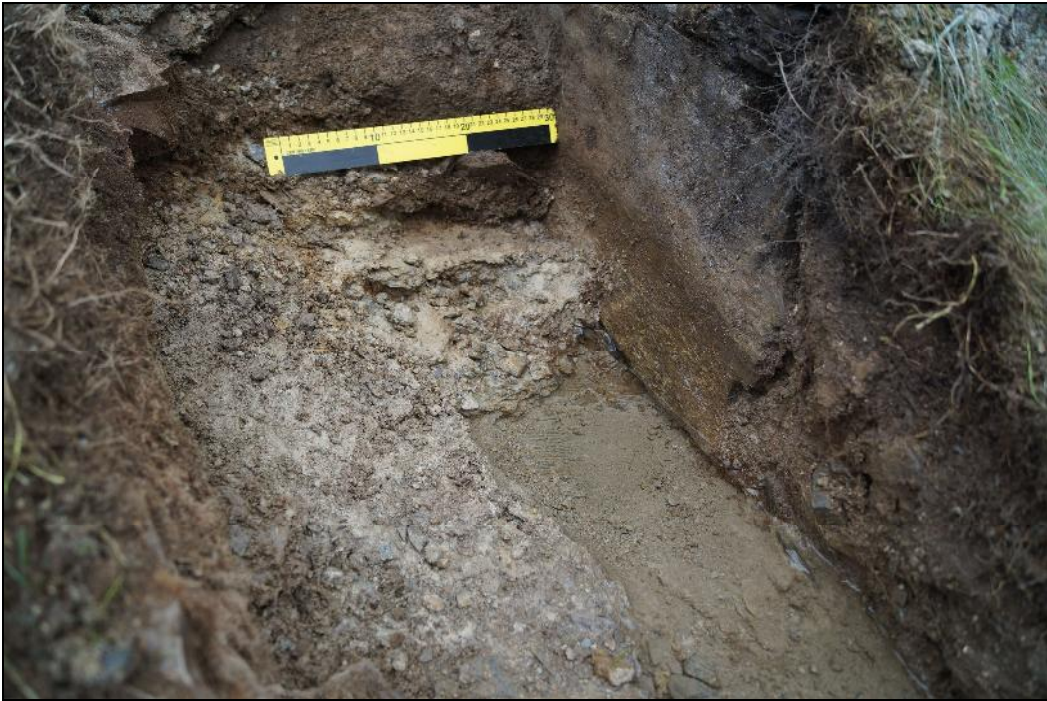
Plate 11: CEM2018_114. A view of the gravel and clay layer (004) at the base of test pit. This lower layer is thought to have been lain down during the construction of the wheel pit and overlies bedrock. The stone seen right of centre is the base stone of the wheel pit at the southeast corner of the structure. It sits directly on the bedrock, and it appears that the site was quarried to create a level platform before the wheel pit was constructed. Looking northwest.

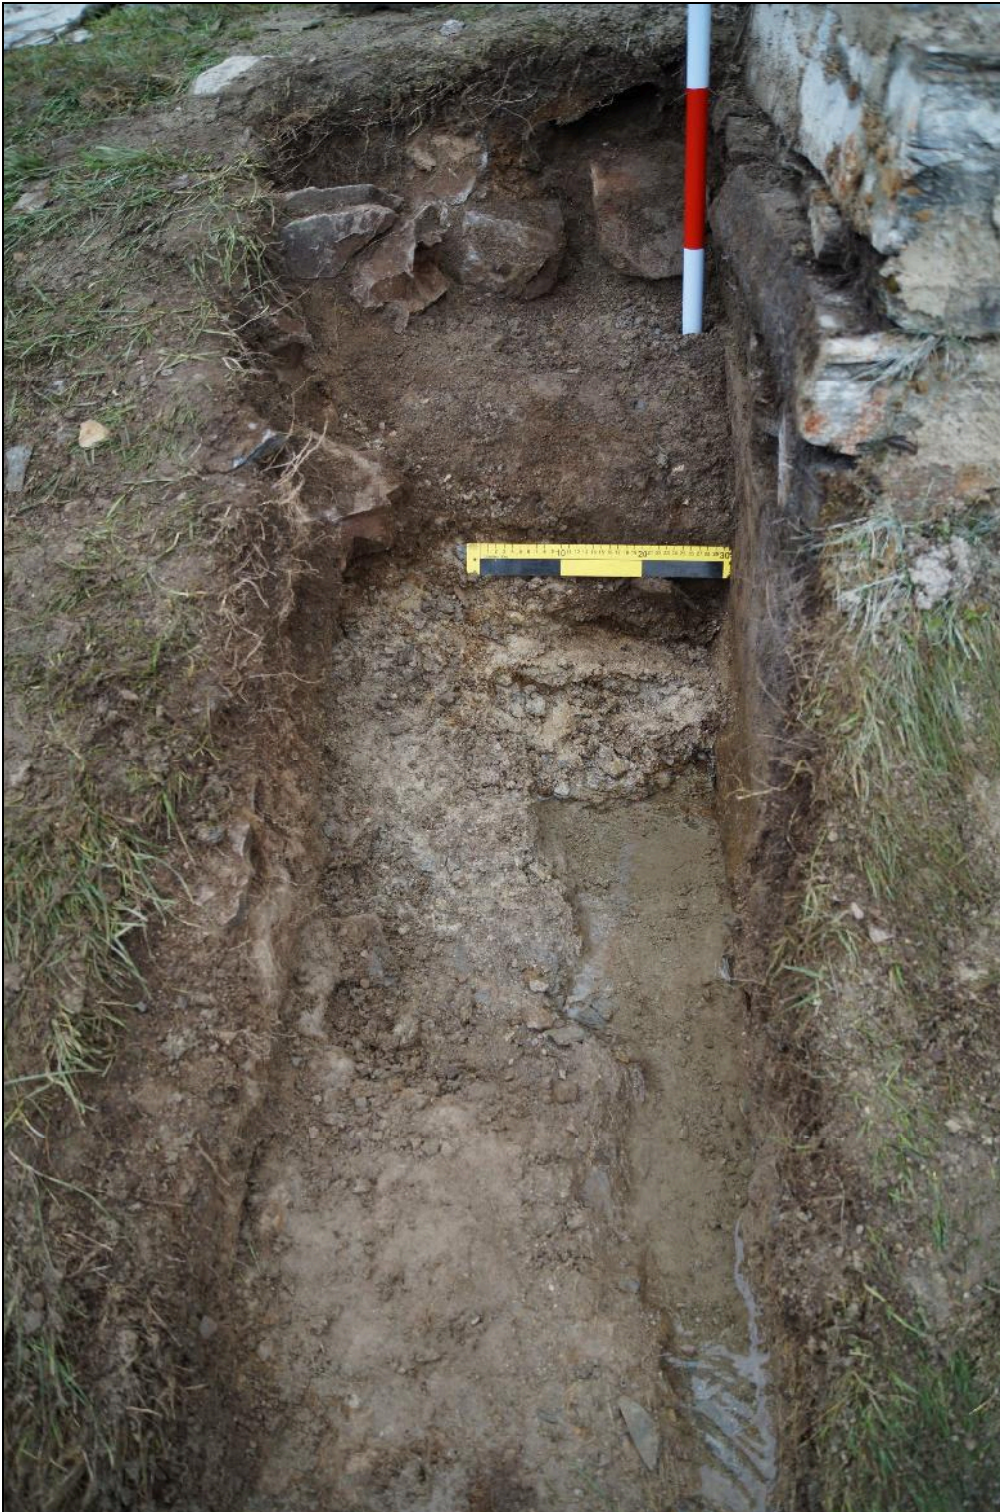
Plate 12: CEM2018_116. A view of test pit showing the full stratigraphy from the turf (001) down through (002), (003) and (004) to the bedrock where water is flowing and in the foreground. Groundwater began flowing strongly from beneath the wheel pit at this depth. Looking west-northwest.

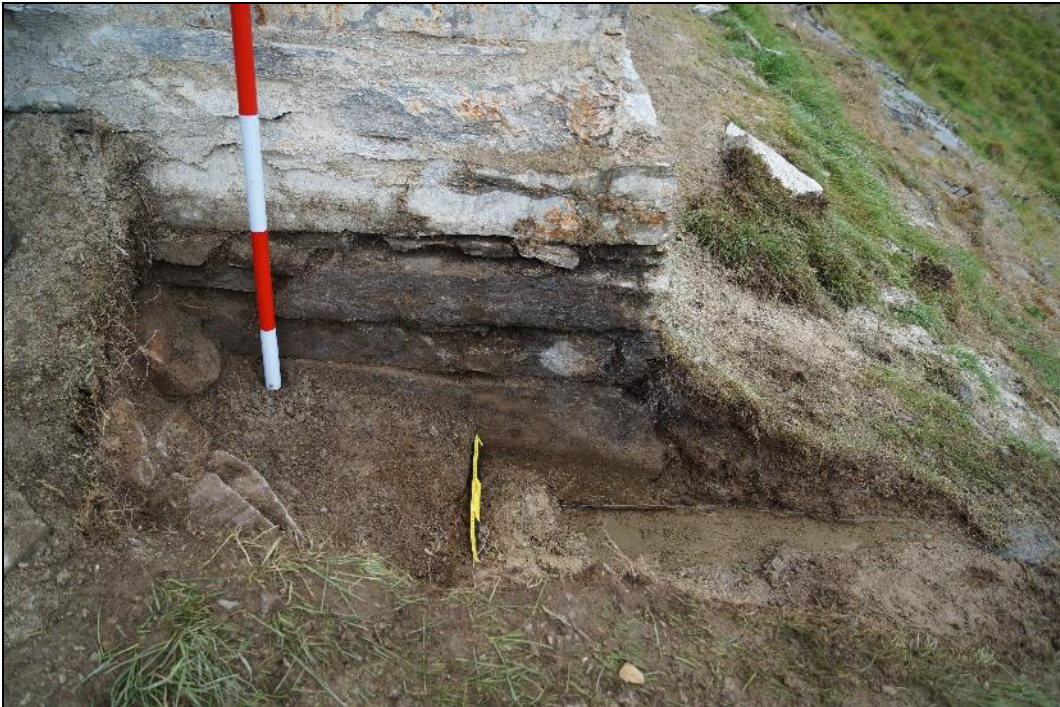
Plate 13: CEM2018_118. Another view of test pit. Looking north-northeast, showing (001) and (002) in section, and (003) and (004) in test pit.

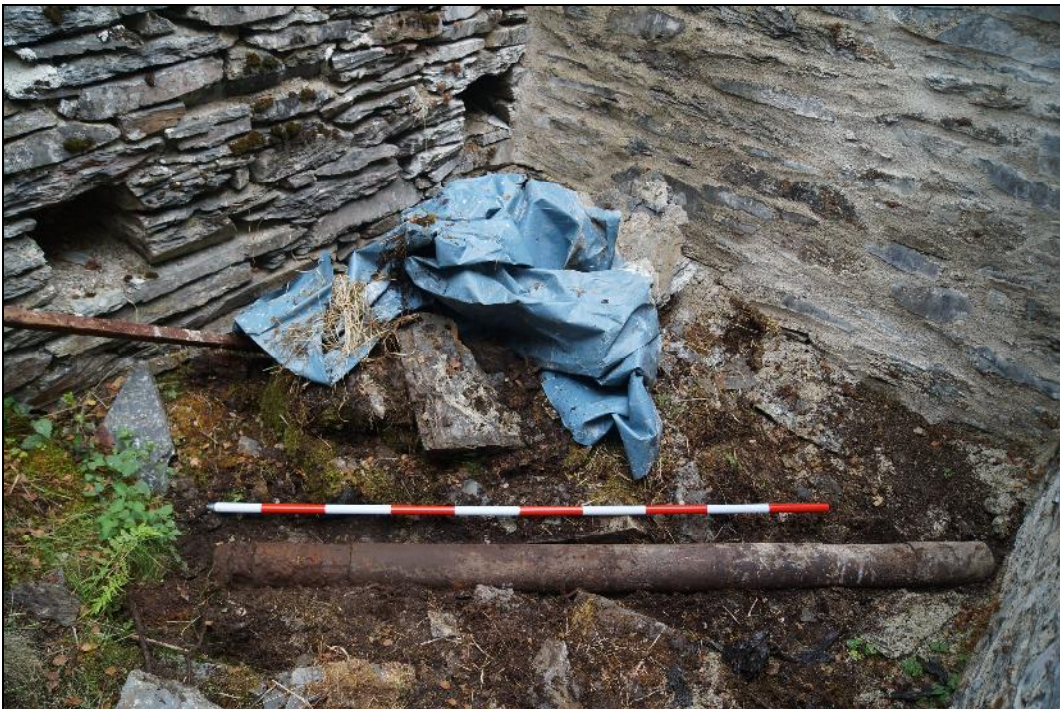
Plate 14: CEM2018_121. A view of the iron axle that is now laying in a cell to the west of the wheel pit. Looking east.

8.2 The metal axle lies on the floor within a cell to the west of the main wheel pit. The axle was 2.43 metres long and at the ends was 0.135 metres in diameter. The central section was 1.47 metres long but the ends of the axle do not mirror each other. The northwestern end narrowed for 0.285 metres, narrowed for a further 0.08 metres and then widened again for a further 0.045 metres at the very end. The southeastern end narrows for 0.285 metres and then widens again for the remaining 0.26 metres. It is thought to be an axle for a winding drum on top of the walls of the cell.

10.2 The iron axle may have been for a winding drum mounted on the walls of the cell to the west of the wheelpit.

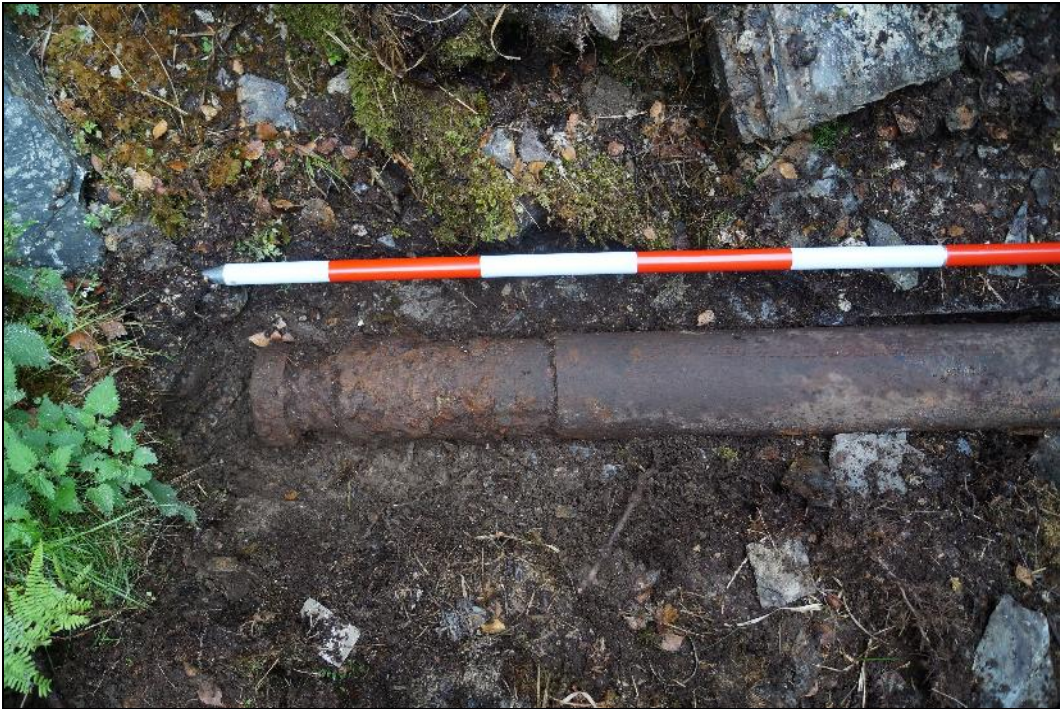
Plate 15: CEM2018_122. A more detailed view of the iron axle. Looking northeast.

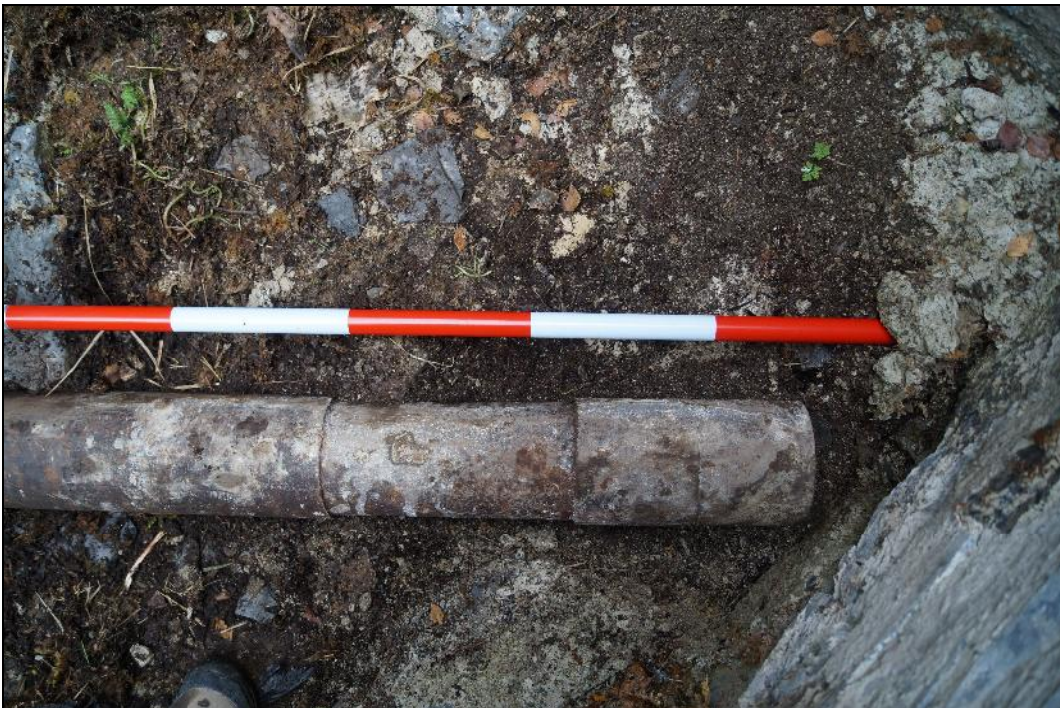
Plate 16: CEM2018_123. A more detailed view of the southeastern end of the iron axle. Looking northeast.

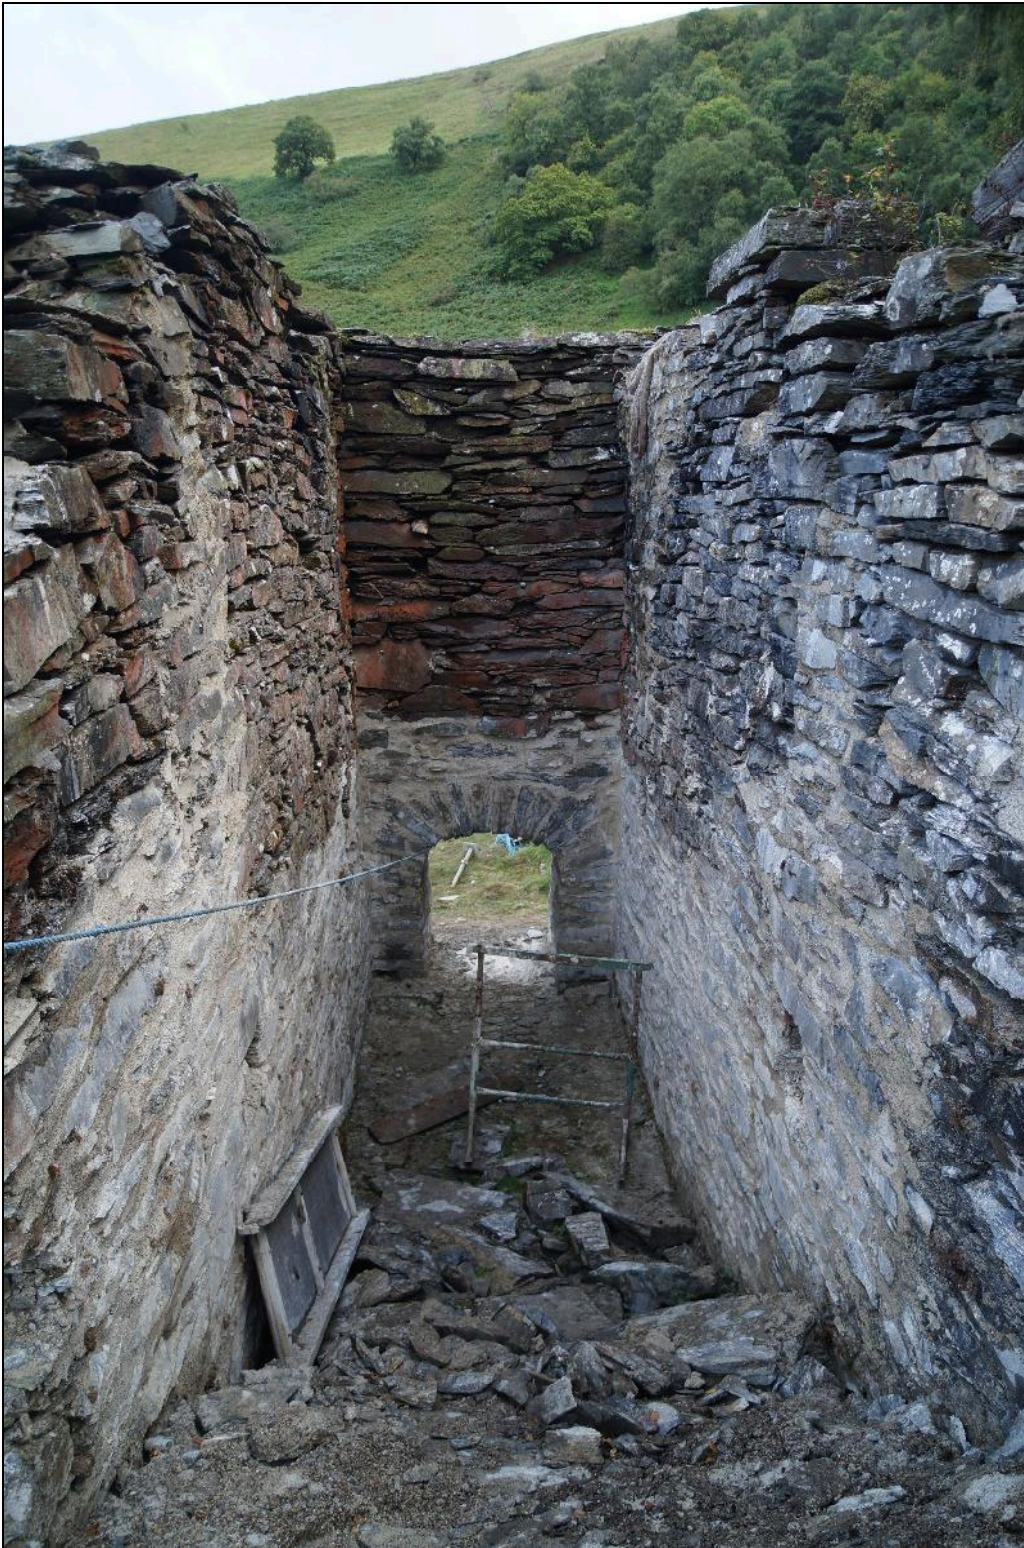
Plate 19: CEM2018_126. A view inside the wheel pit during consolidation work. Looking south-southwest.

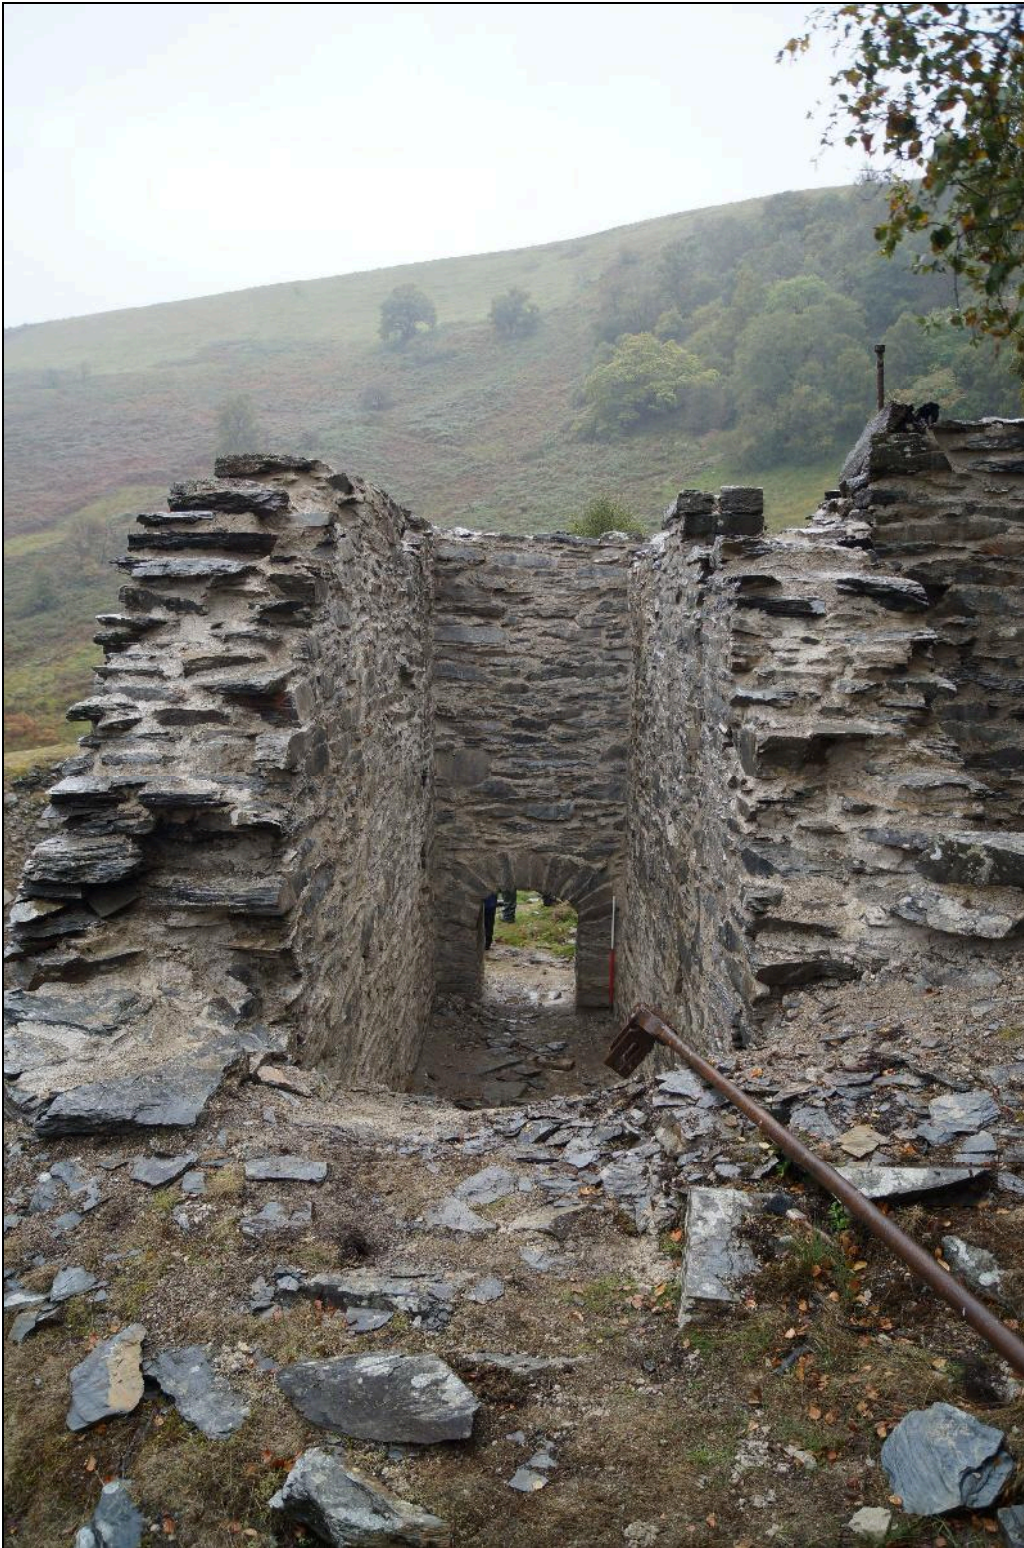
Plate 21: CEM2018_129. A view inside the wheel pit after consolidation work had been completed. Looking south-southwest.
