# Dam Builders Hut at Cwmclyd Farmstead Level 2 Building Recording

Report by: Trysor

For: The Elan Valley Trust

Trysor Project No. 2018/622

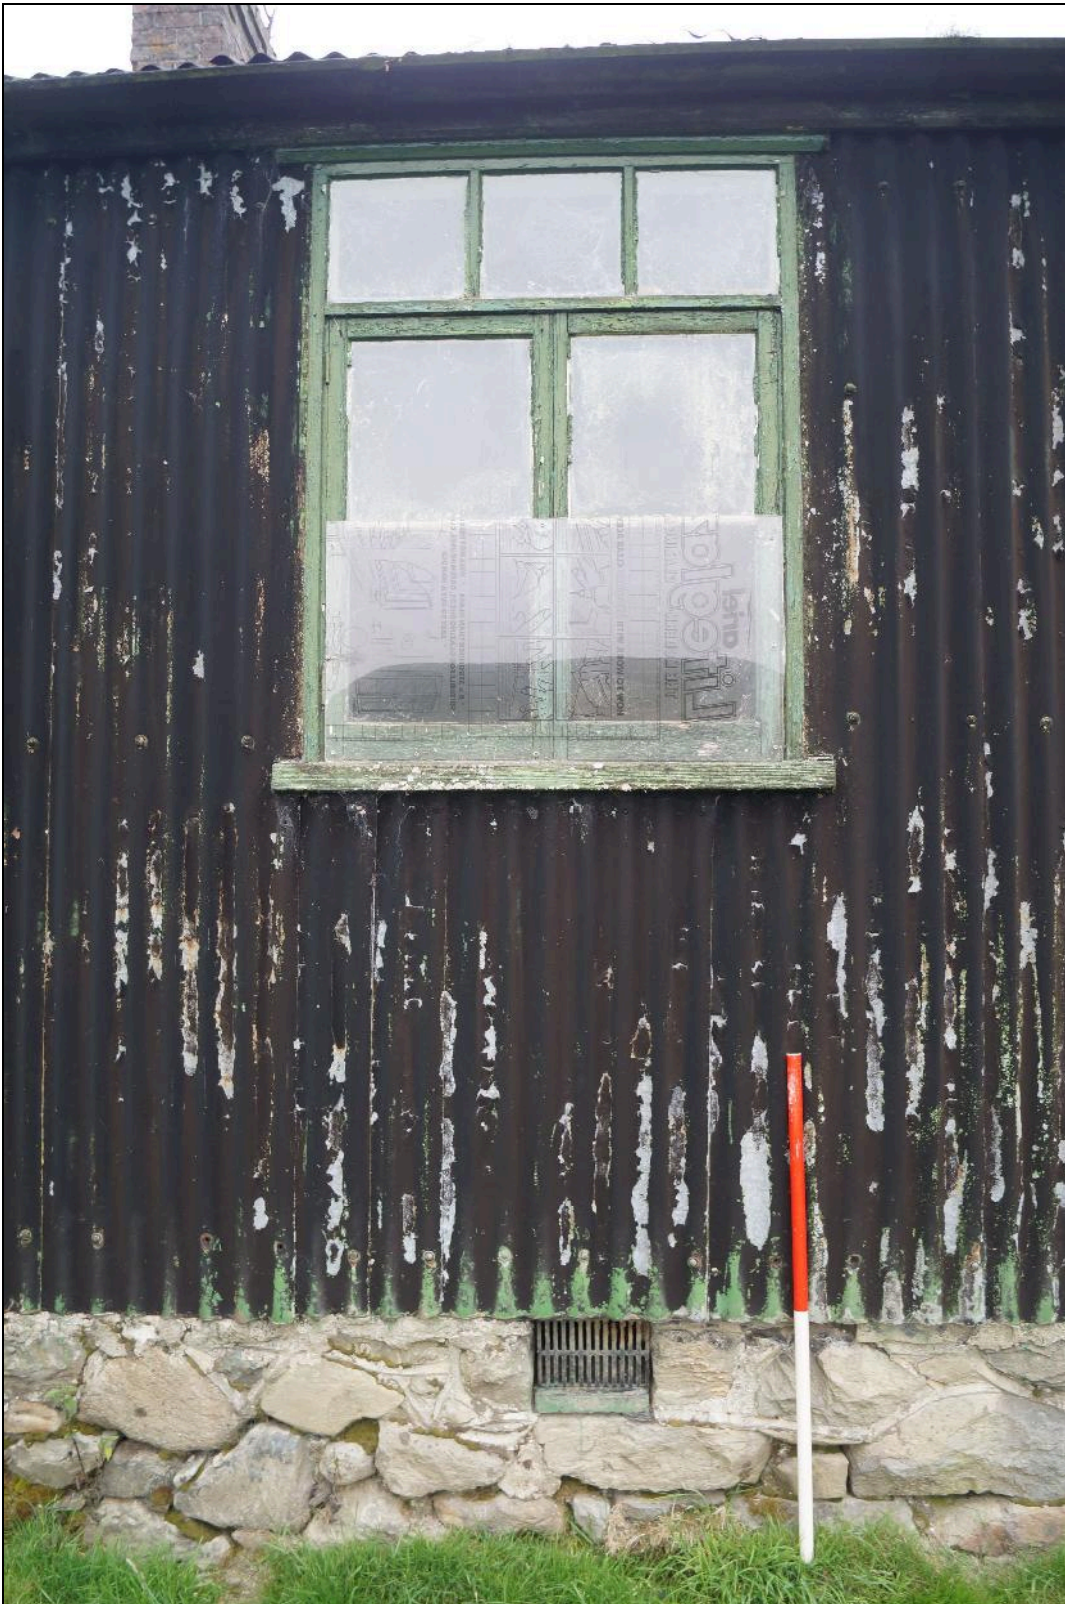
*Plate 3: CYB2018\_003. A view of the middle window in the front of the Dam Builders' Hut. Looking north-northeast. Note the underfloor vent through the stone plinth at the base of the hut.*

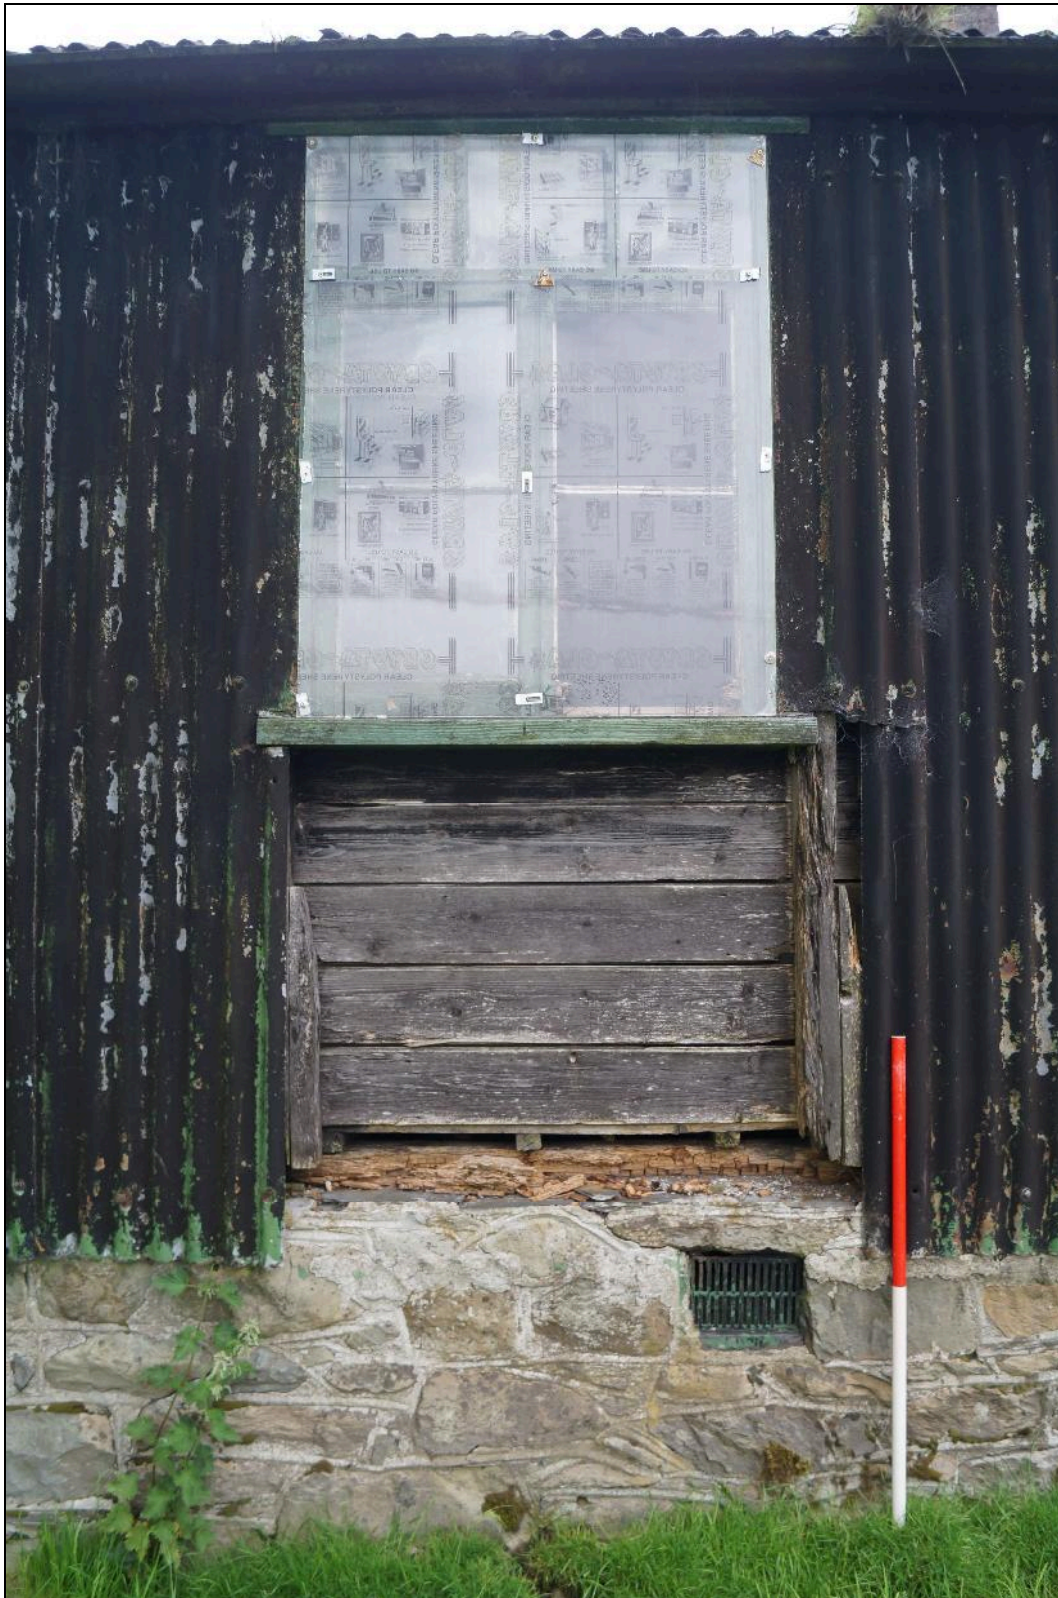
*Plate 5: CYB2018\_005. A view of the western window in the front of the Dam Builders' Hut, with a section of repaired wall below. Looking north-northeast.*

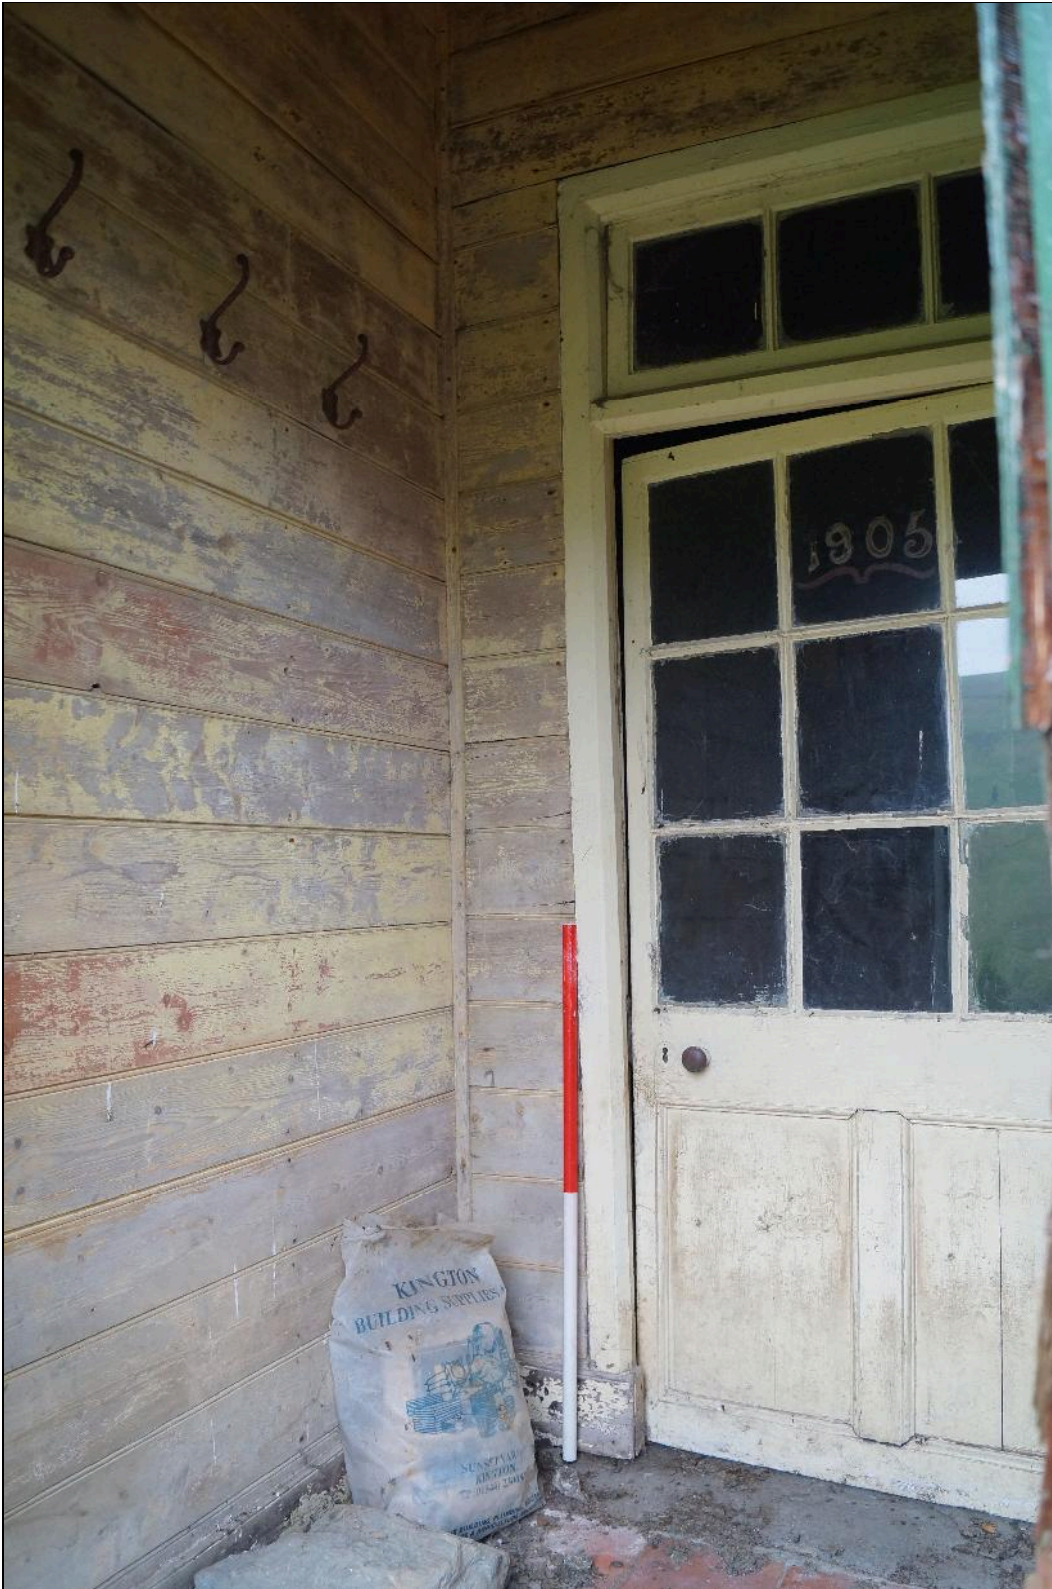
7.2.1 There is no record of when the "Dam Builders' Hut" was taken to Cwmclyd or from where it was brought. It has the date 1905 painted on a glass pane of the front door (see Plates 18 and 19) but it is not certain that the hut was erected at Cwmclyd at that time.

*Plate 19: CYB2018\_019. A view inside the porch at the front door of the Dam Builders' Hut. Note the 1905 date on the glass pane in the door. Looking north-northwest.*

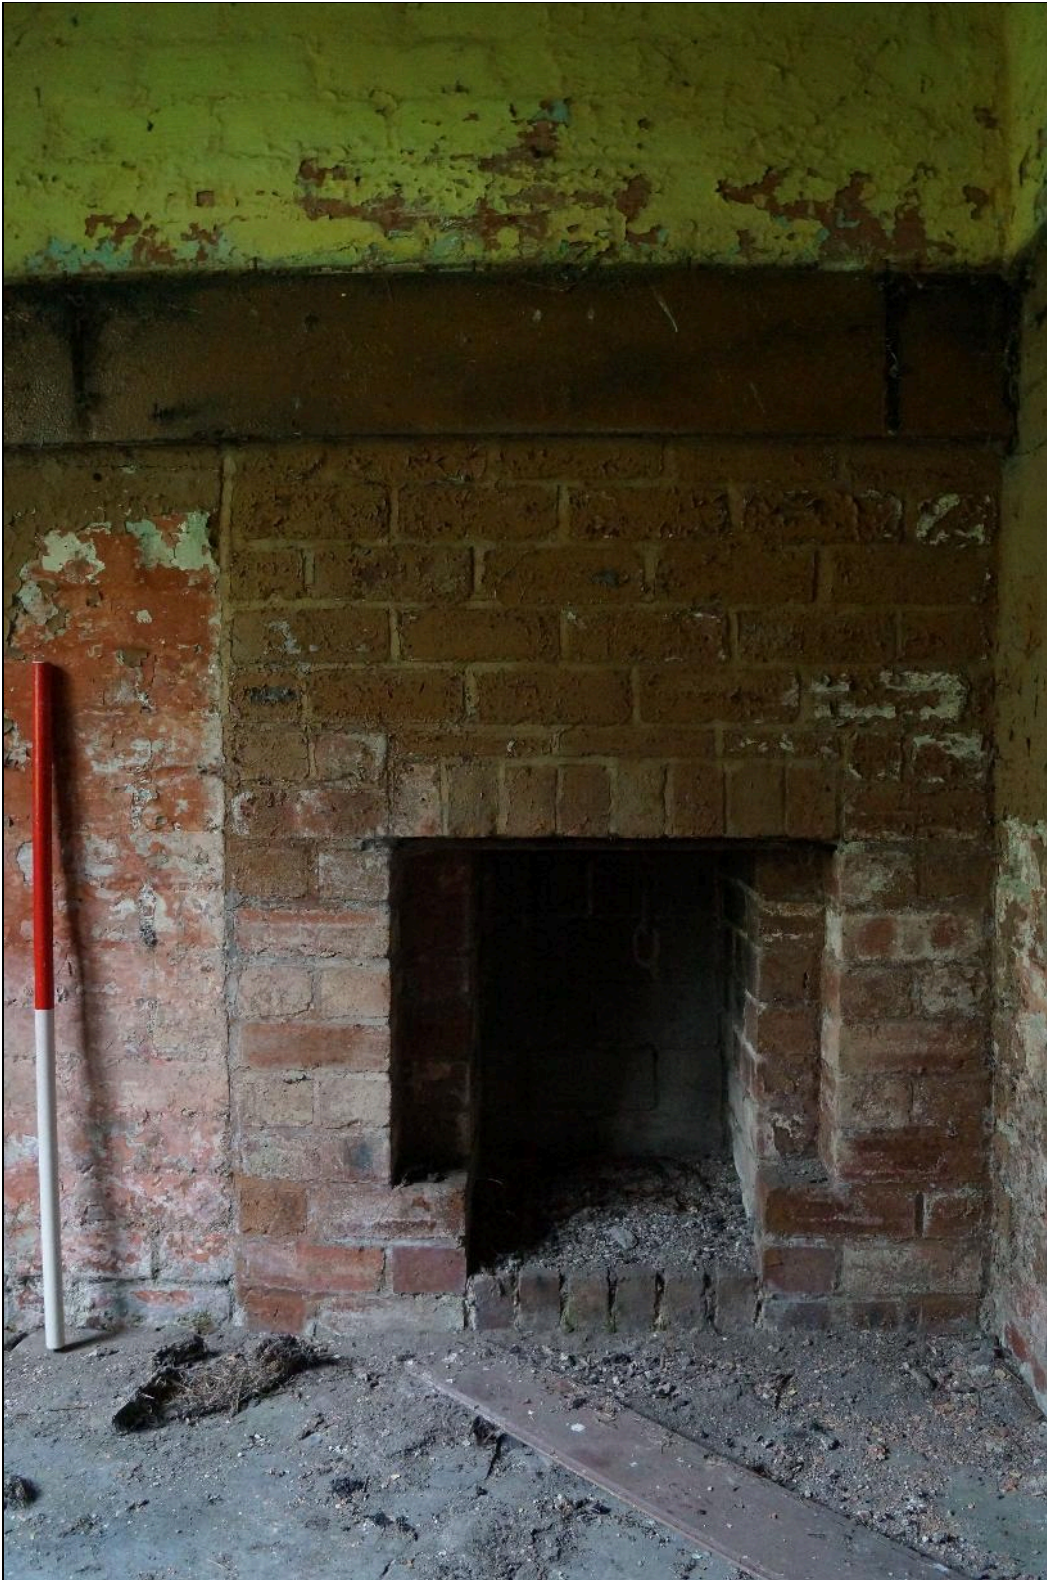
features include a flagstone floor and a constructed chimney breast into which is set a fireplace (Plate 33) with a bread oven built into the wall at the southeastern angle of the range (Plate 34). A series of iron bars with hooks for hanging meat remain fixed to the ceiling (Plate 42).

*Plate 34: CYB2018\_034. A view of the fireplace in Room 02. Note the flagstone floor. Looking east-southeast.*

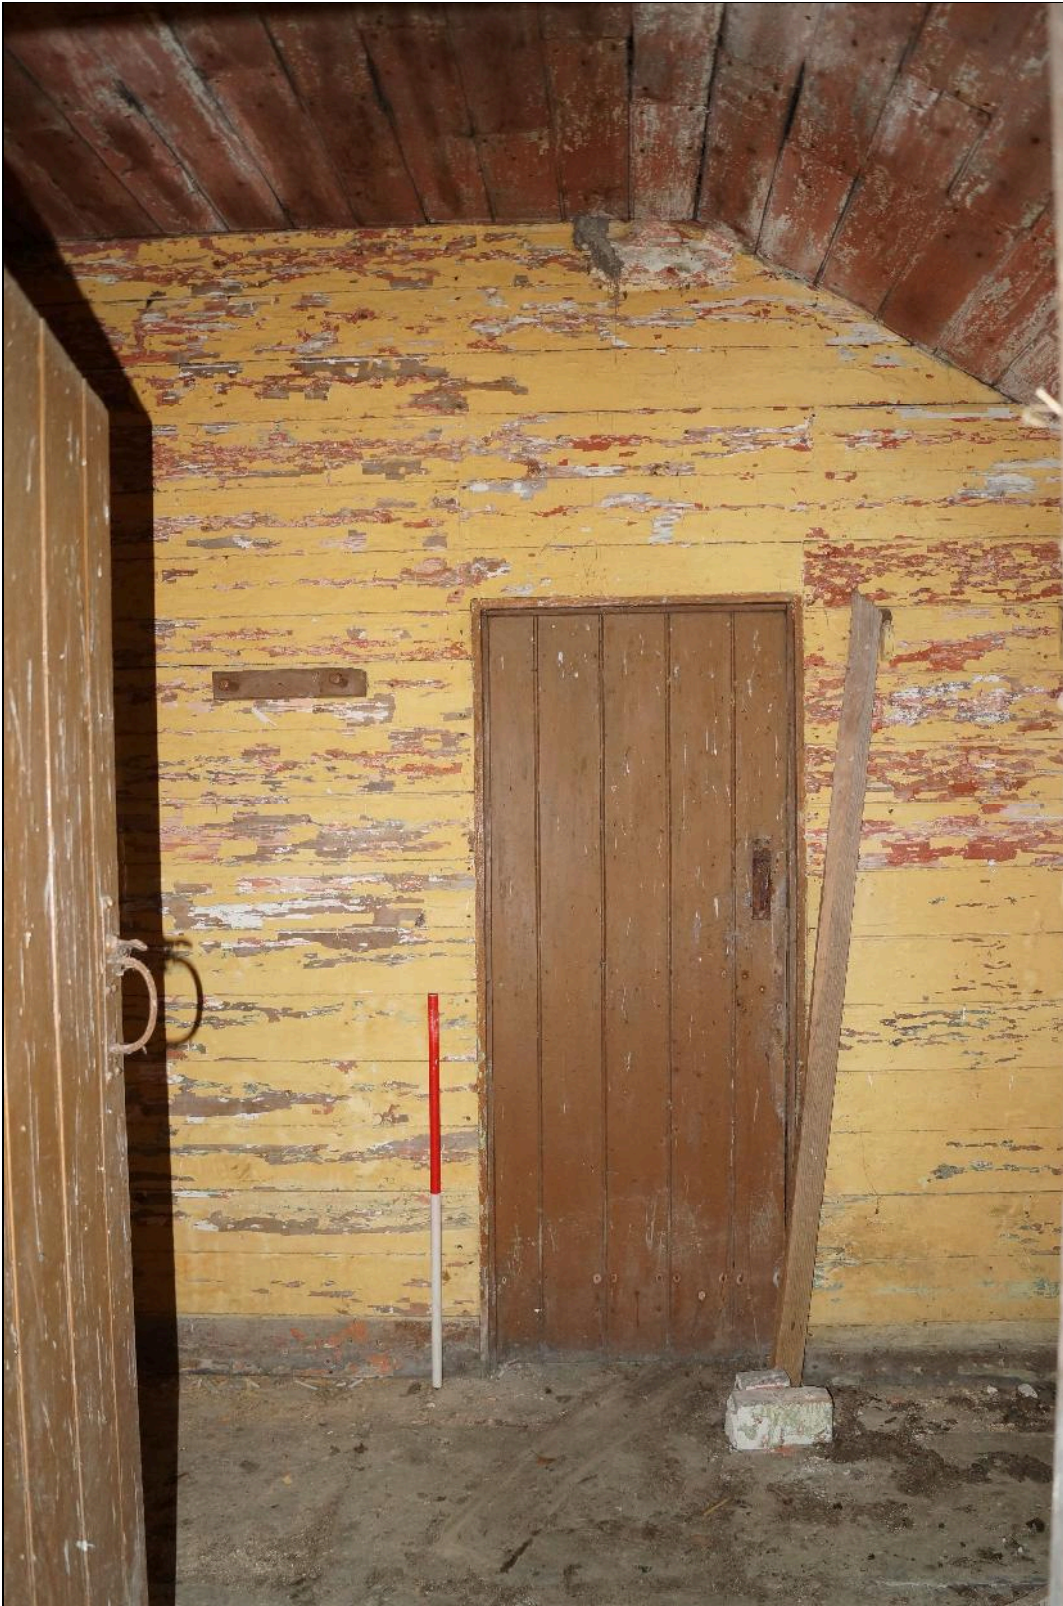
Plate 42: CYB2018\_042, A view of the iron bars fixed to the ceiling of Room 02 with hooks still in place for hanging meat. Looking west-southwest.

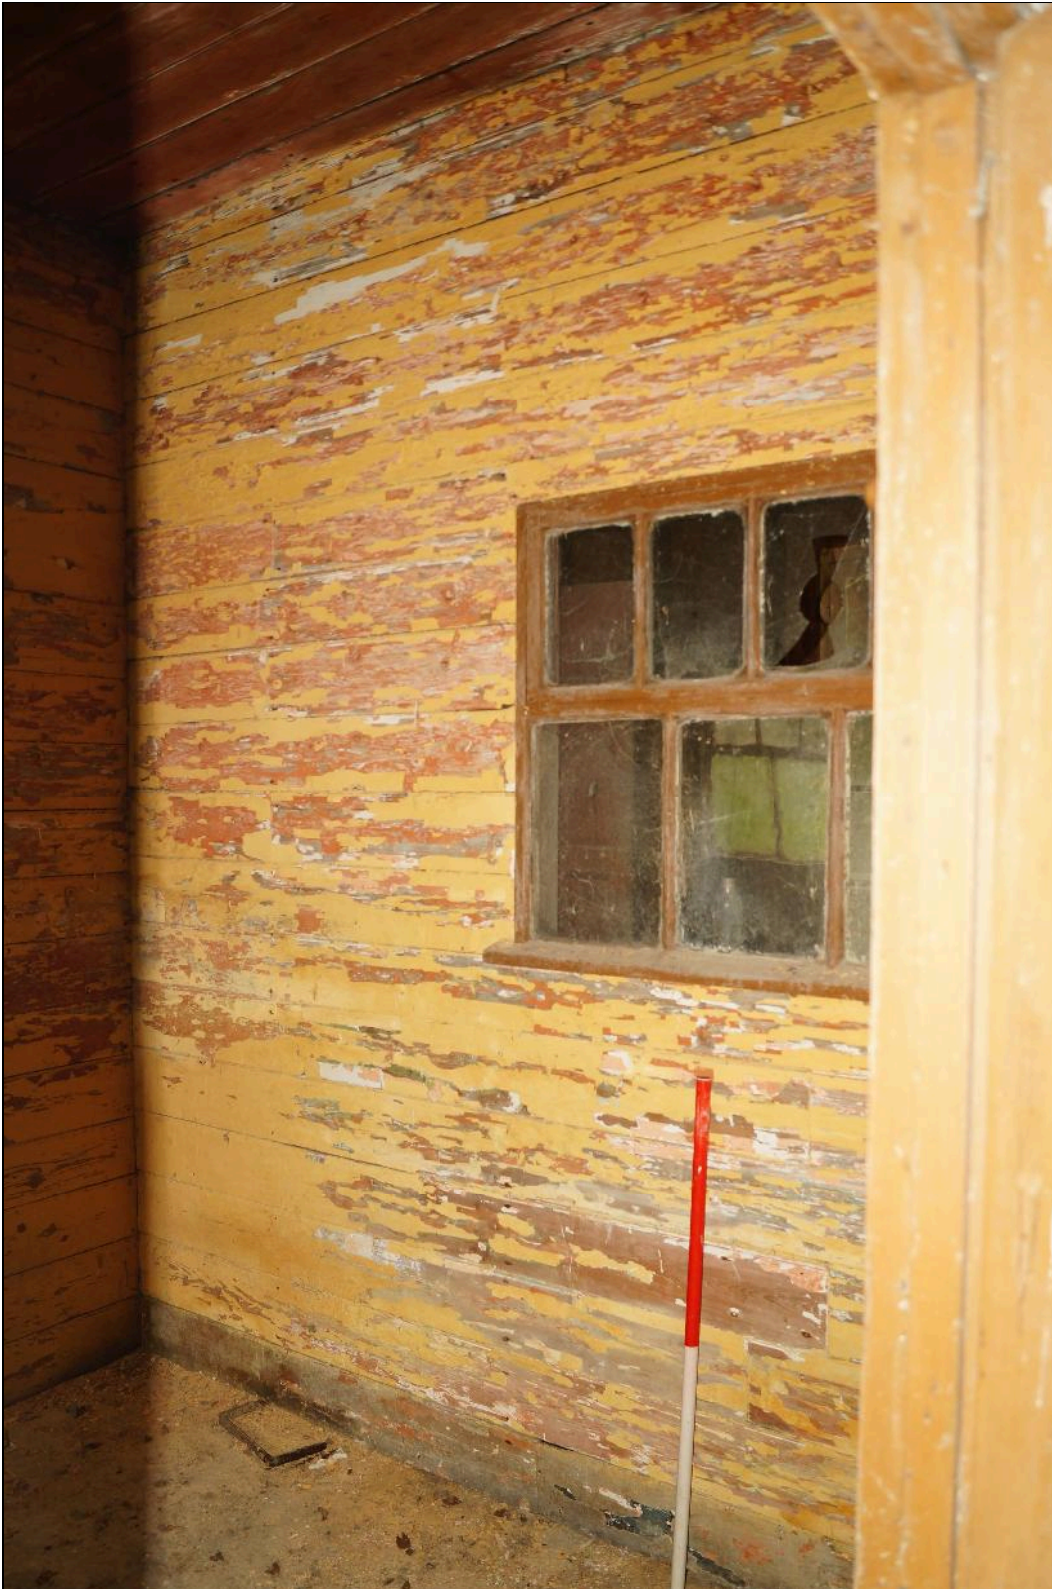
**8.3 Hallway.** Inside the inner door is a small hallway. This also has a red quarry tile floor. Light is allowed in through the glass panes in the upper half of the inner front door and also through a window between the hallway and Room 03 to the north-northeast (Plate 46), where the rear doorway is located (although there is no direct link between the front hallway and Room 03). From the front hallway, a door to the east leads into Room 01 and a door to the right leads into Room 07, which is the main corridor within the house.

*Plate 46: CYB2018\_046. A view of the window in the southern wall of Room 03. This allowed a view towards the front door, which can be seen through the window. Looking south-southwest.*

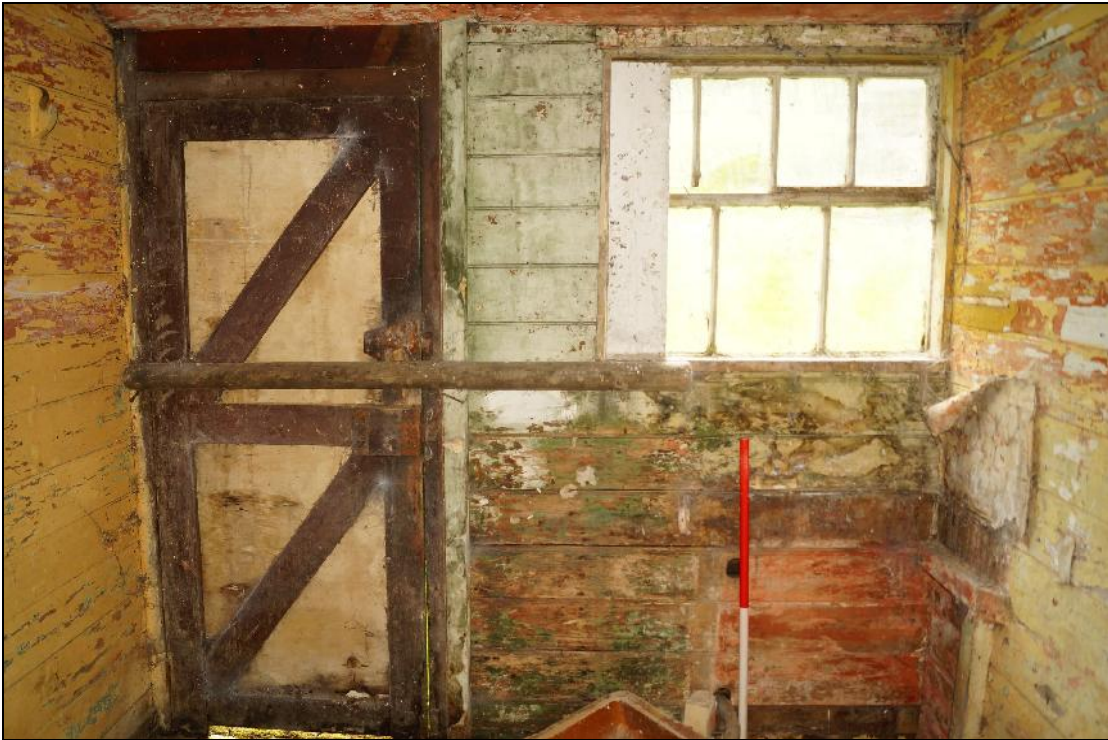
*Plate 51: CYB2018\_051. A view of the window in the northern side of Room 03. The Belfast sink on the floor appears to have originally been mounted below the window. Looking east-northeast.*

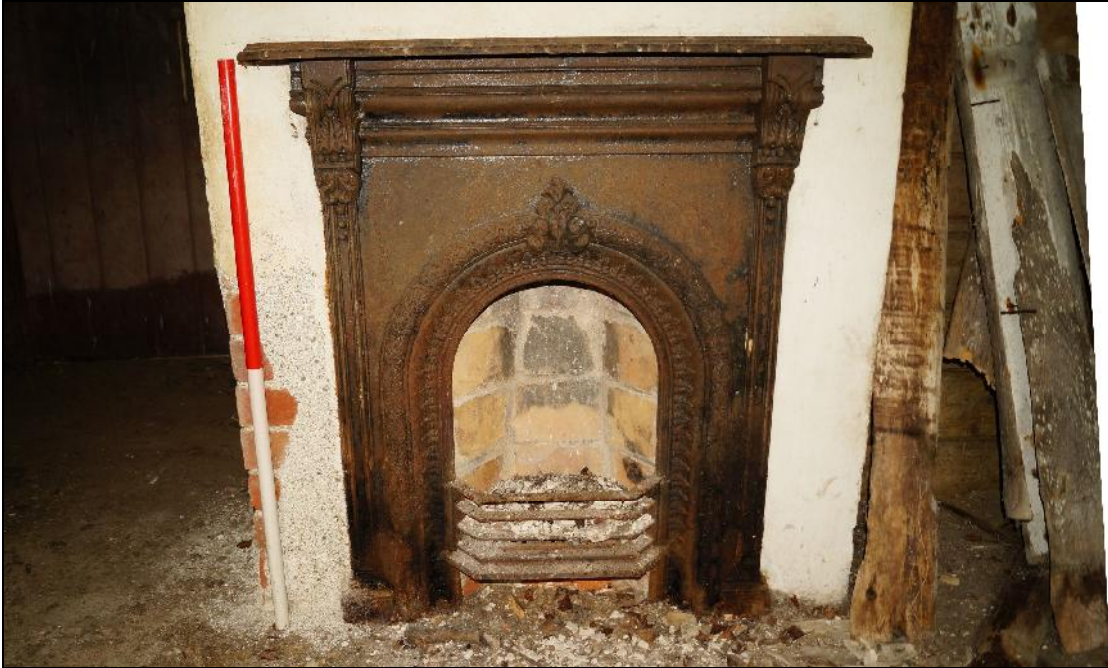
**8.8 Room 05.** This room is accessed from a doorway in its southern side, opening out to the main corridor (Room 07). There is a chimney breast and fireplace in the southern wall (Plates 64 and 65) and a window in the northern wall (Plate 72). It is likely that this room was a bedroom. The floor is composed of wooden planking.

*Plate 64: CYB2018\_064. A view of the fireplace in the southern side of Room 05. Note the red-brick chimney breast exposed to the left. Looking south-southwest.*

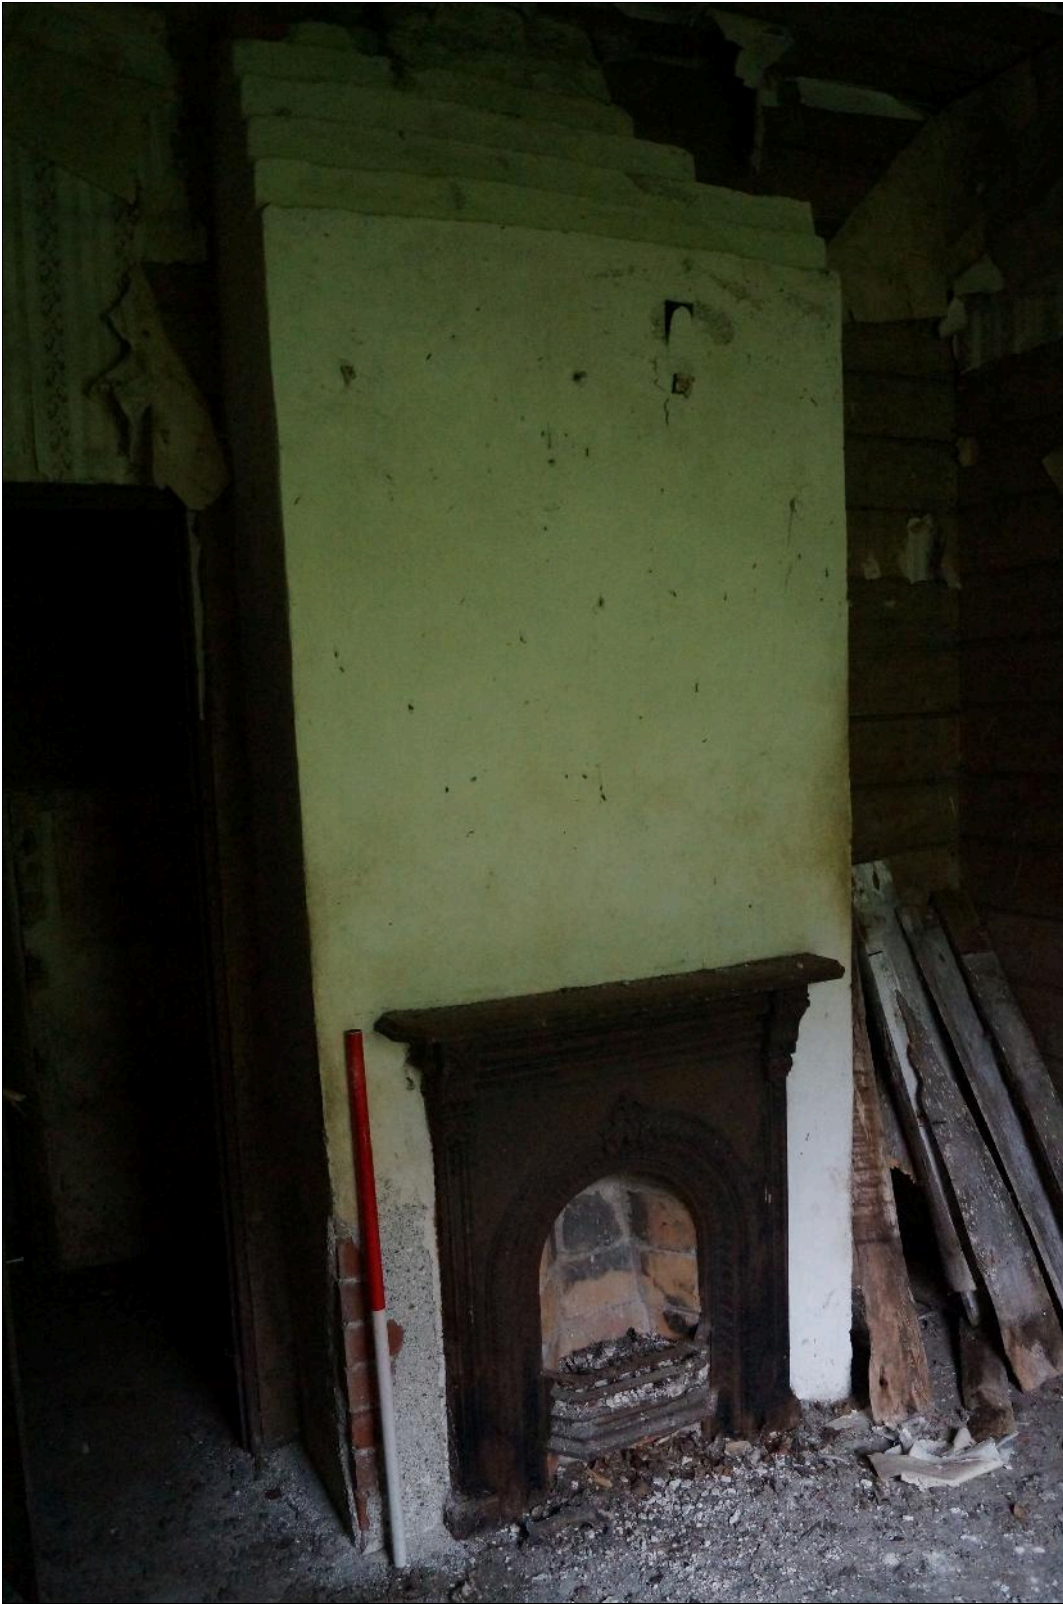
*Plate 65: BTC2017\_065. Another view of the fireplace in the southern side of Room 05. Note the red-brick chimney breast exposed to the left. Looking south-southwest.*

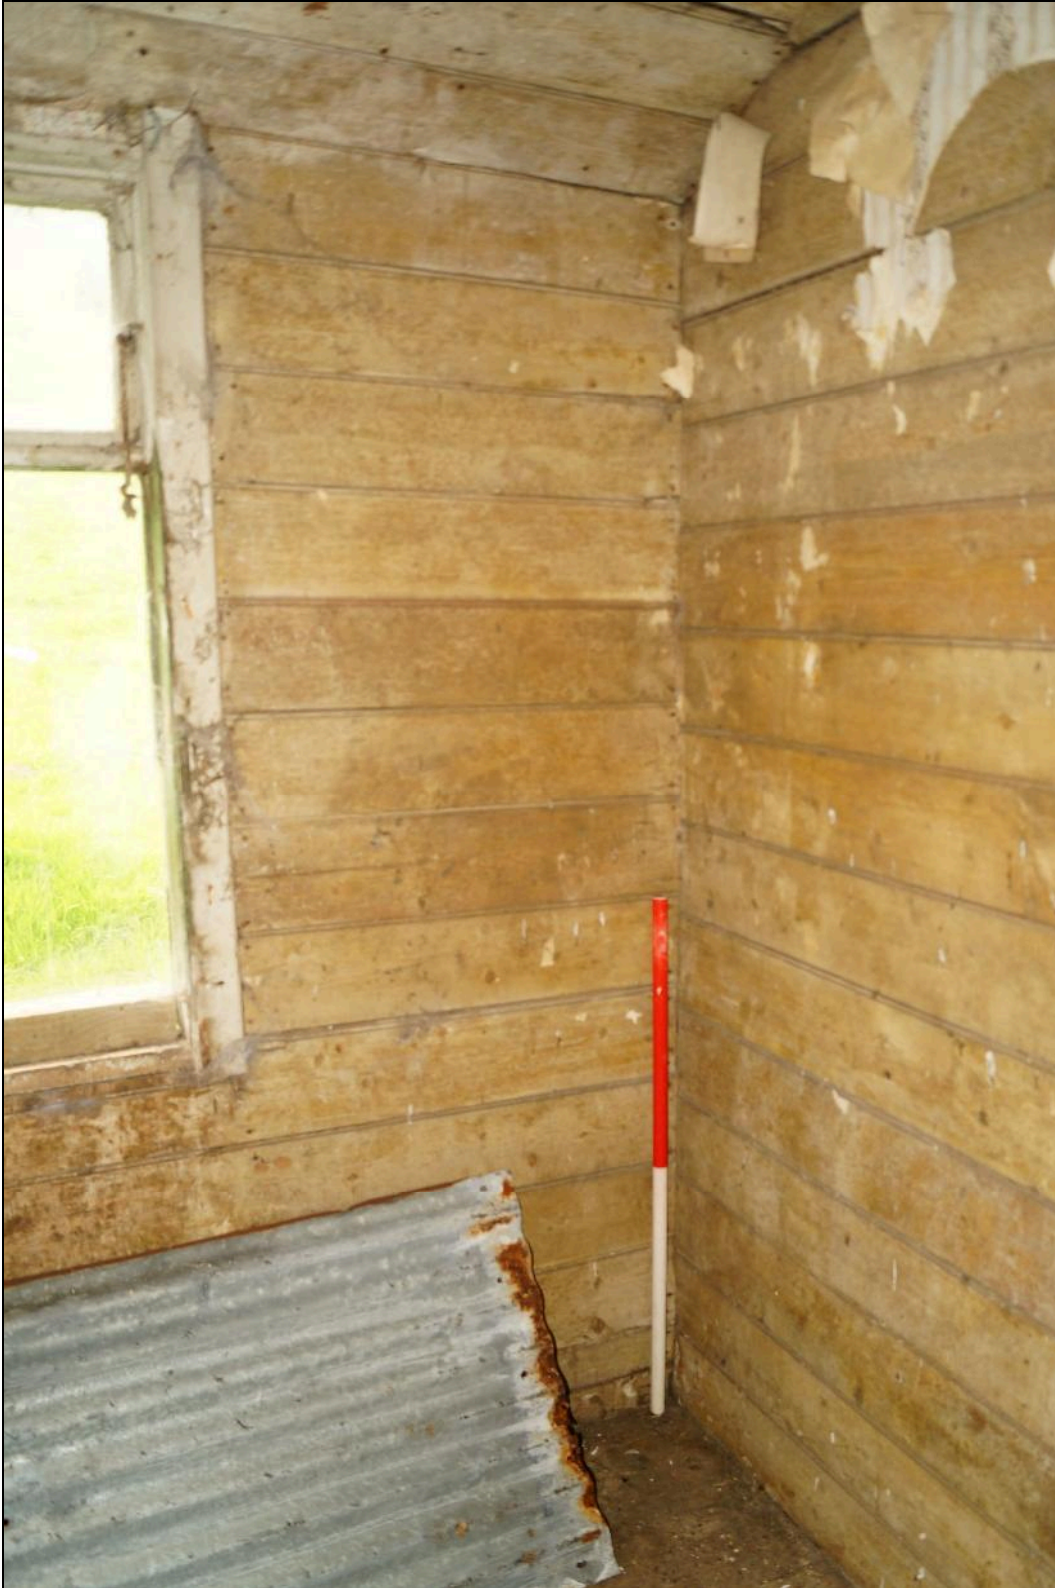
*Plate 72: CYB2018\_072. A view of the northern side of Room 05 showing the central window in the wall. Looking north-northeast.*

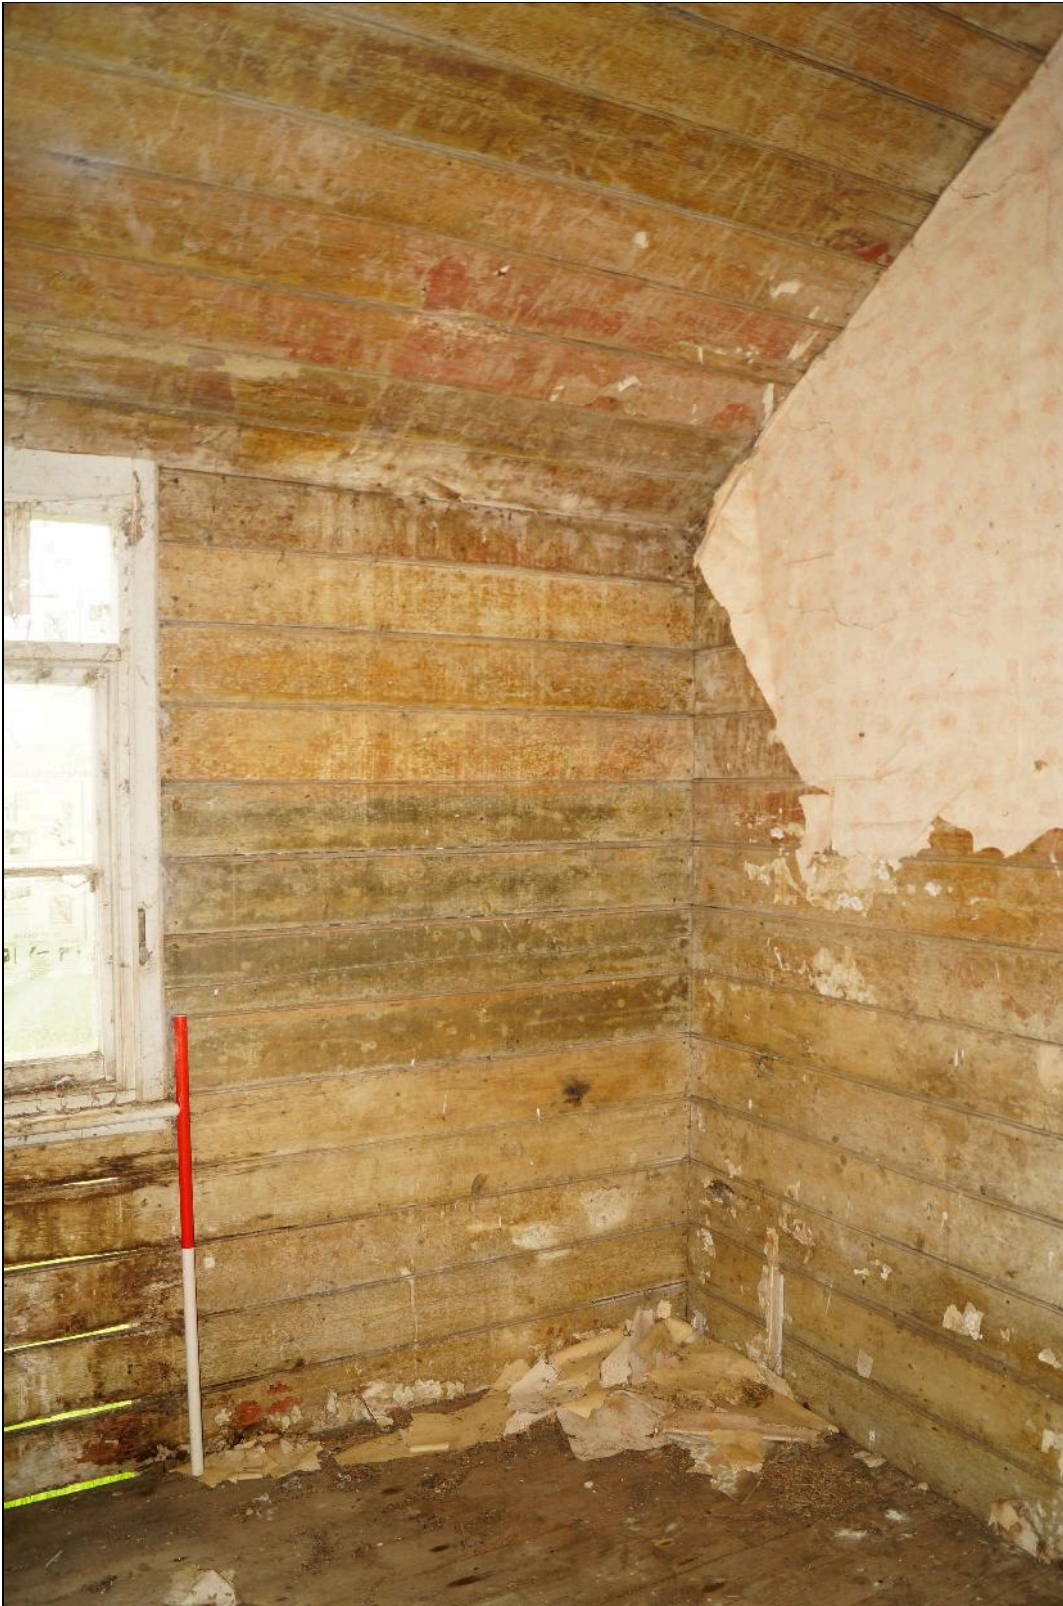
CYB2018_096	A view of the window in the southern wall of Room 08, showing the crude repair to the hole beneath the window.	South-southwest
CYB2018_097	A view of the southern side of Room 08.	Southwest
CYB2018_098	A view of the southern side of Room 08.	South-southeast
CYB2018_099	A view of the fireplace in Room 09. The fire surround and grate have been removed.	North-northwest
CYB2018_100	A view of the western side of Room 09.	West-northwest
CYB2018_101	A view of the doorway in Room 09 which leads out to Room 07, the main corridor.	North-northeast
CYB2018_102	A view of the northern side of Room 09. Note the wooden floorboards.	Northeast
CYB2018_103	A view of the eastern side of Room 09.	East-southeast
CYB2018_104	A view of the eastern side of Room 09.	Southeast
CYB2018_105	A view of the southern side of Room 09.	South-southwest
CYB2018_106	A view of the southern side of Room 09, showing the central window.	South-southwest

*Plate 96: CYB2018\_096. A view of the window in the southern wall of Room 08,  
showing the crude repair to the hole beneath the window. Looking south-southwest.*
