**Cwmclyd Farmstead,
Claerwen Valley,
Rhayader, Powys
Level 2 Building Recording
P/2017/0573 (Powys)**

For: The Elan Valley Trust

August 2018

Trysor Project No. 2018/619

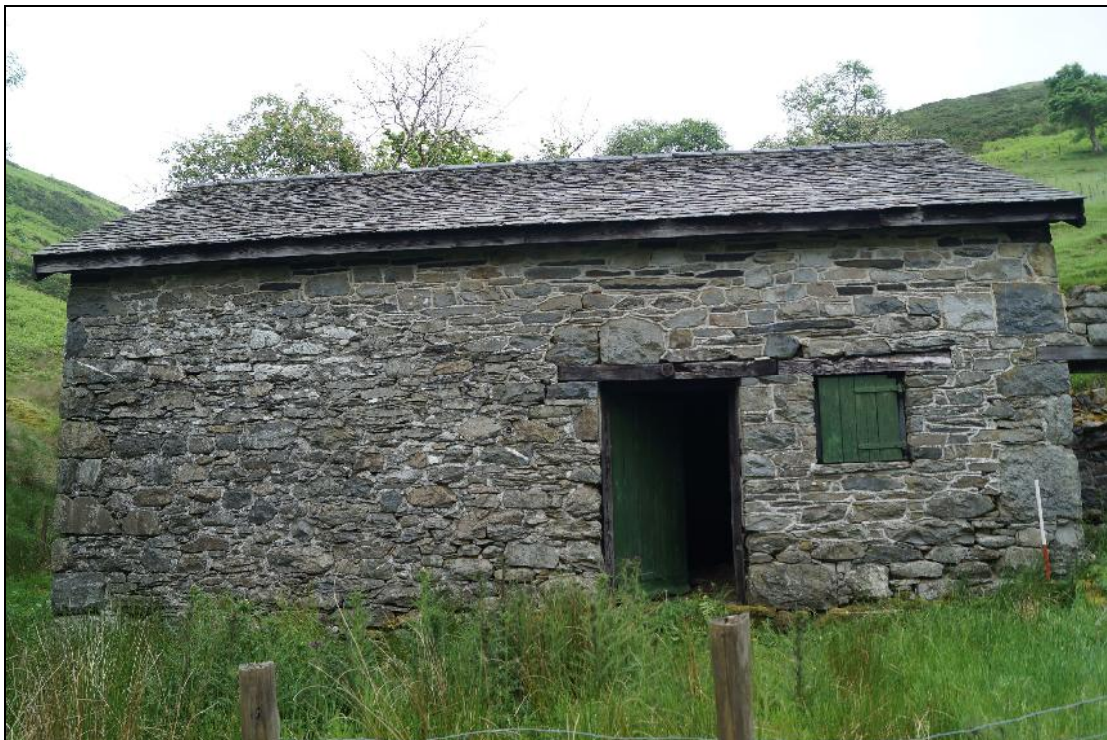
Plate 2: CYD2018_002, external view of the stable and cartshed building, looking east-northeast.

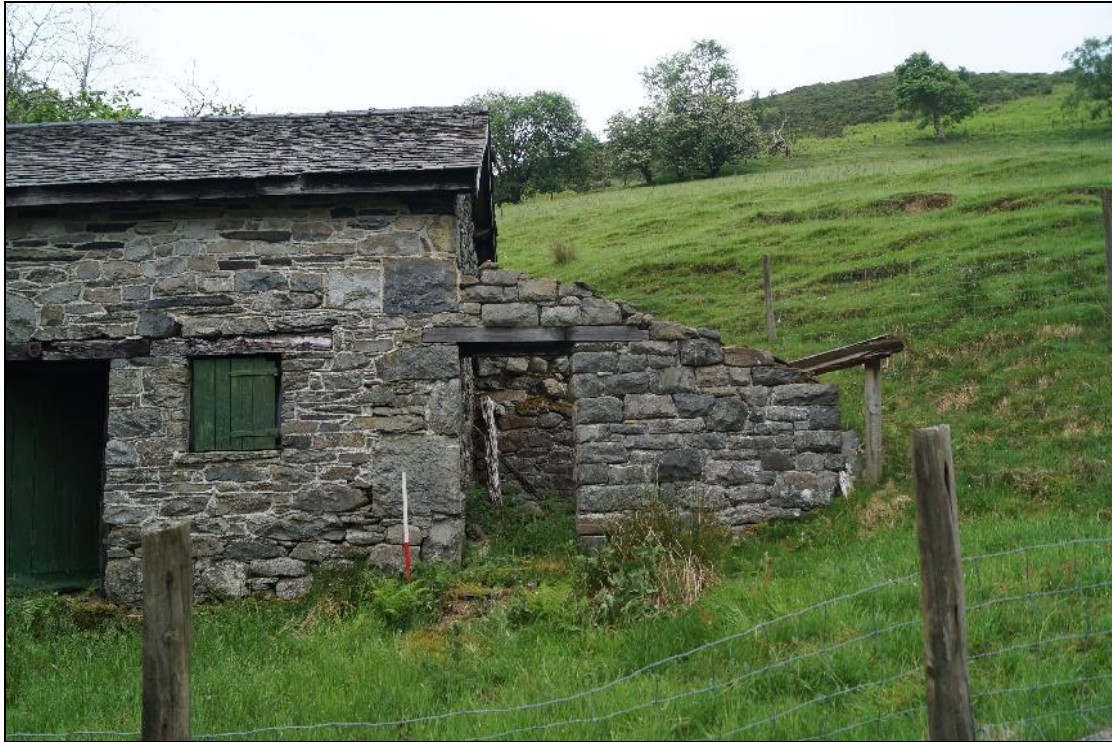
7.7.4 A small, stone-built, lean-to stood against the southern gable wall (see Plates 3, 6, 7, 10 & 11). This was roofless and in a ruinous condition. It had been built on a terrace which had been cut into the rising slope to the south, with its southern wall therefore acting as a revetment wall (see Plate 36). This lean-to was evidently built at the same time as the main building, as the timber lintel over the door in its western side extends into the fabric of the stable.

Plate 3: CYD2018_003, external view of the now roofless lean-to extension at the southern end of the stable looking east-northeast.

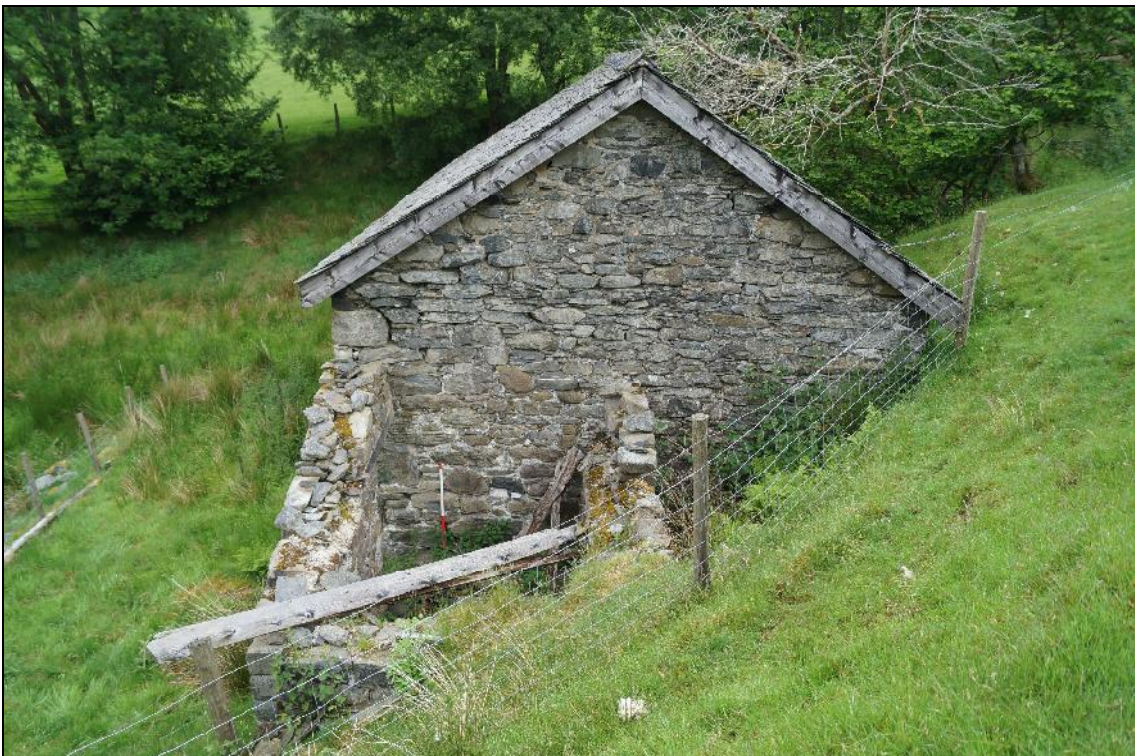
Plate 6: CYD2018_006, external view of the now roofless lean-to extension at the southern end of the stable looking north-northwest.

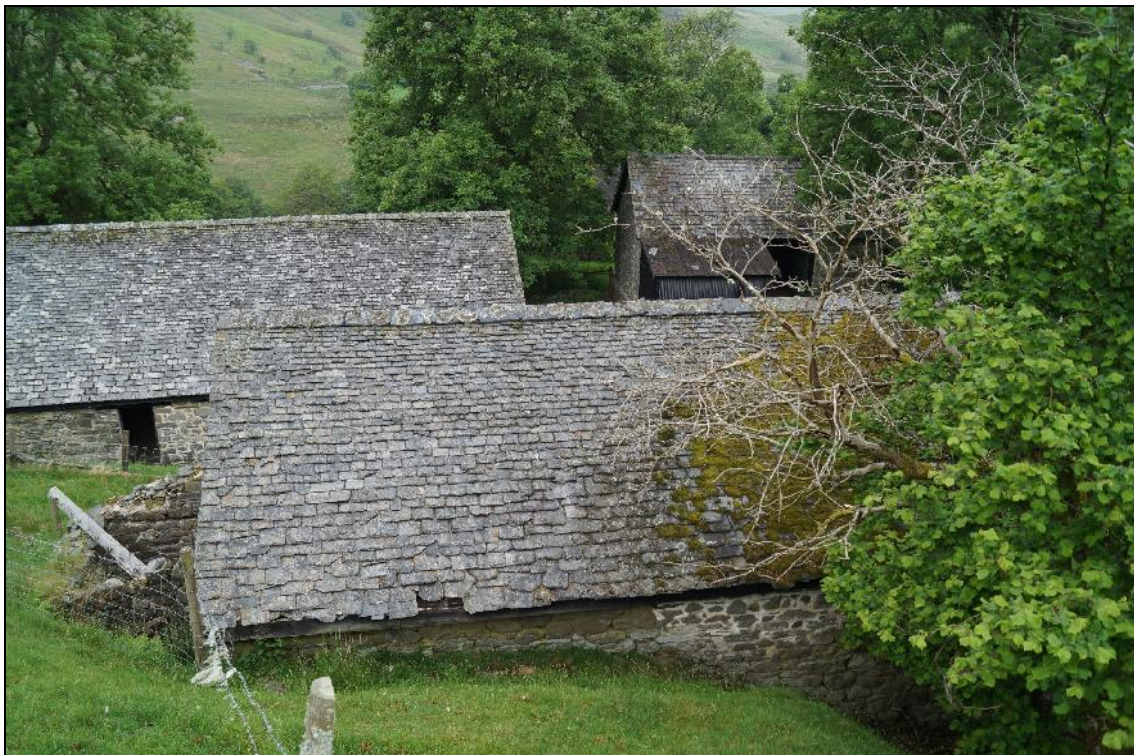
Plate 8: CYD2018_008, external view of the stable and cartshed roof looking west-southwest.

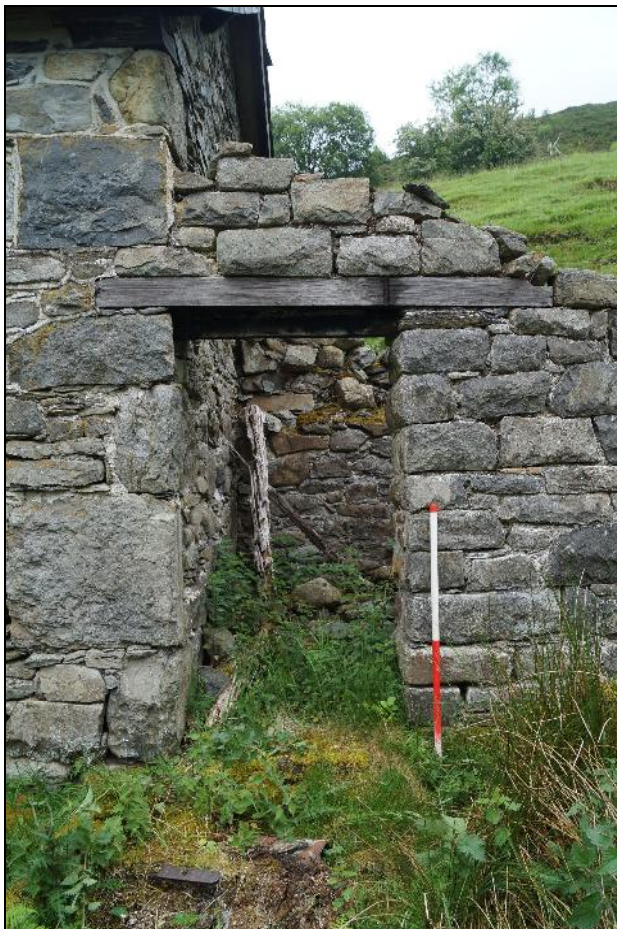
Plate 10: CYD2018_010, external view of the doorway of the now roofless lean-to extension at the southern end of the stable looking east-northeast.

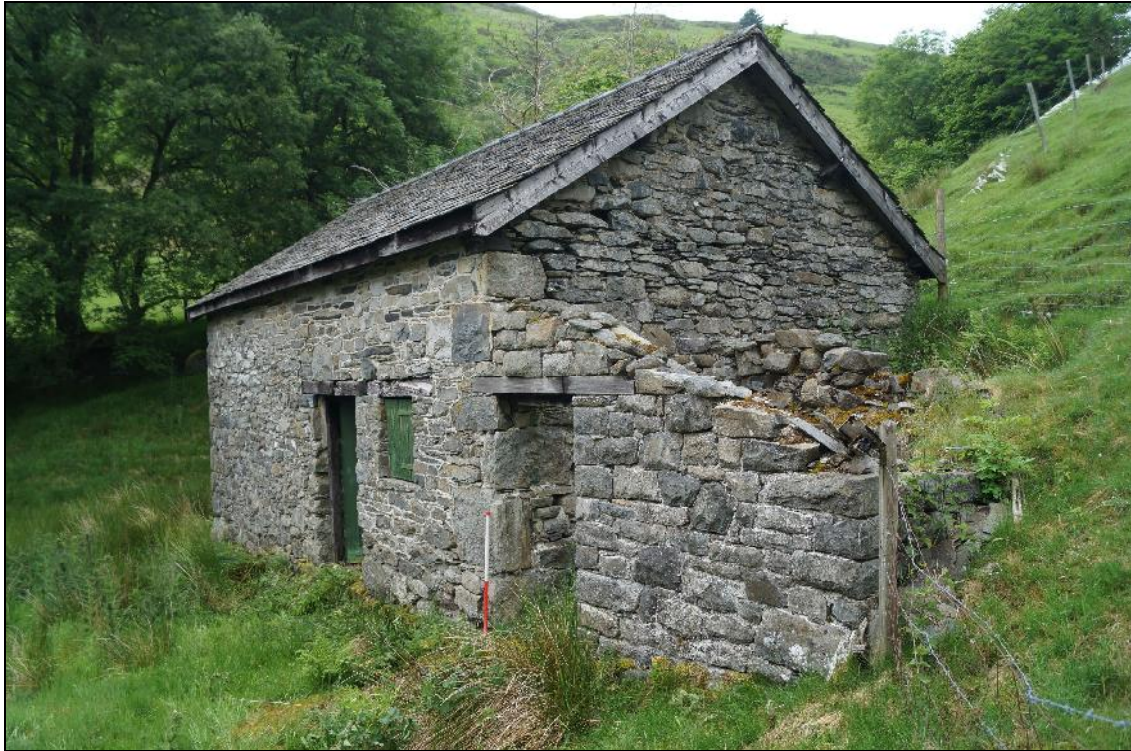
Plate 11: CYD2018_011, external view of the stable and cartshed building looking north.

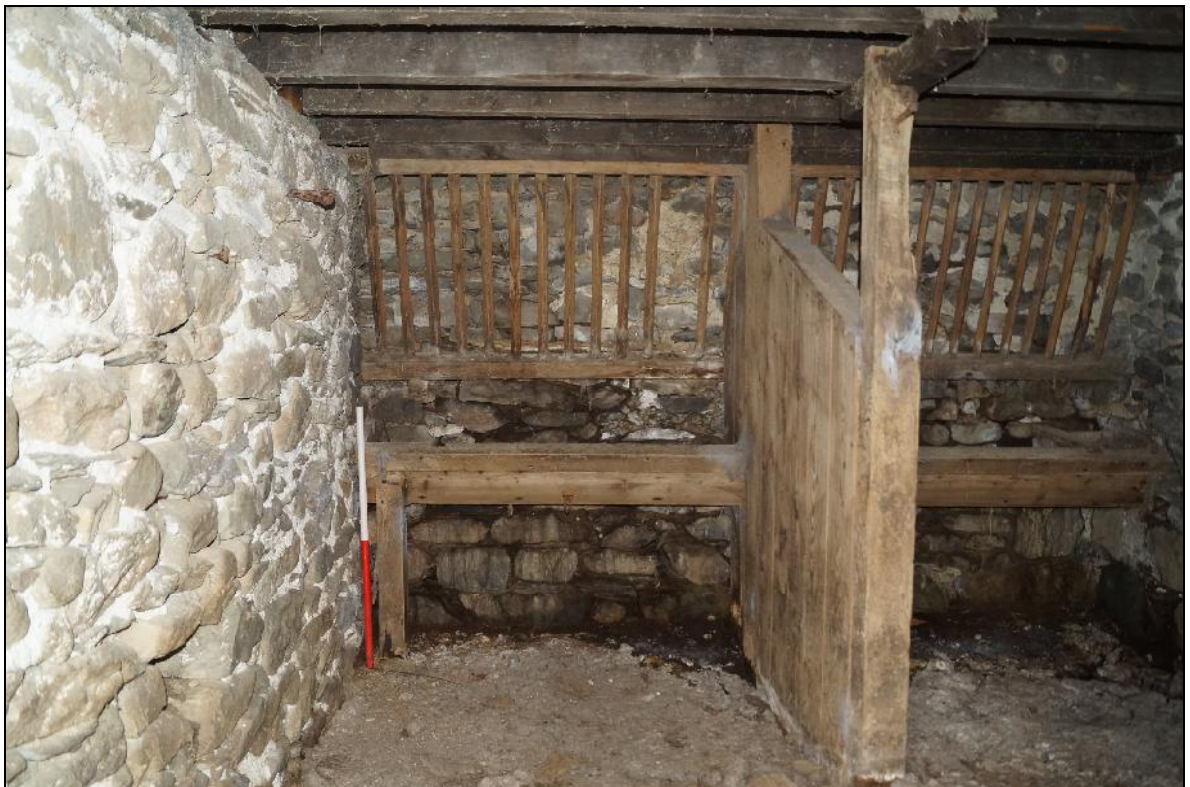
7.7.3 The stable occupies the southern half of the building. This portion is accessed through a single doorway in the west-facing wall (see Plate 2) and there is a small, shuttered window to the southern side of the doorway. Internally, there are two wooden feeding stalls against the eastern wall (see Plates 22-27), separated by a wooden partition. Above the feeders are gaps in the ceiling to allow hay to be thrown down from the hayloft above. The floor of the stable is obscured by a thick layer of dung, although this was thin enough inside the doorway to be scraped away to reveal a cobbled floor below (see Plate 35).

Plate 22: CYD2018_022, an internal view of the stable, showing the northern feeding stall, looking east-northeast.

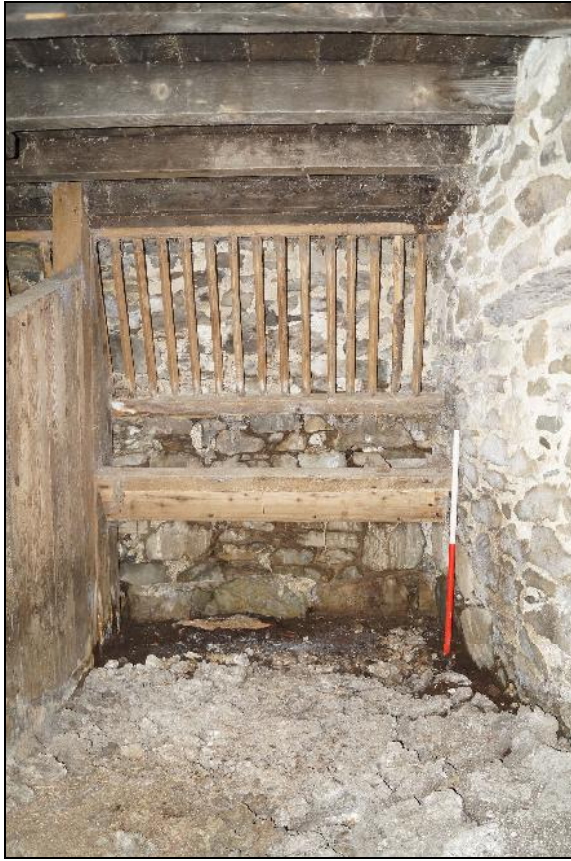
Plate 23: CYD2018_023, an internal view of the stable, showing the southern feeding stall, looking east-northeast.

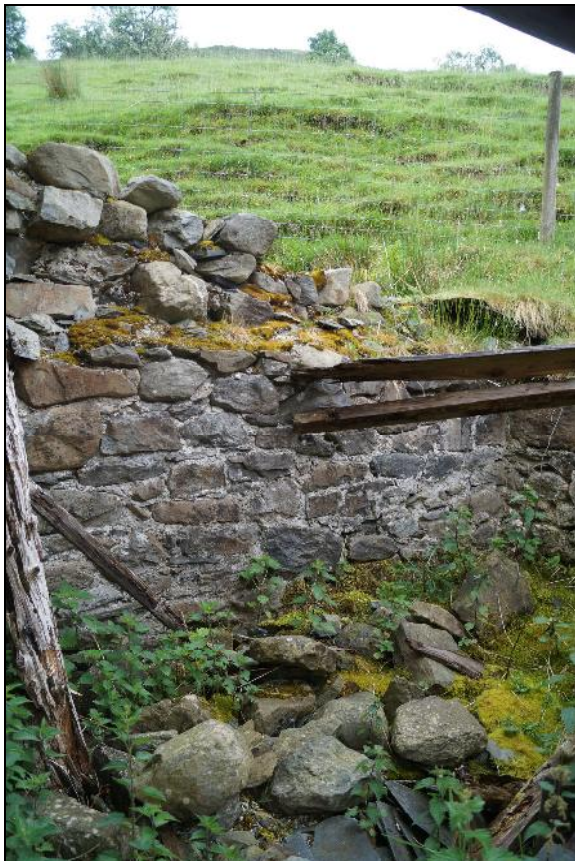
Plate 36: CYD2018_036, a view of the ruined lean-to extension at the southern end of the stable and cartshed building, looking south-southeast.

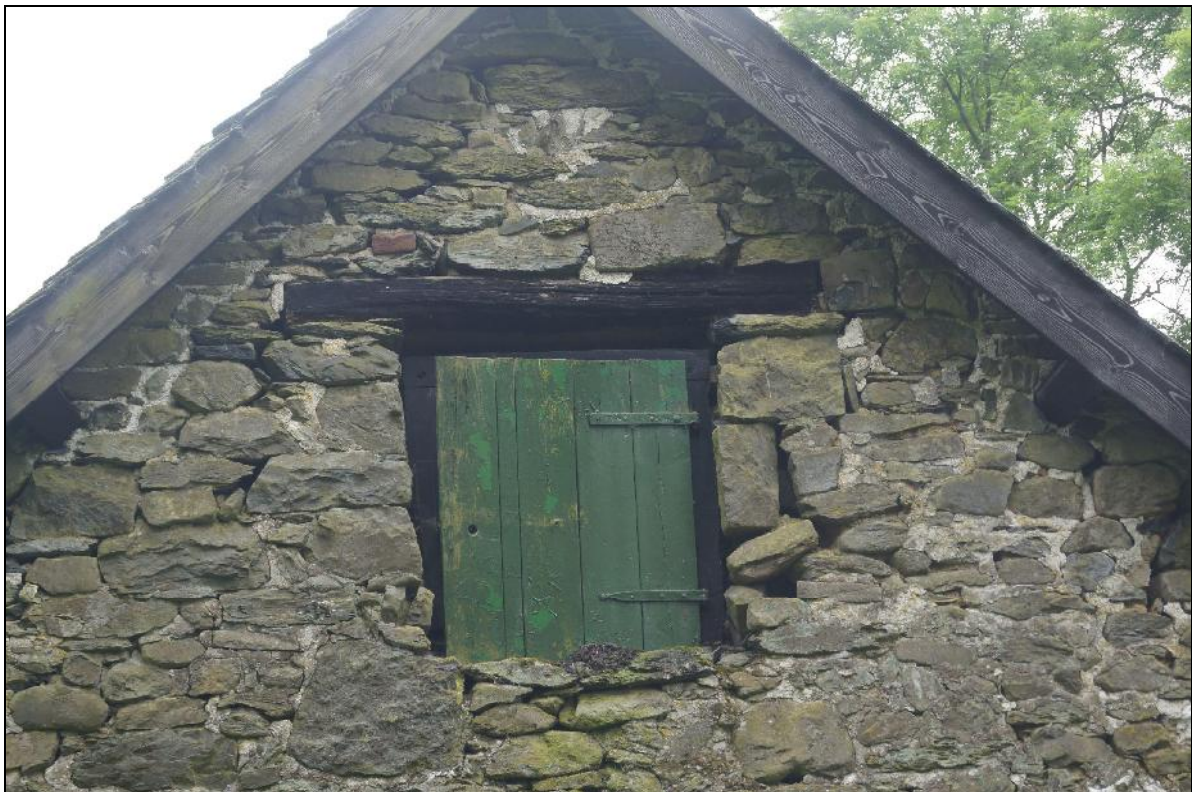
7.6.8 Historic Ordnance Survey maps show that a benchmark was carved into the northern gable end of the farmhouse and cowshed building, marking an altitude of 1021.8 feet. This benchmark is clearly visible near the bottom of the wall (it can be seen left of centre in Plate 37).

Plate 37: CYD2018_037, an external view of the north wall of the house and cowshed building, looking east-southeast. An Ordnance Survey benchmark is visible towards the base of the centre of the wall.

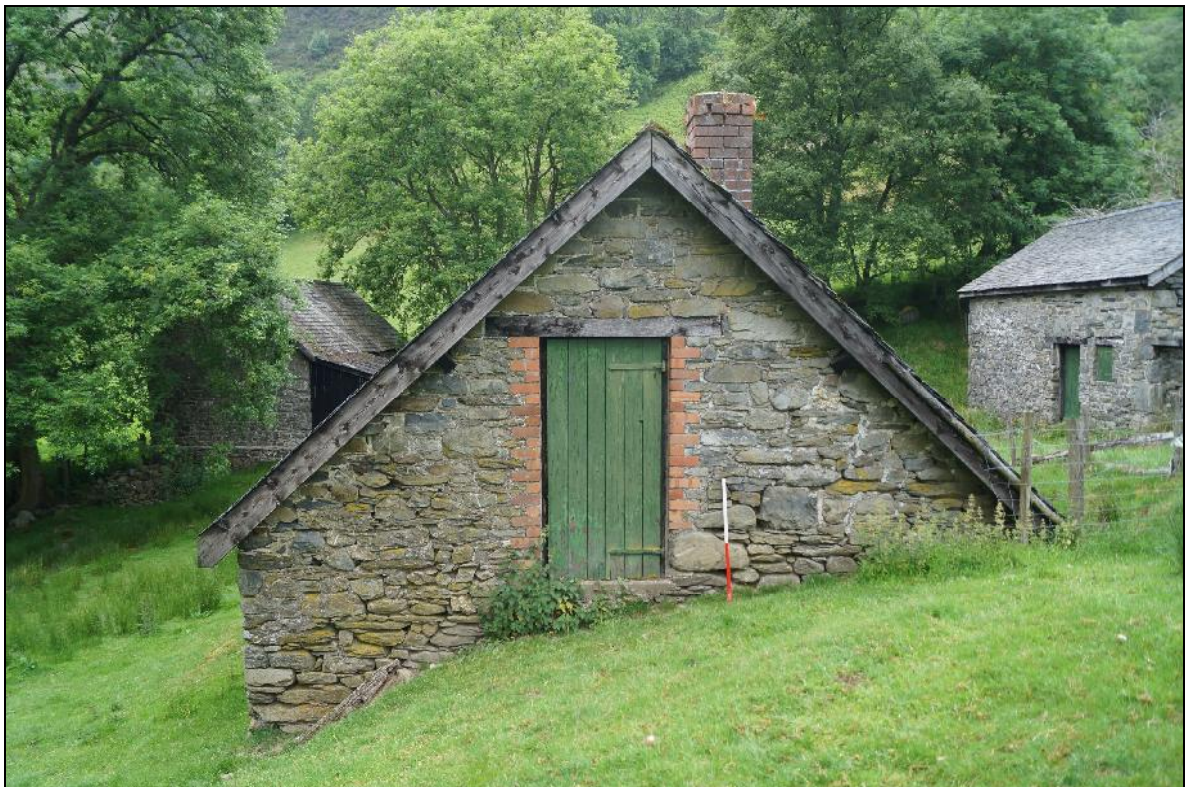
7.6.4 The farmhouse and cowshed building is also terraced into the slope along its eastern side, where a 1.25 metre-wide pathway has been created to give access to the dairy and cowshed doors (see Plate 39). The edge of the cut into the slope along this side is revetted with stone.

Plate 39: CYD2018_039, an external view of the house and cowshed building, looking south.

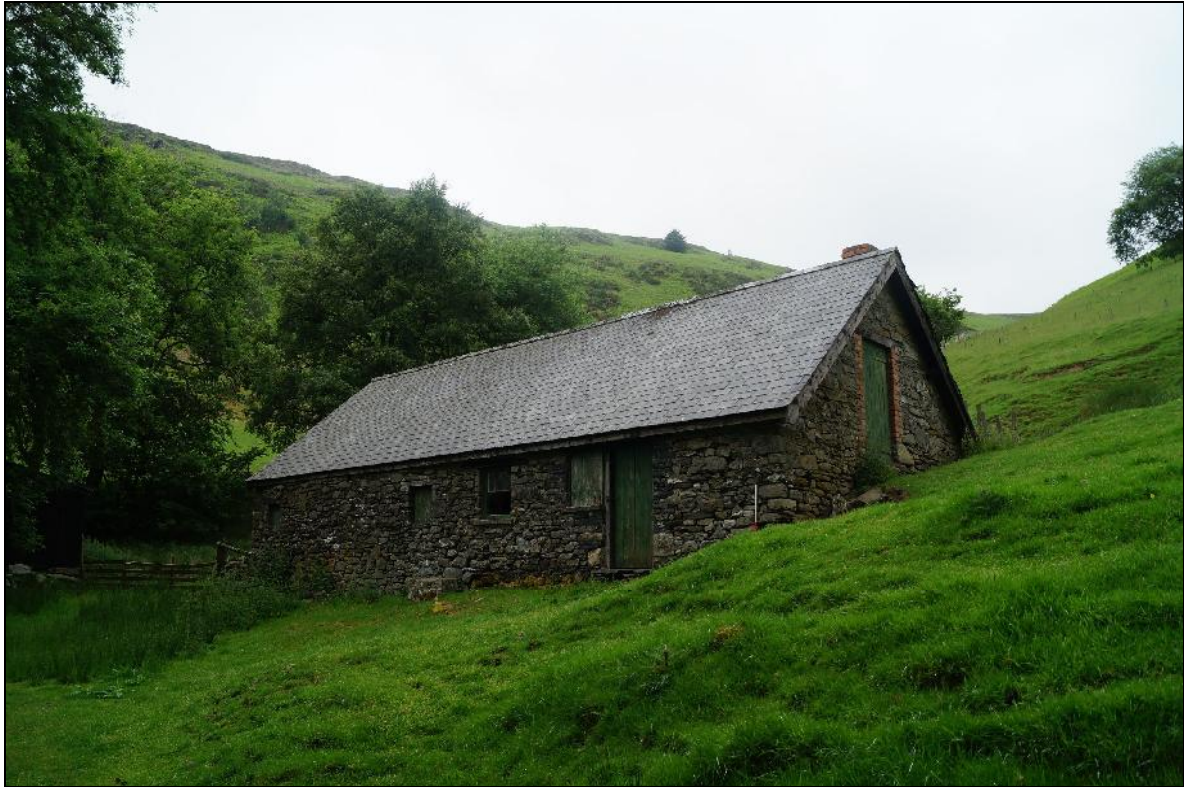
7.6.3 The southeastern corner of the building, at the house end, is terraced into the slope (see Plates 40 & 41). At this corner there is the scar of an infilled doorway, with a sawn timber lintel still in place above (see Plate 91). From the interior, this looks like a simple, blocked-up doorway. From the outside, the southern part of this "door" is however buried in the slope (see Plate 43). If this was a doorway, it is evident that earth has either been piled around the southeastern corner of the building after it was constructed or has slumped forward. This is the doorway identified on the RCAHMW plan of 1990 as a "blocked original door".

7.6.5 The stairs which lead from the kitchen up to the loft at the southern end of the building also lead to a doorway out through the upper part of the gable wall, emerging at ground level due to the terracing of the building into the slope at this end (see Plate 40).

7.6.6 The RCAHMW were correct to state that the original chimney had been removed from the house, but do not mention that a replacement, red-brick, chimney had been inserted at some point (see Plates 40, 44 & 108). This chimney would probably have served the cast-iron range which formerly stood in the fireplace.

Plate 40: CYD2018_040, an external view of the south wall of the house and cowshed building, looking north-northwest.

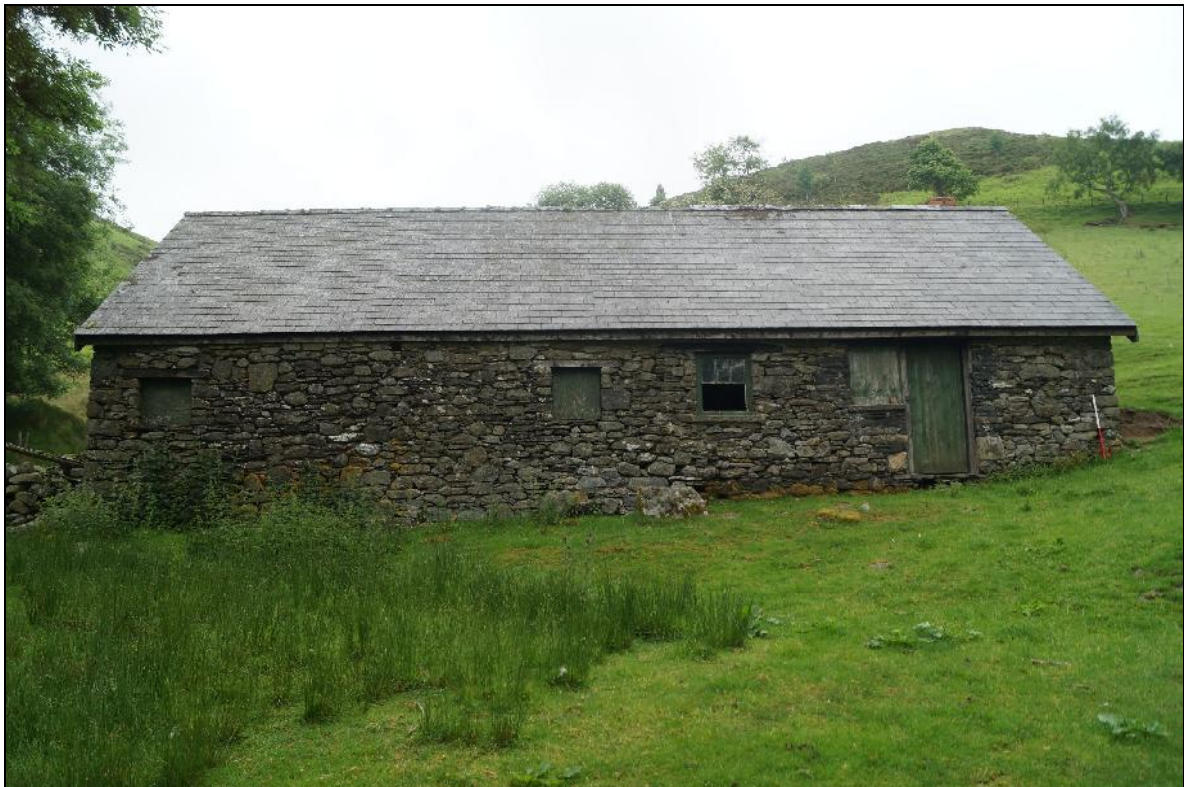
Plate 41: CYD2018_041, an external view of the house and cowshed building, looking northeast.

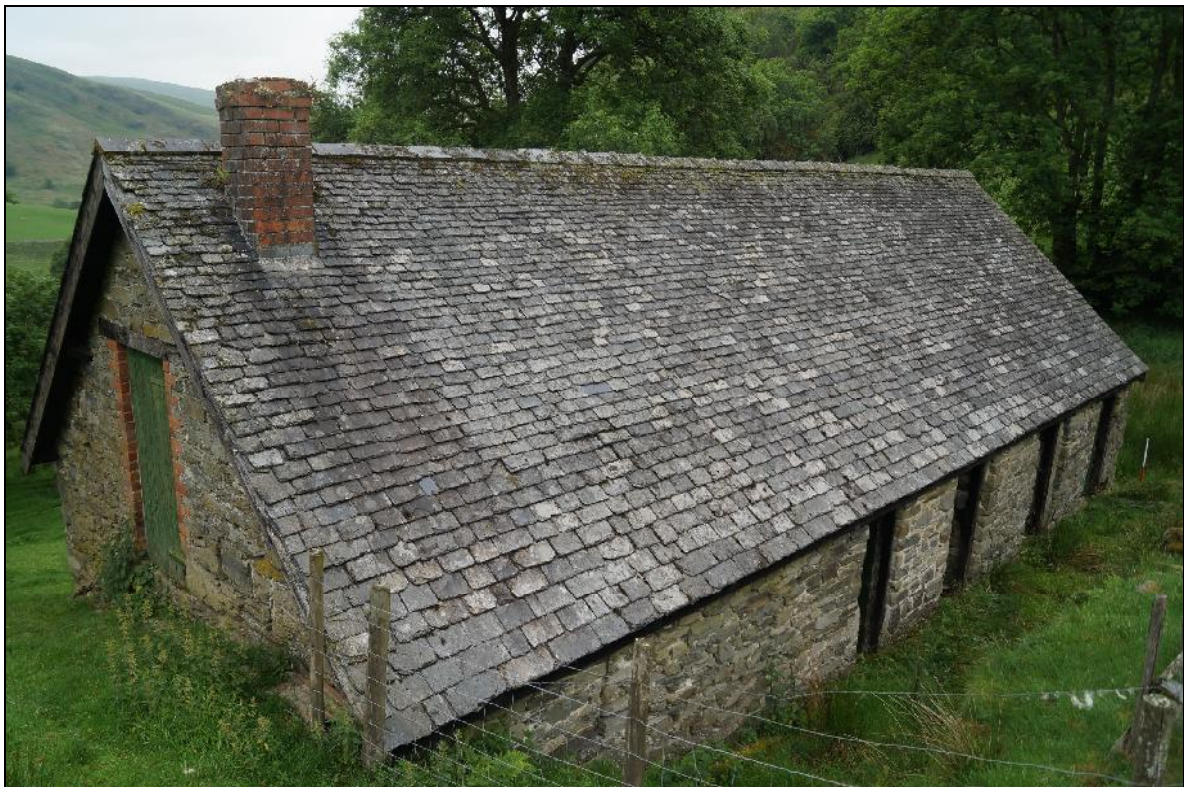
Plate 43: CYD2018_043, external view of the southern end of the house and cowshed building, looking west-southwest, showing rip joint said to represent an original doorway (see Plates 90 & 91 for internal views).
